# *City of Boiling Spring Lakes*

## STAFF REPORT

Stormwater Department Status of Work Completed

Stormwater

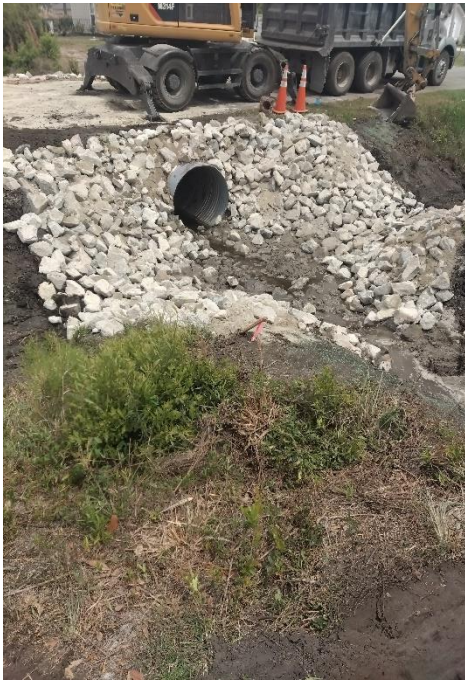
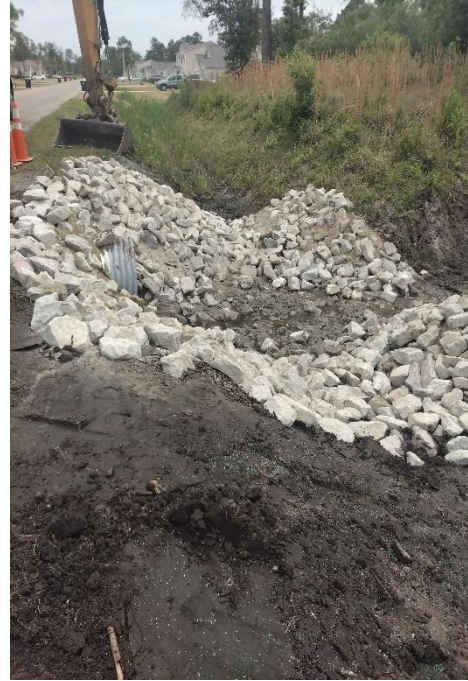
Pine Needles Road  
Pipe Replacement-Downstream

In addition to ditching and stormwater maintenance, the team has completed upgrading pipe culverts on Pine Needles and Westway in the Highlands section of the city. These areas have been problematic with flooding. The existing pipes were 36" corrugated metal pipe (CMP) on Pine Needles and a 24" plastic pipe (HDPE) on Westway that did not provide enough hydraulic capacity to efficiently handle larger storm events resulting in frequent flooding. The stormwater team removed the existing pipes with a 48" corrugated metal pipe (CMP-round) on Pine Needles and a 57"x 38" arched corrugated metal pipe (CMP-arched) on Westway. The arched pipe was used on Westway to provide additional hydraulic capacity with existing pipe cover requirements. In addition to the pipe repairs, we are coordinating pavement repair with the home building group for those streets. Another upgrade to our existing stormwater system was located at a cross culvert along Windemere. This cross culvert had signs of soil erosion and wash out at the downstream side of the pipe. Our goal was to repair the wash out and provide additional protection downstream from future storm events. The team added a galvanized flared end section (FES) to the existing

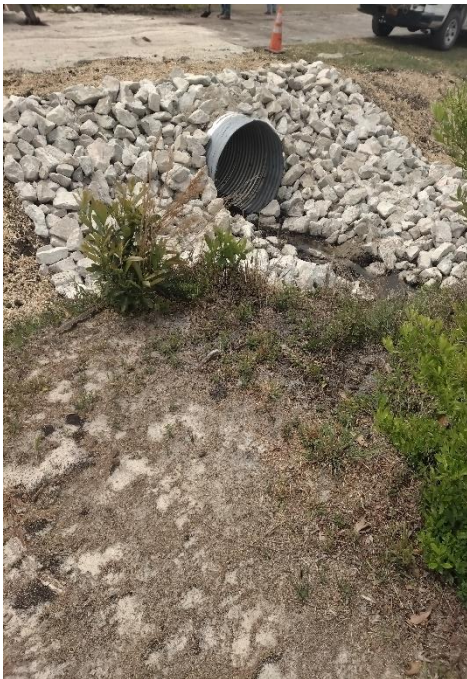
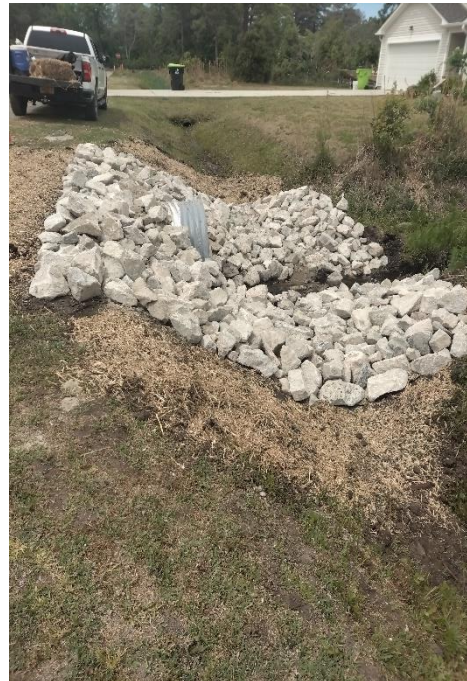
Pine Needles Road  
Pipe Replacement-Upstream

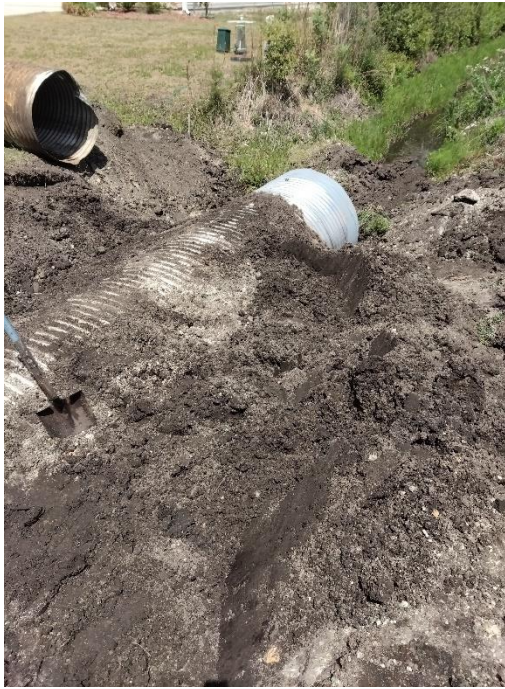
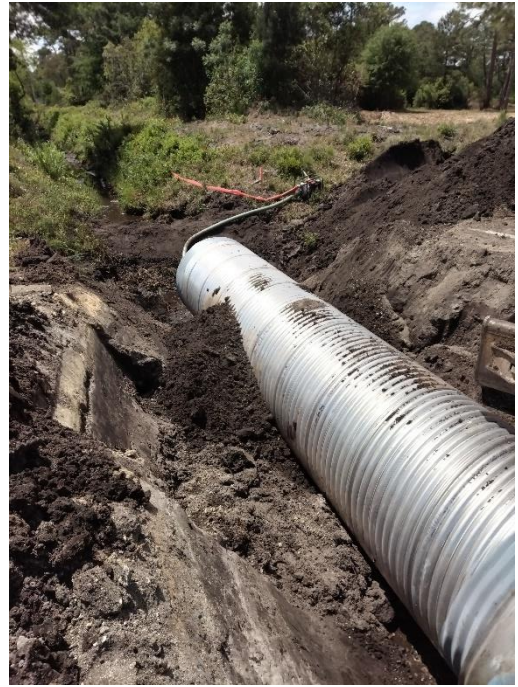
Pine Needles Road  
48" CMP Pipe Installation

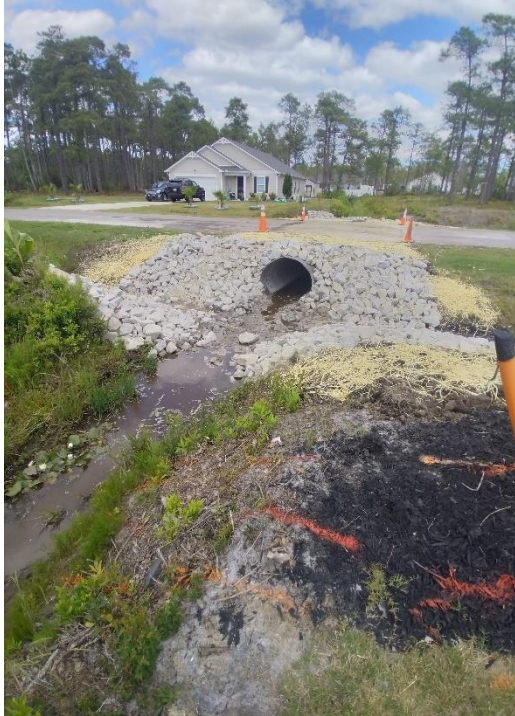
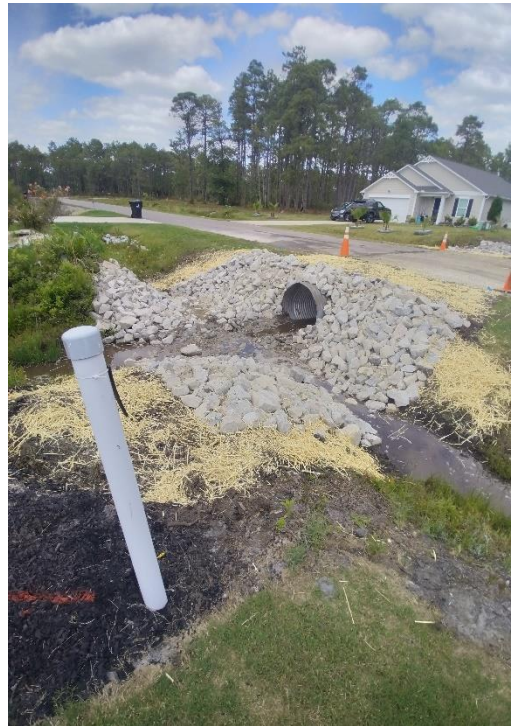
Westway Road  
Pipe Replacement-Downstream

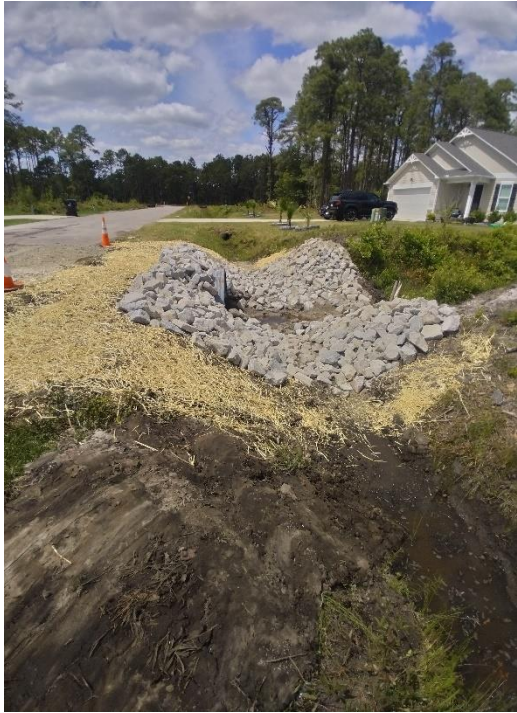
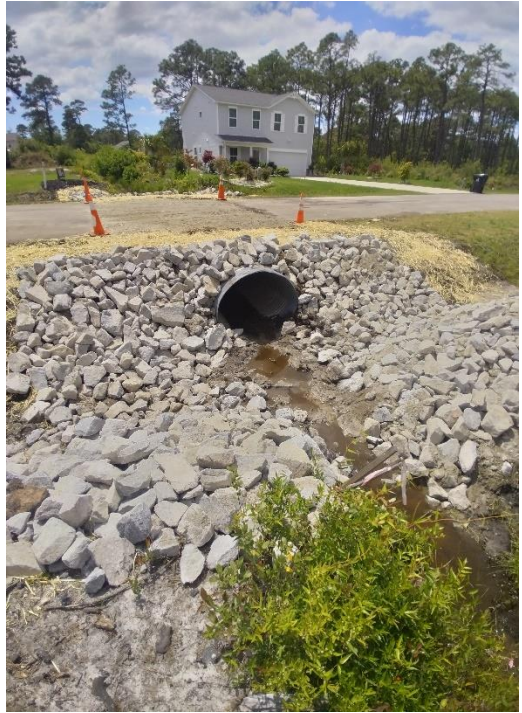
Westway Road  
Pipe Replacement-Upstream

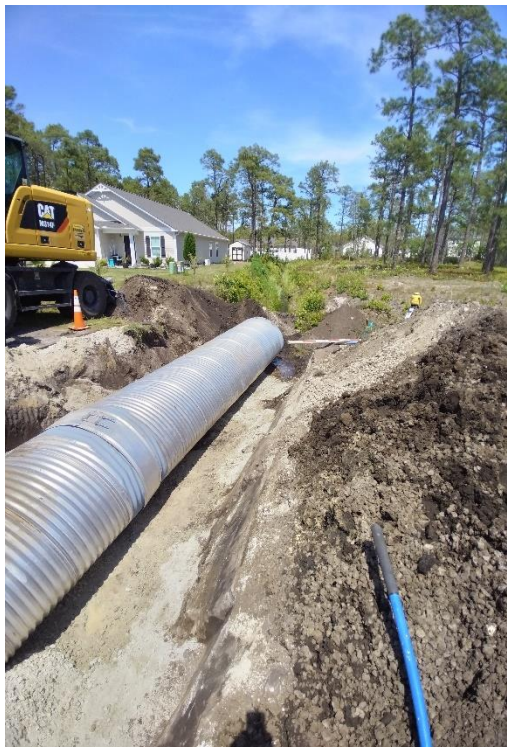
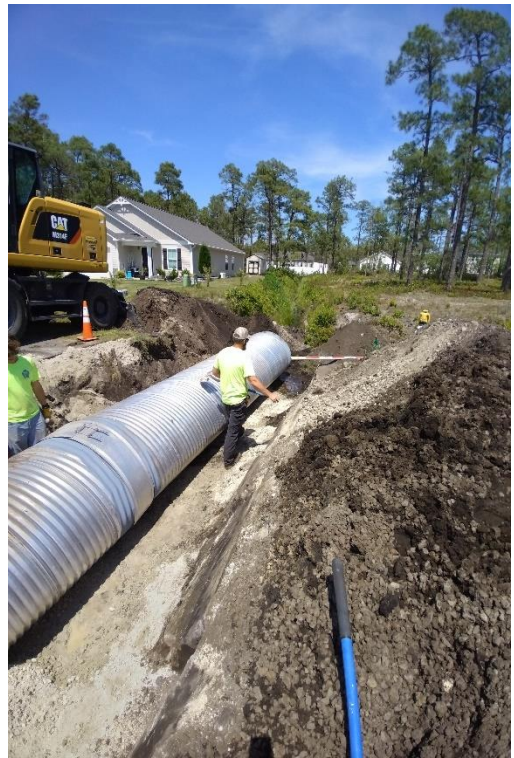
Westway Road  
Arch Pipe Installation

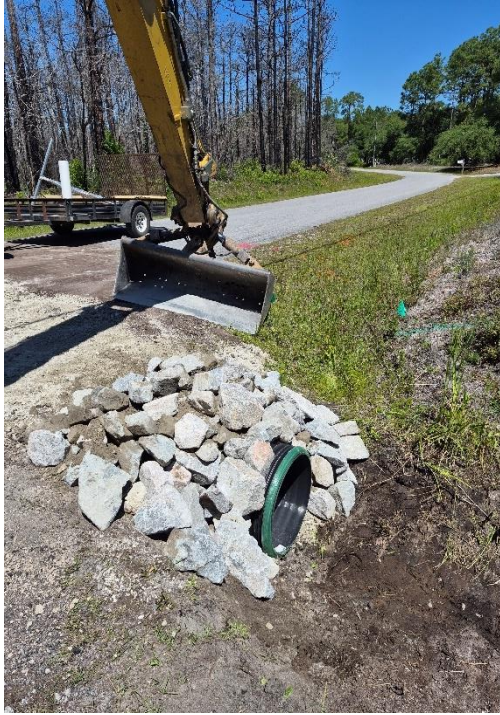
Typical Cross Culvert Repair  
Upstream

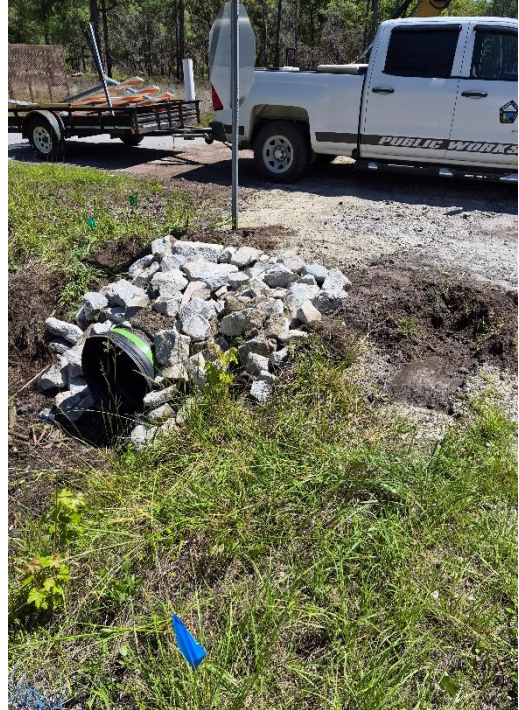
Typical Cross Culvert Repair  
Downstream

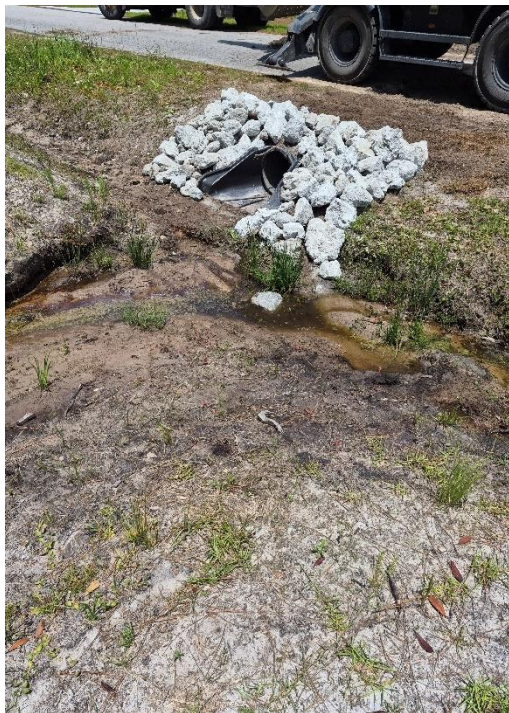
Stormwater Management Plan  
Pipe Replacement w/FES

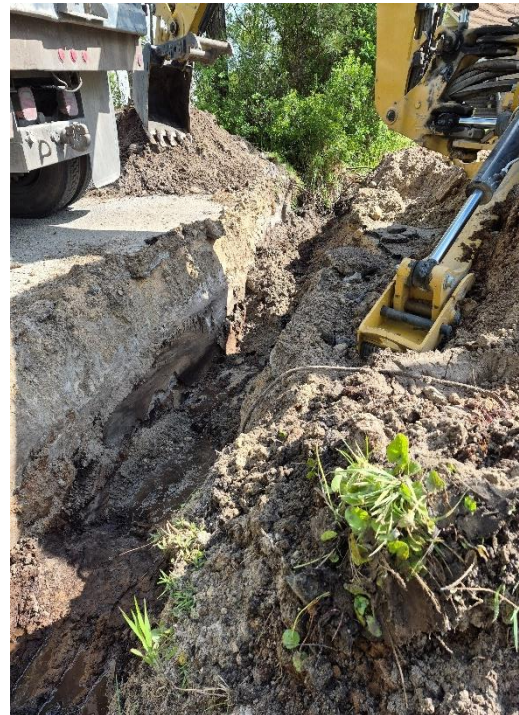
Stormwater Management Plan  
Pipe Excavation

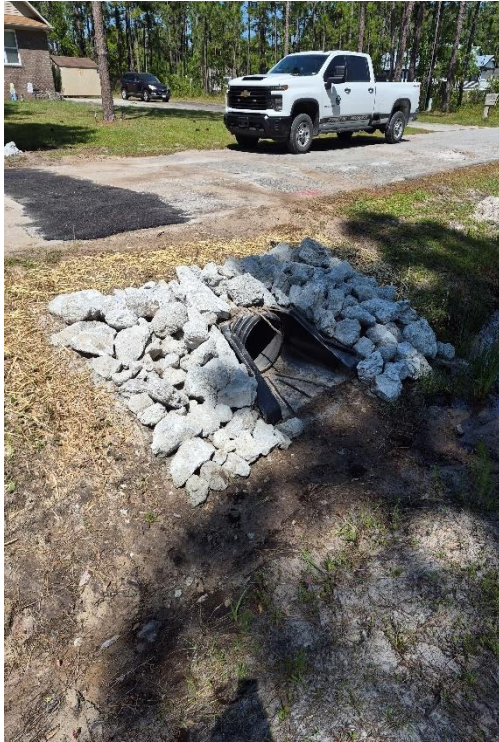
Stormwater Management Plan  
Pipe & Road Repair

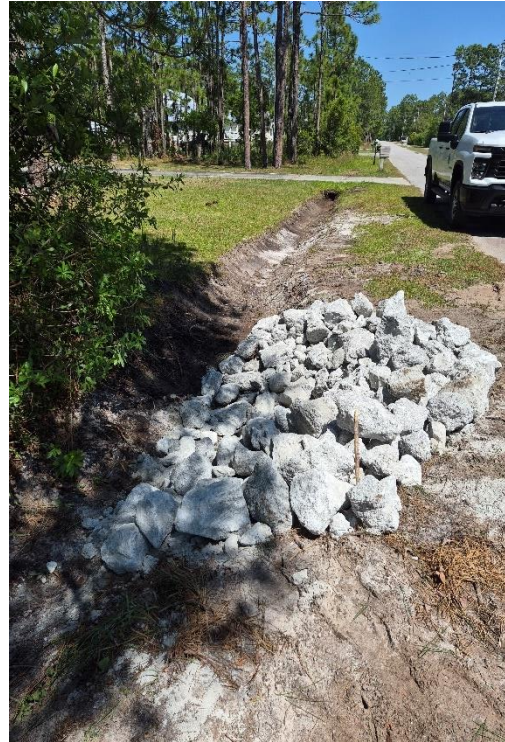
Stormwater Management Plan  
Upstream Inlet Protection

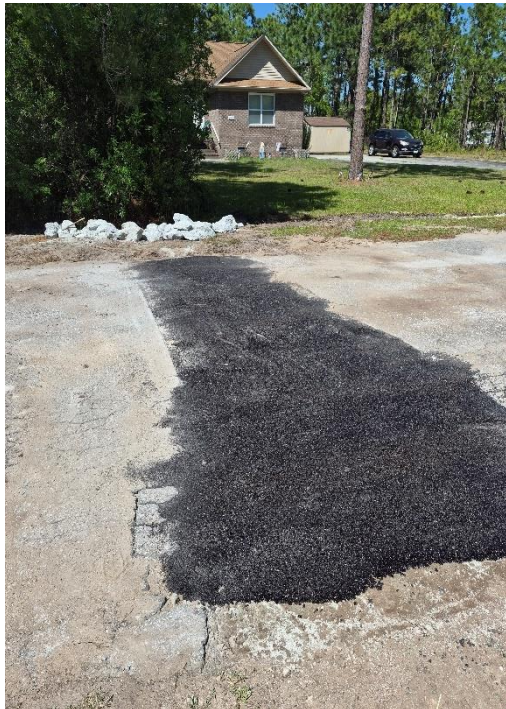
Stormwater Management Plan  
Pipe/Road Repair

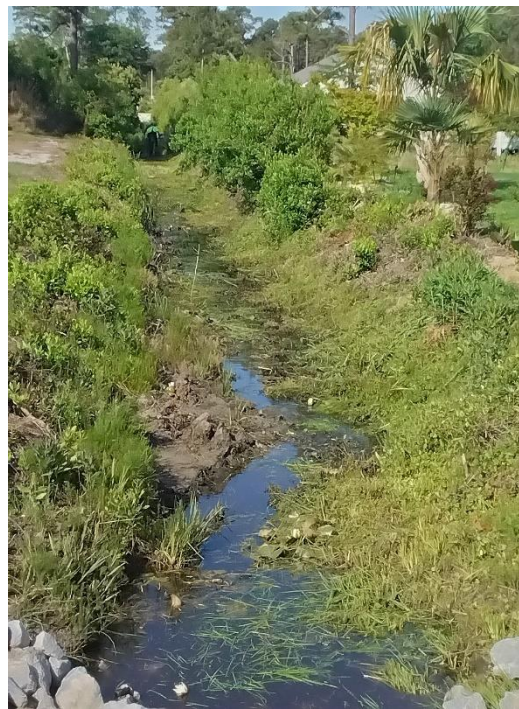
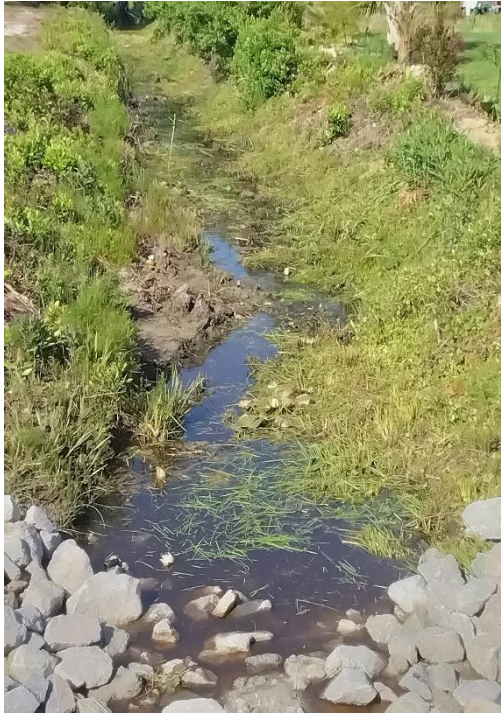
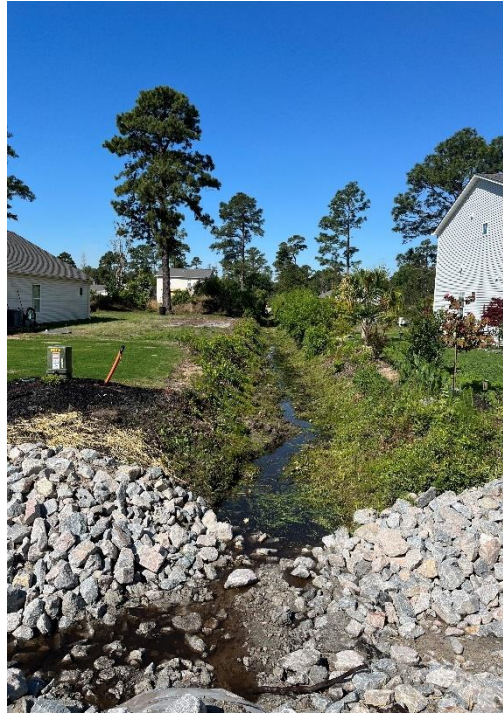
General Primary Ditch  
Maintenance

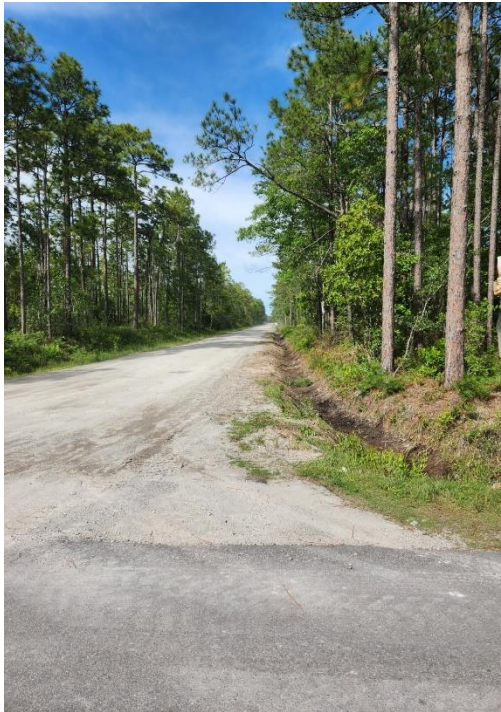
General Roadside Ditching

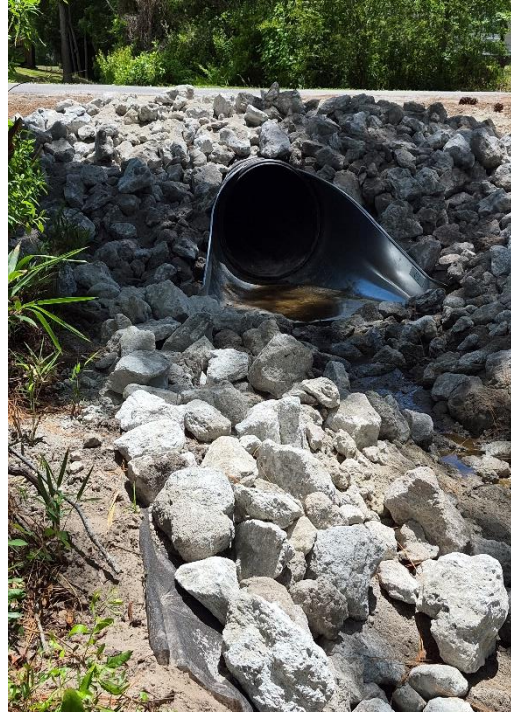
Windemere Pipe Upgrade Downstream  
New FES and Rip-Rap

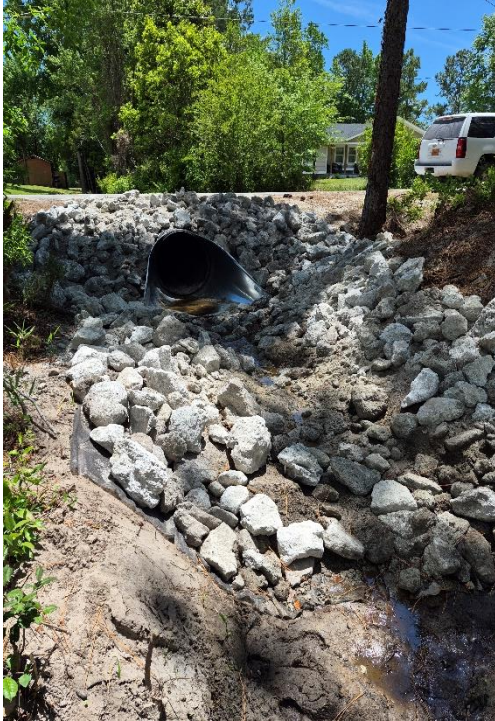
Windemere Pipe Upgrade Downstream  
Flared End Section and Rip-Rap Protection

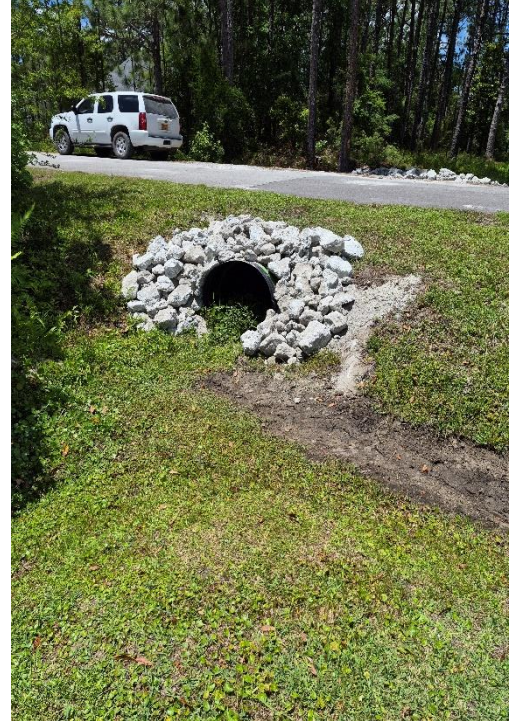
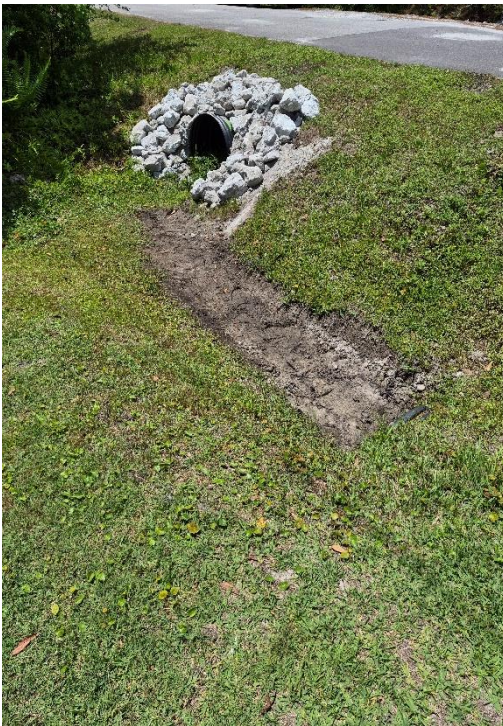
Windemere Cross Culvert  
Rip-Rap Protection Upstream
