ADDENDUM #2

**REPORT
OF
ACCESS RAILROAD SINKHOLE INVESTIGATION
BOILING SPRING LAKES, NC**

Remedial Dam Repair Investigation
and Design Report
Boiling Springs Lake Dam
Boiling Springs Lake, North Carolina
S&ME Job No. 1051-87-291

**REPORT OF SUBSURFACE EXPLORATION AND GEOTECHNICAL
ENGINEERING ANALYSIS**

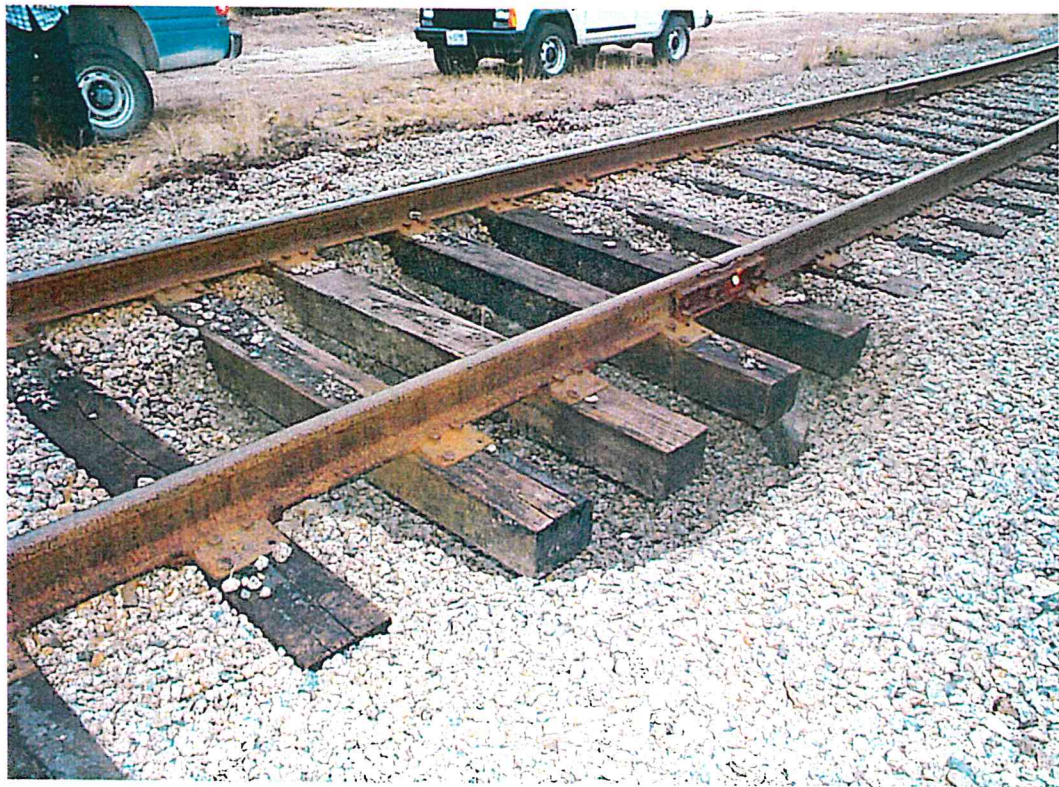
On 8 January, 2001, a sinkhole approximately 8 feet in diameter appeared underneath the access railroad track at approximate station 837+77 (about 522 feet south of the south end of the land bridge constructed in 1987), in the vicinity of an existing paleo-sink pond that was apparently partially filled in during construction of the railroad embankment (Photo 1, and Figure 4). MOTSU railroad crews discovered the sinkhole. As a result of the sinkhole, the access track was temporarily closed to traffic. On 9 January, the MOTSU Public Works Office requested that the Savannah District Geology, Hydrogeology and HTRW Design section mobilize to the site to determine the cause and extent of the problem.

Photo 1. New Sinkhole Under Track at Station 837+77.

Based on these initial findings, the Savannah District recommended a temporary repair. On 12 January 2001, a MOTSU rail crew backfilled the sinkhole with railroad ballast stone and tamped it. After the repair, the section of track was tested by driving a locomotive back and forth across the area.

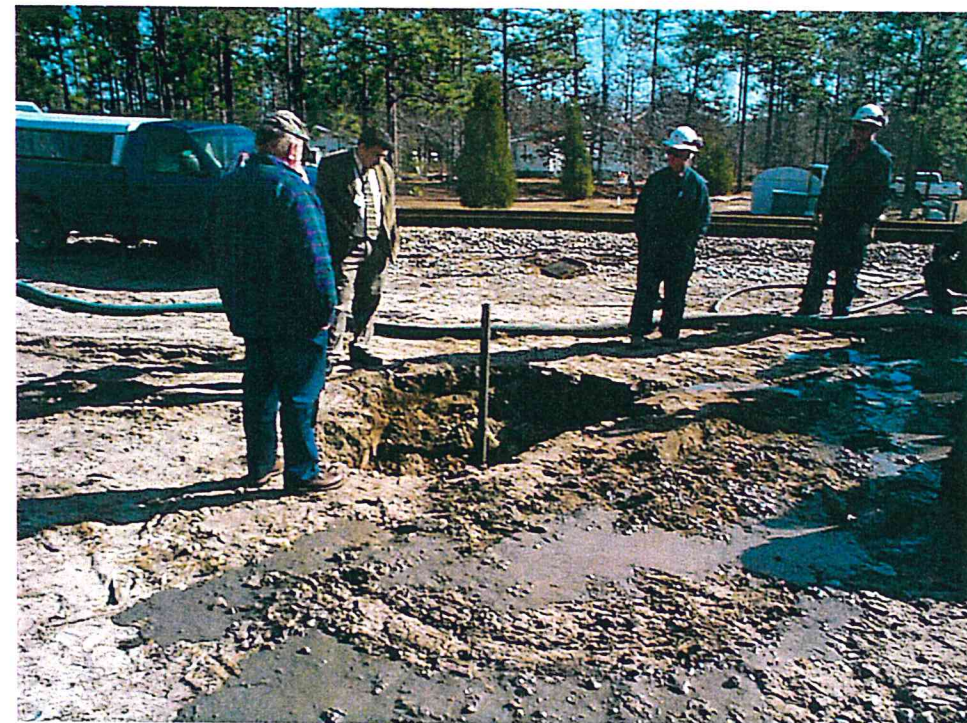
feet, all drilling fluid in the borehole was lost and soil from above this zone could be heard caving into the uncased hole. Shortly thereafter an approximately 20-foot diameter area underneath the rear end of the drill rig began to slump down about one-half foot. Since the boring was about 4.5 feet into the shelly SC zone when fluid was lost, it is apparent that a void exists within or below this zone. When this zone is breached, loose, sandy soil from above and just below a shallow dense soil zone flows down into the void, causing the bridged-over dense sand to collapse up to the ground surface due to lack of support below.

Photo 4. Sink Which Occurred Under Drill Rig at SPC-3.

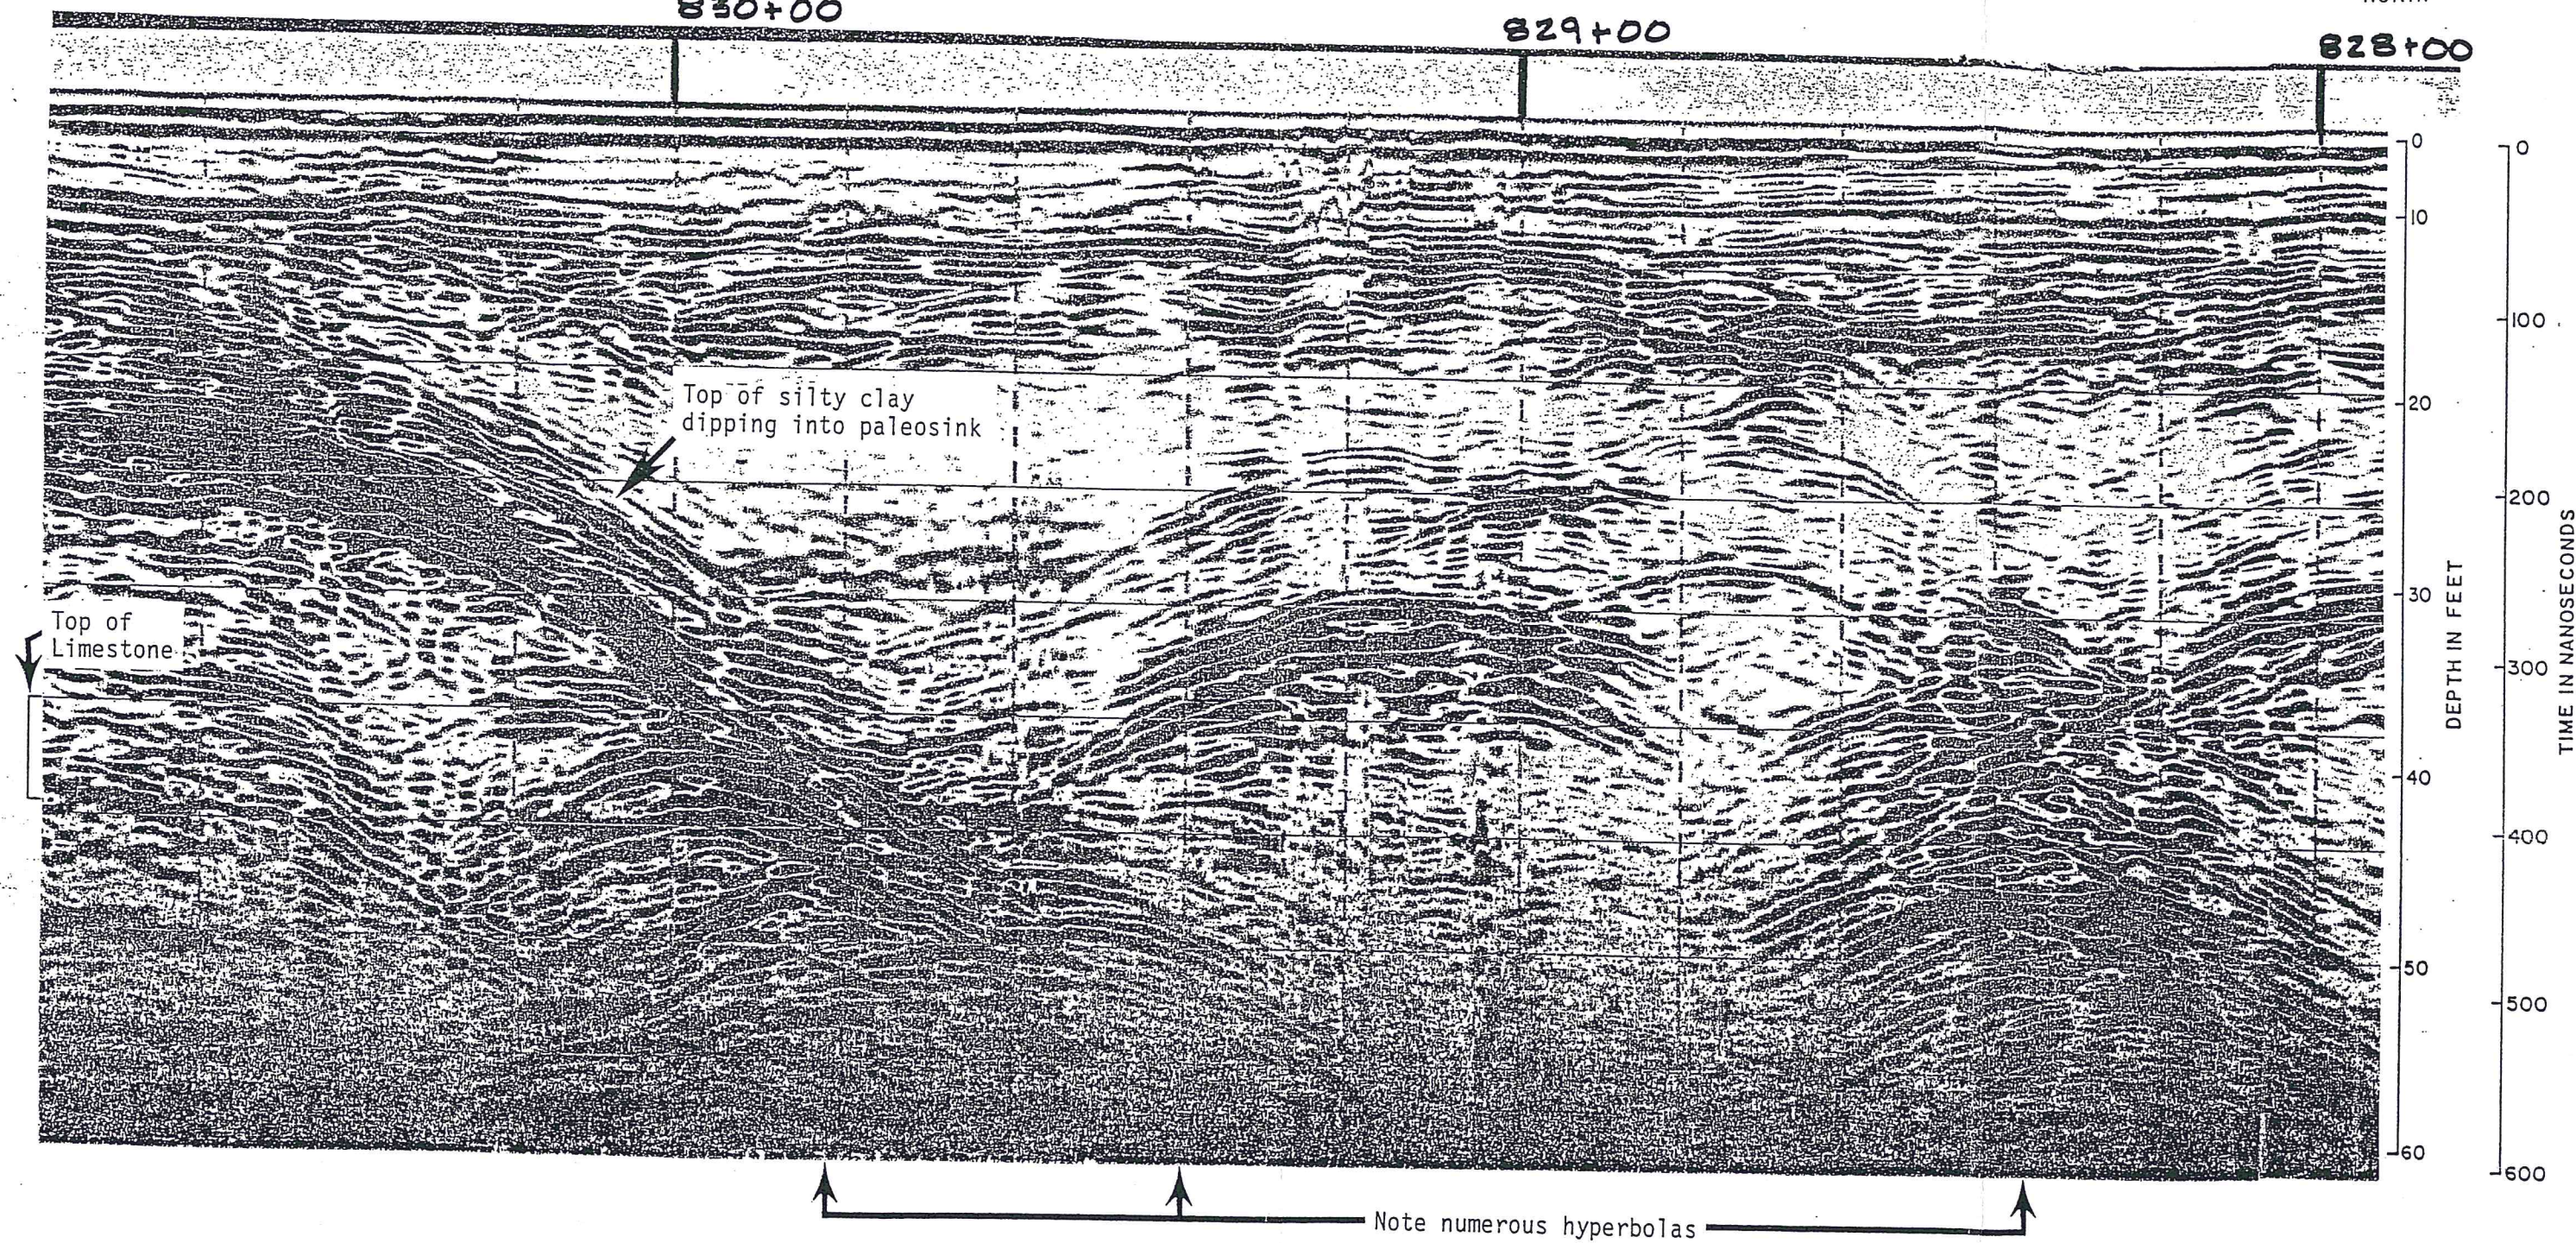
Figure 7. Deep Radar Data Showing a Paleosink.

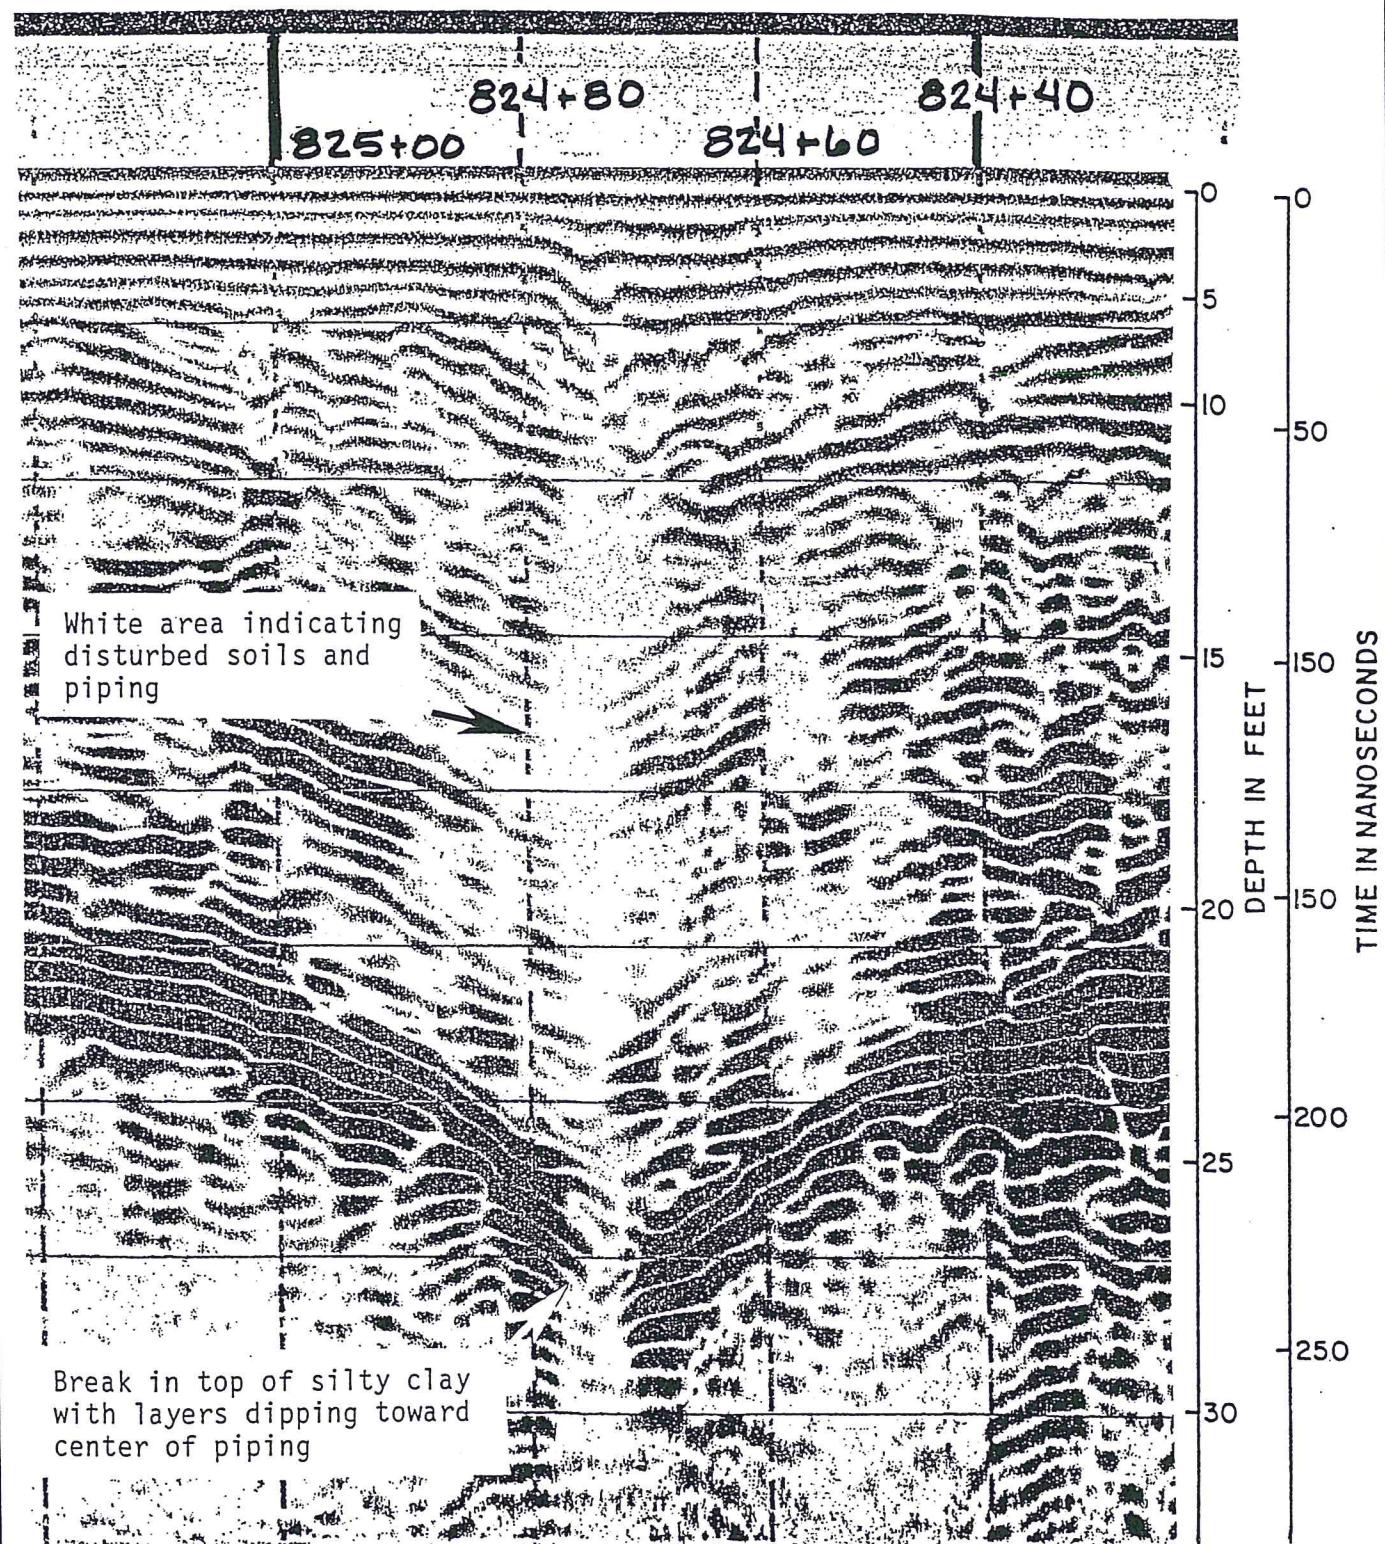
Figure 8. Shallow Radar Data Showing a Break in the Silty Clay Layer.

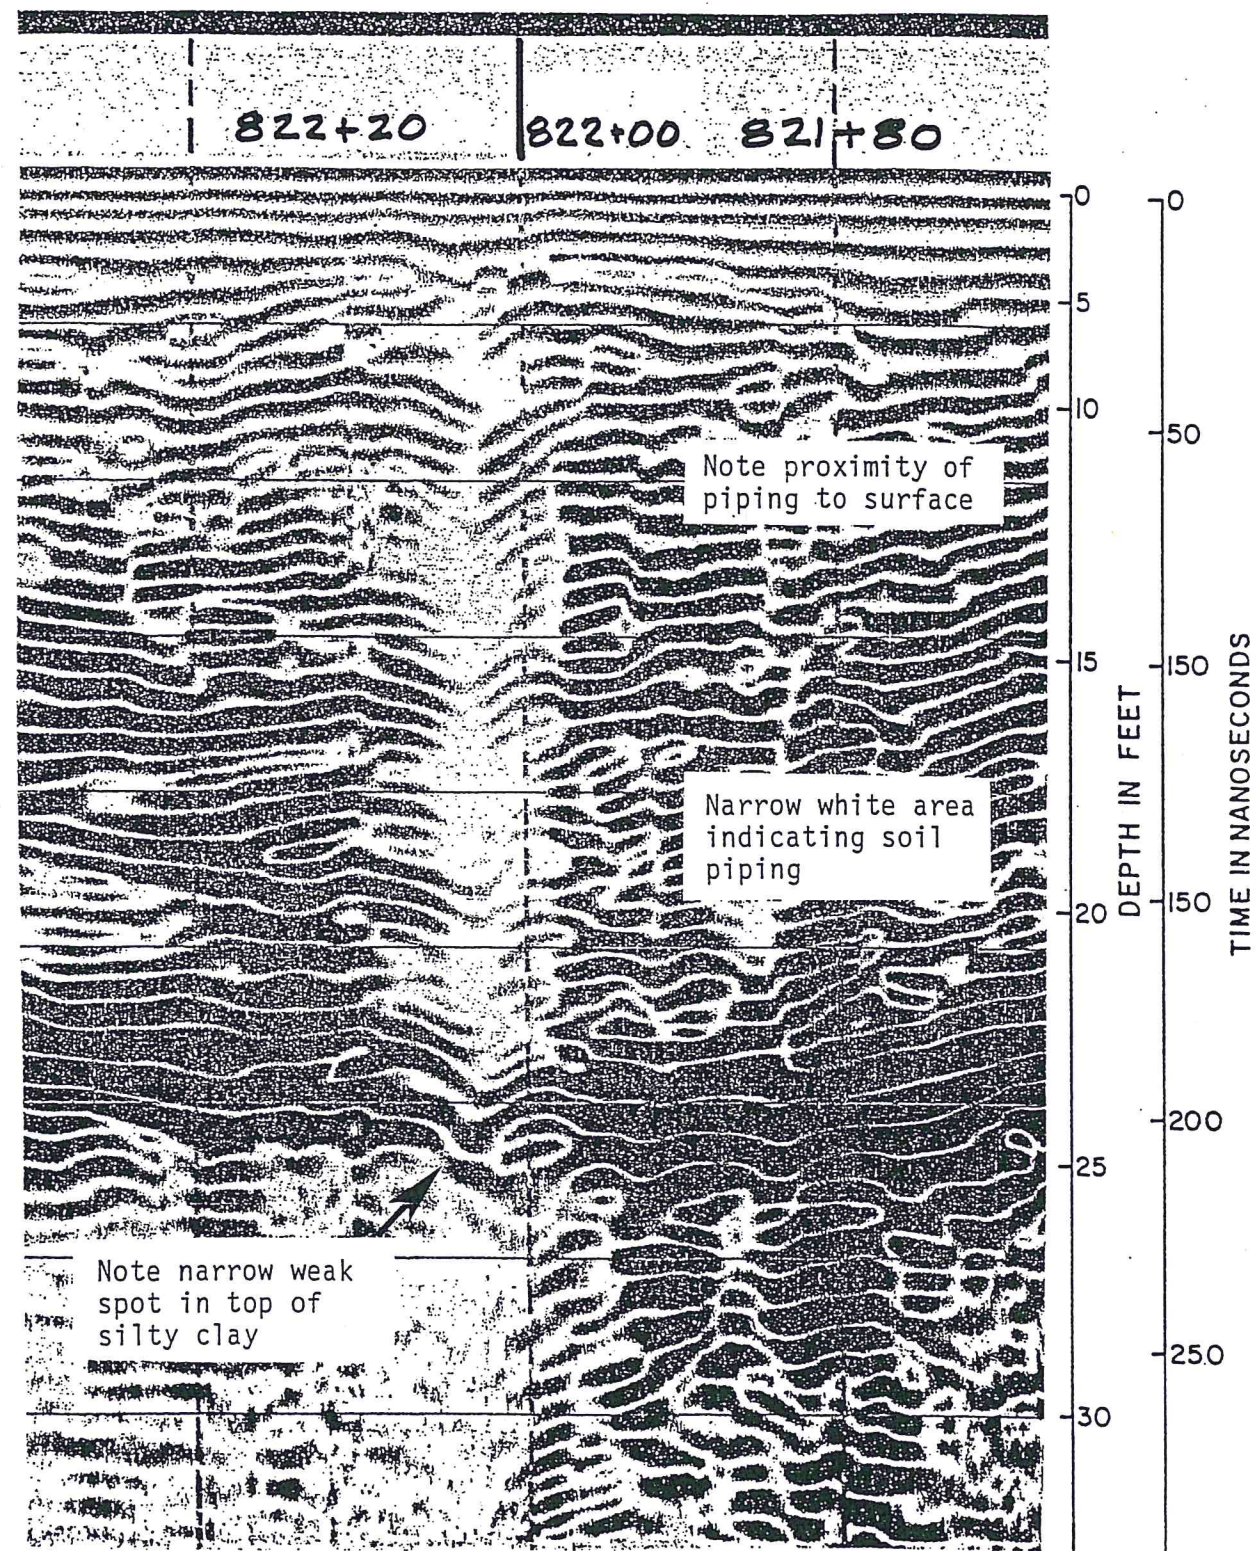
Figure 10. Shallow Radar Data Showing a Narrow Piping Feature.
