# City of Boiling Spring Lakes

## Stormwater Department

### STORMWATER DEPARTMENT REPORT OCTOBER 2025

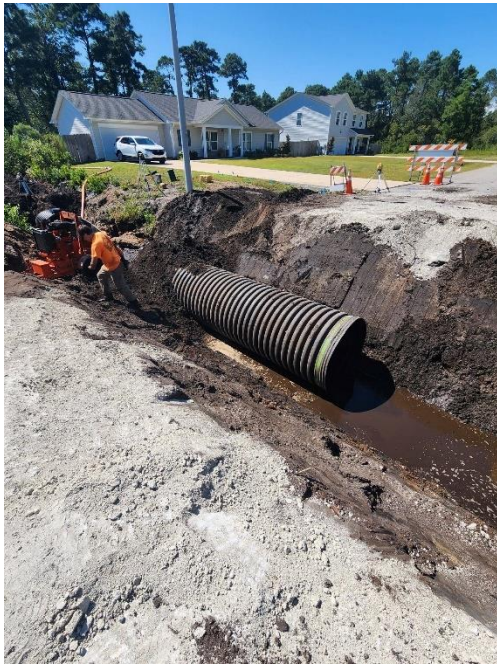
Golf View Pipe Invert Reset

In addition to the ditching, a primary 48" HDPE pipe culvert was re-excavated and reset to the proper invert elevations at Golf View Road in the Highlands Development. As you know this was an area that has been impacted by numerous flooding events in the past. As a side note, that area fared very well with this latest storm event that occurred over the weekend. The team also has been proactive with identifying troubled areas where ponding water is occurring. For example, the corner of Liberty Road and Kannapolis Road was not draining properly from this most recent storm. The team conducted a field inspection and identified a crushed and decaying corrugated metal pipe (CMP) that had blocked the drainage ditch. The team removed the pipe and alleviated ponding issues on Kannapolis, Liberty as well as a portion of Goldsboro. The pipe is scheduled to be replaced in the next couple days with a new 18" high-density polyethylene pipe (HDPE). Other duties include on-call services when residents call with issues along property frontage. Our residents are the front line support with helping the department address on-going issues around the City.

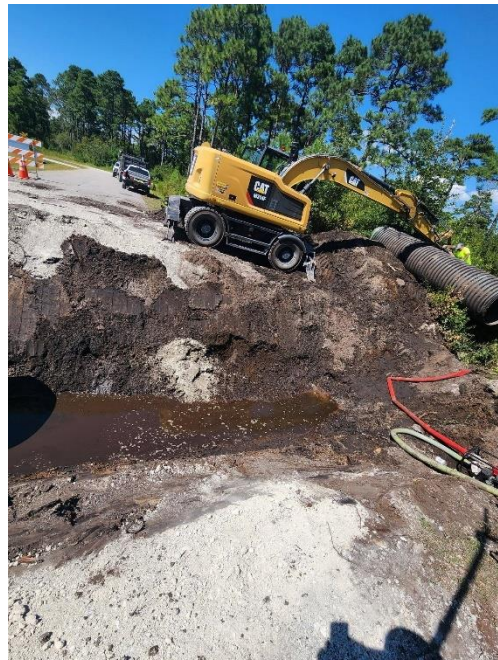
Golf View Pipe Invert Reset

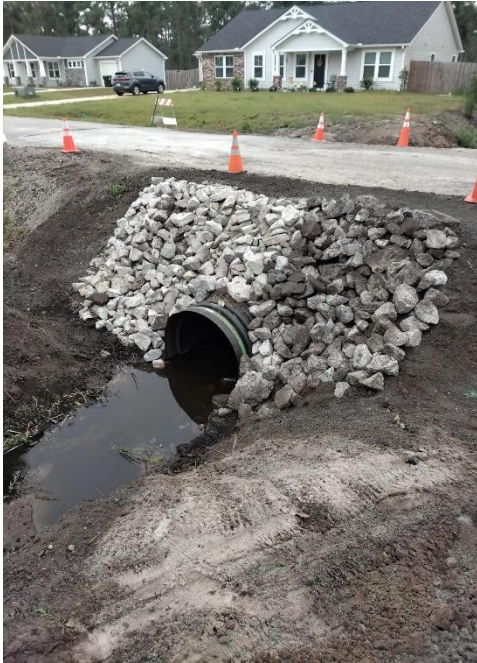
Golf View Pipe Install w/Rip-Rap  
Protection (Upstream)

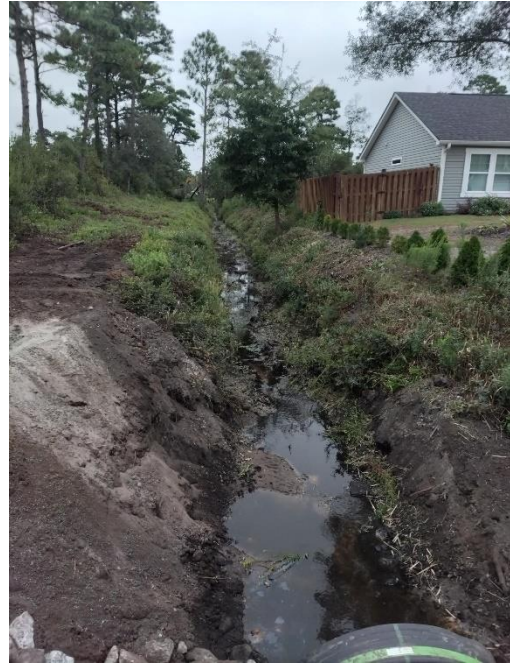
Ditch Maintenance  
Vegetation cut and groomed

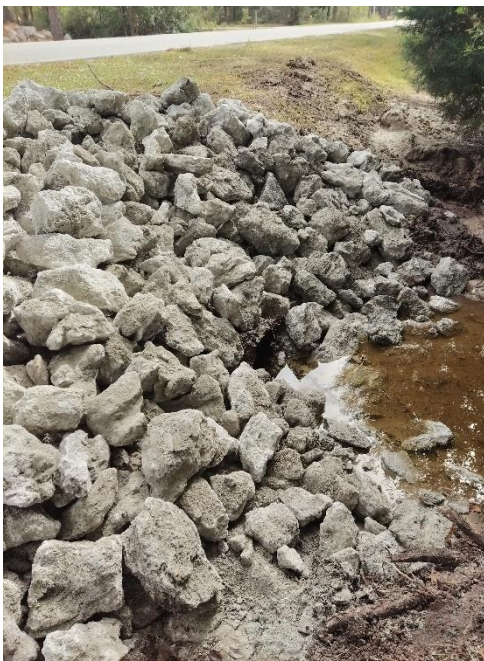
Pipe Culvert Restoration w/Rip-Rap  
Protection (Upstream)

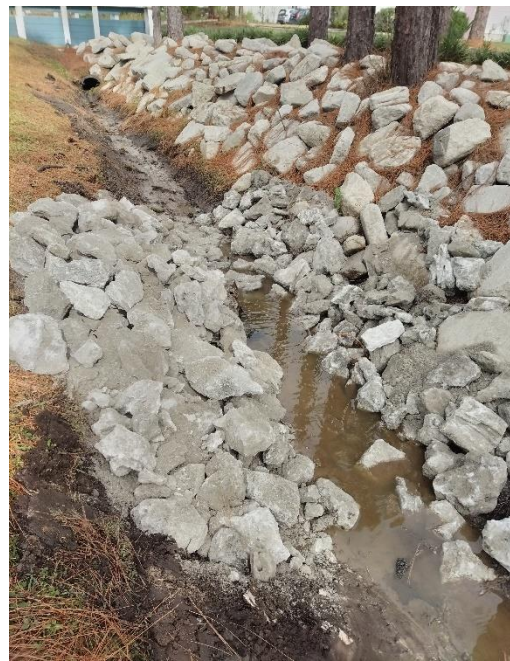
Pipe Culvert Restoration w/Rip-Rap  
Protection (Downstream)

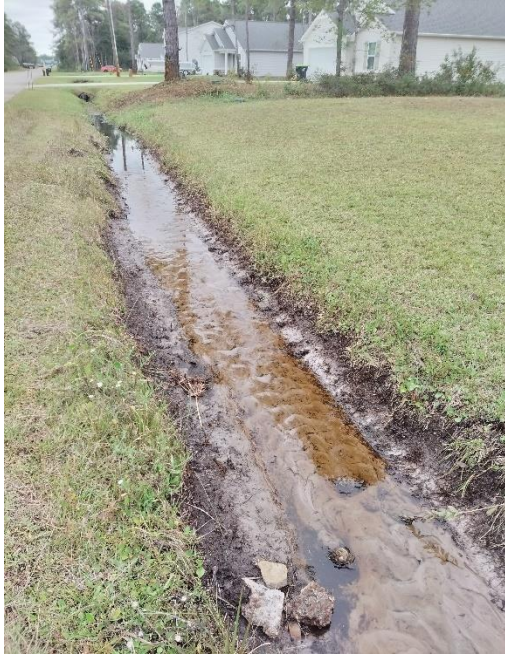
Ditch Cleaned and Shaped  
(typical)

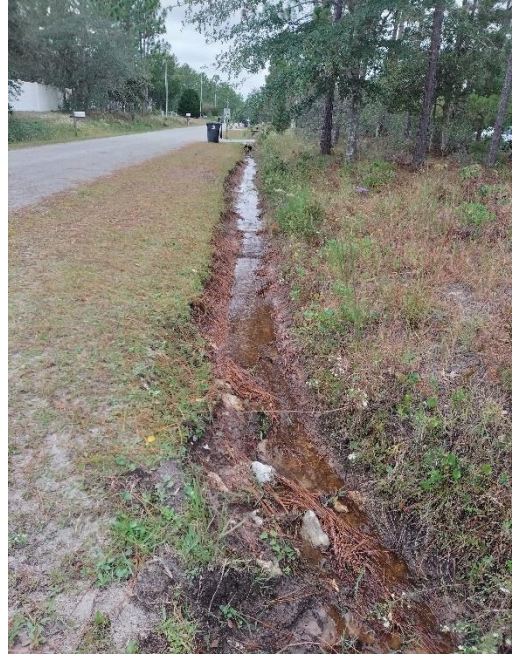
Ditch Cleaned and Shaped  
(typical)

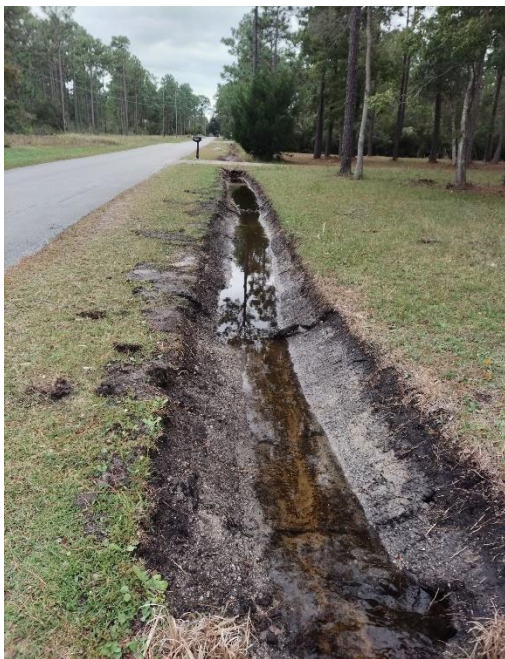
Ditch Maintenance  
(typical)

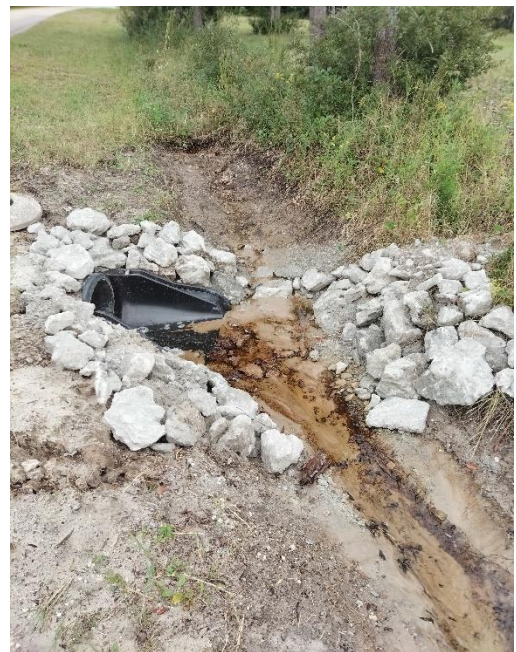
New Pipe Repair w/Flared End Section  
and Rip-Rap Protection

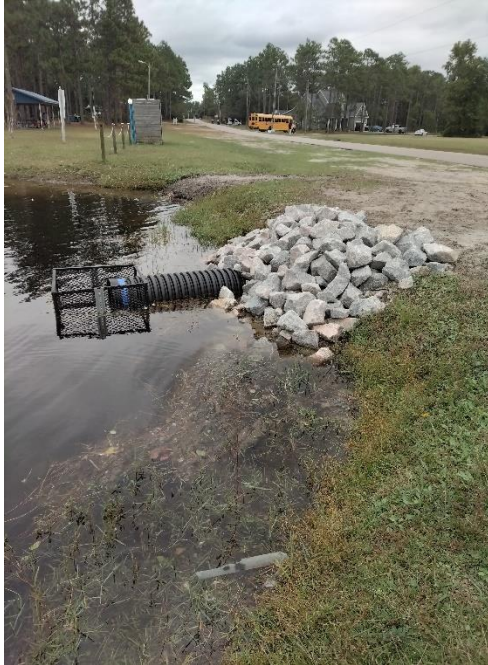
Spring Lake Pipe Outlet Restoration  
Outlet #1

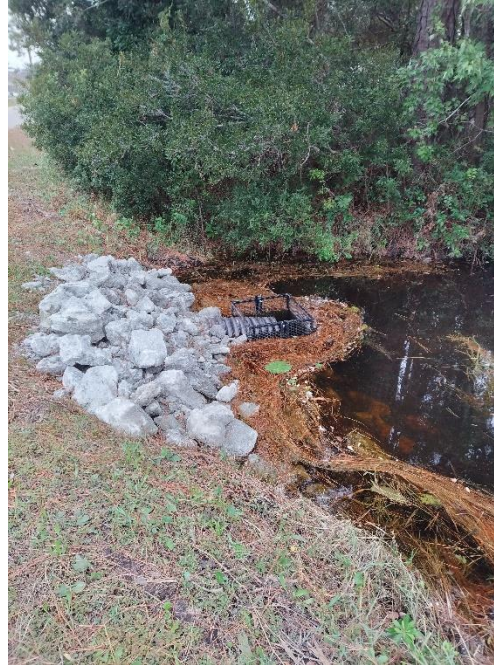
Spring Lake Pipe Outlet Restoration  
Outlet #2

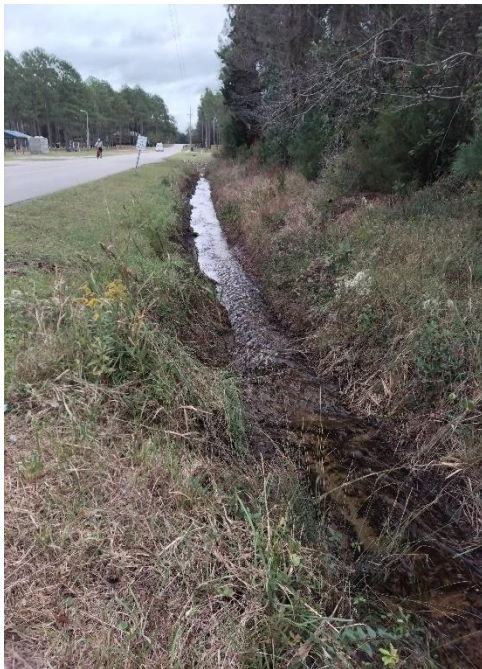
Recently Cleaned and Reshaped Ditch  
Unobstructed Flow

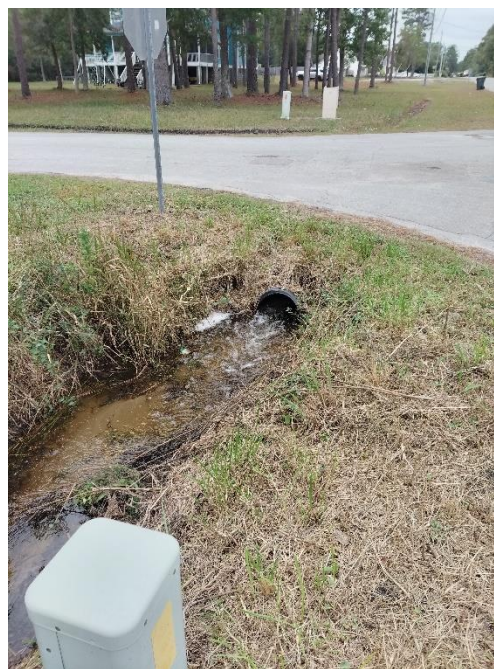
Cleaned and Reshaped Ditches  
Free Unobstructed Flow
