City of Boiling Spring Lakes

STAFF REPORT

Stormwater Department Status of Work Completed

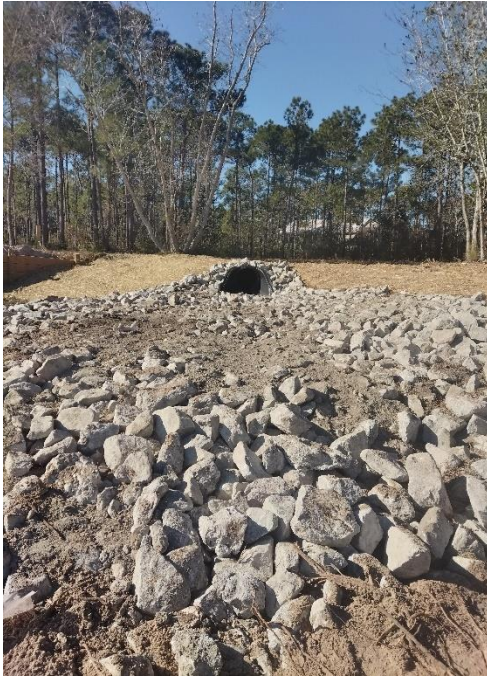
Finished Pipe Discharge
w/Rip Rap Protection

In addition to the ditching and stormwater maintenance, the team has begun a stormwater upgrade to the Miller and Pine Lake Road intersection. Phase 1 of the project has been completed. The work included the placement of 200 lf of 24" HDPE pipe with a flared end section, discharging onto a rip-rap apron. The apron was sized accordingly to dissipate high flow velocities and prevent erosion at the point discharge. The inlet section of the system located on Pine Lake Rd has also been protected with rip rap to prevent embankment erosion during large storm events. The next phase of the project will be to remove and replace the existing 18" pipe running under Pine Lake Rd with a larger 24" HDPE pipe that will connect to the pipe system completed in Phase I.

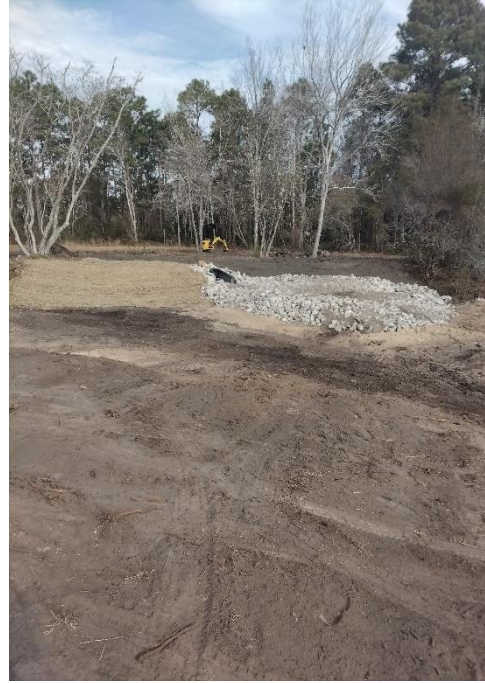
Final Grading at Pipe
at Pipe Discharge

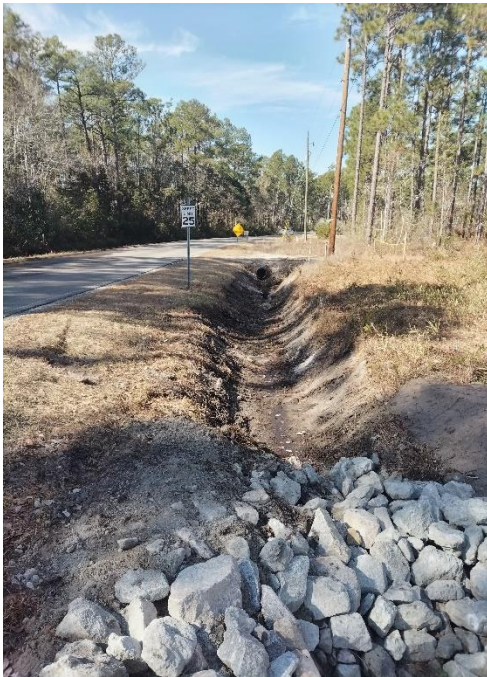
Ditch Reshaping with
Rip-Rap Protection

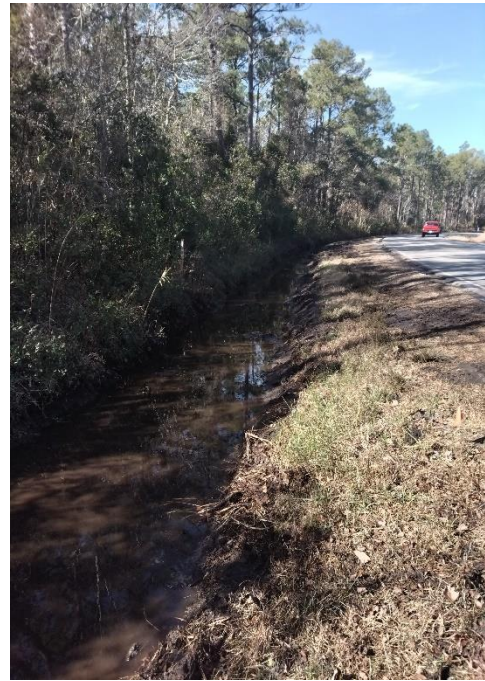
Pine Lake Rd
Ditch Cleaning and Reshaping

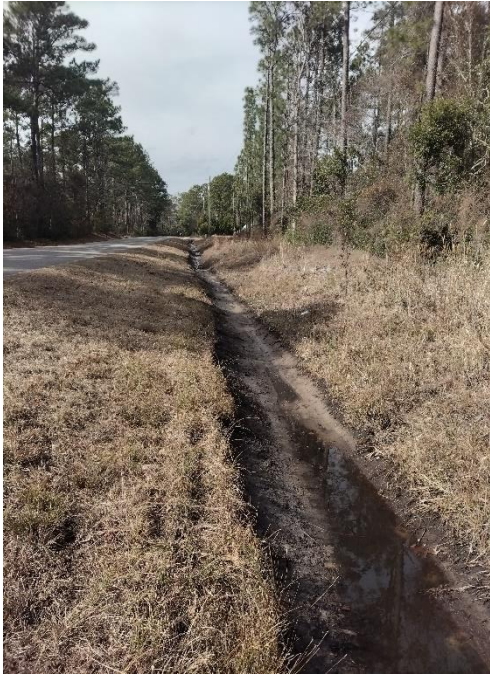
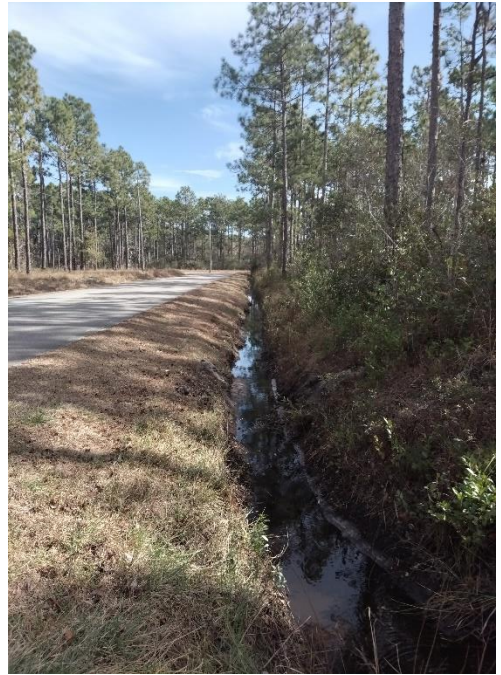
Ditch Cleaning & Reshaping
Baymeade Road

- 1.) 1,090 lf. Baymeade Road
- 2.) 300 lf. Glen Oak Road
- 3.) 1,418 lf. Winston Salem Rd

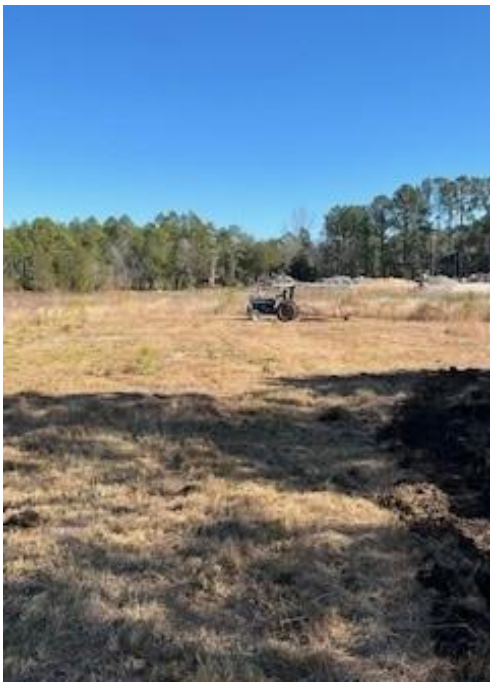
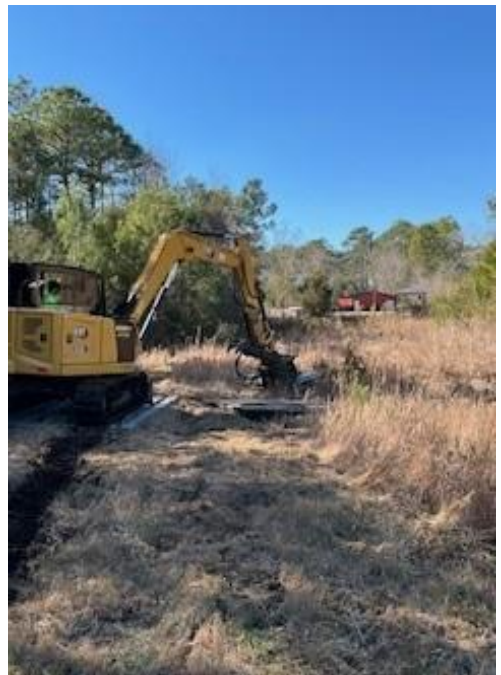
Pine Lake Bed Mowing

In addition to replacing culverts and cleaning drainage ditches, the team is also removing overgrown vegetation from many of our primary ditches, checking existing storm pumps and preparing areas that are flood prone prior to major storm events. The team has also begun grooming the lake bed at Pine Lake with our equipment, cutting brush and small pine saplings that have sprouting up in the last couple months.
