City of Boiling Spring Lakes

STAFF REPORT

Stormwater Department Status of Work Completed

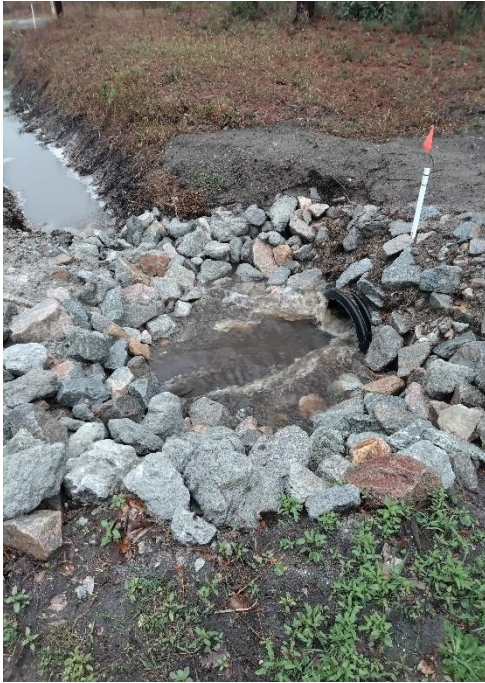
Pine Lake and Miller
Performance Photo

In addition to ditching and stormwater maintenance, the team has finished the first phase of the stormwater upgrade to the Miller and Pine Lake Road intersection. The attached photos show the performance of the system during the most recent storm event that produced approximately 3” of rain in a relatively short period of time. Due diligence and construction scheduling for phase 2 has started and will include upgrades to culverts and ditches from Miller Rd to E. Boiling Spring Road. The recent storm event has shown other vulnerable areas within the city that include areas in the Highlands and along South Shore Drive. South Shore Drive along the “S” curve experienced a minor wash on the outlet side of the pipe culvert crossing, due to the recent storm event that became a hazard to vehicular traffic. The public works team addressed the issue during the storm event that included placing additional fill material in the wash out. Following the storm, the team began work on a temporary solution to prevent additional washouts to occur until the permanent repair can be completed. The temporary solution included the installation of a road gutter stormwater chute. This chute was placed along the low point of the curve. This chute will easily convey additional road gutter runoff to the downstream discharge point. See the attached photos of the completed work.

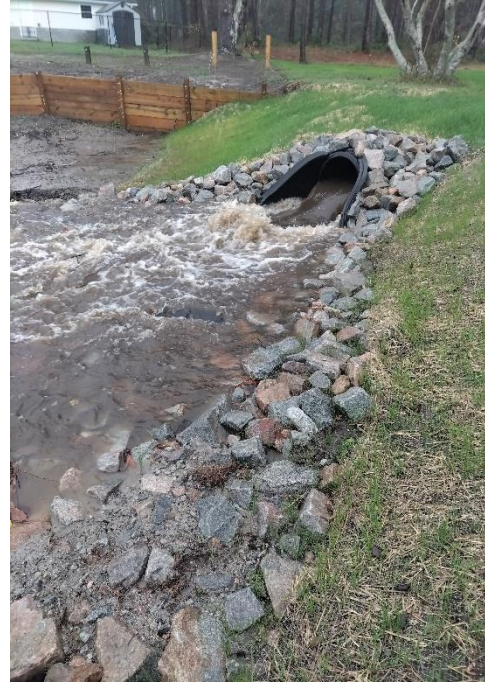
Pine Lake and Miller
Pipe Discharge

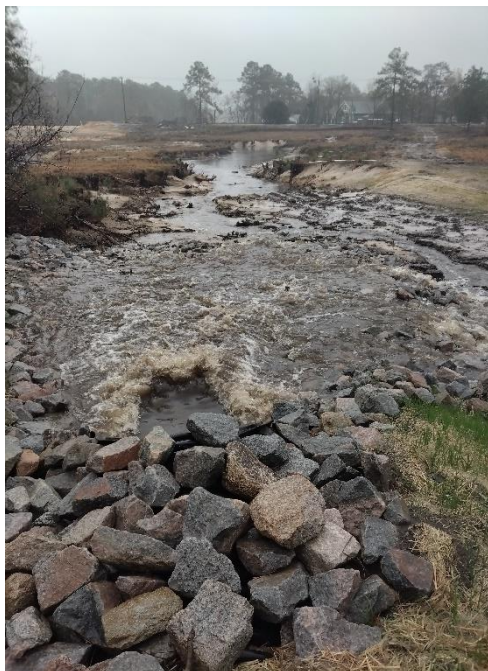
Pine Lake and Miller
Rip-Rap Apron

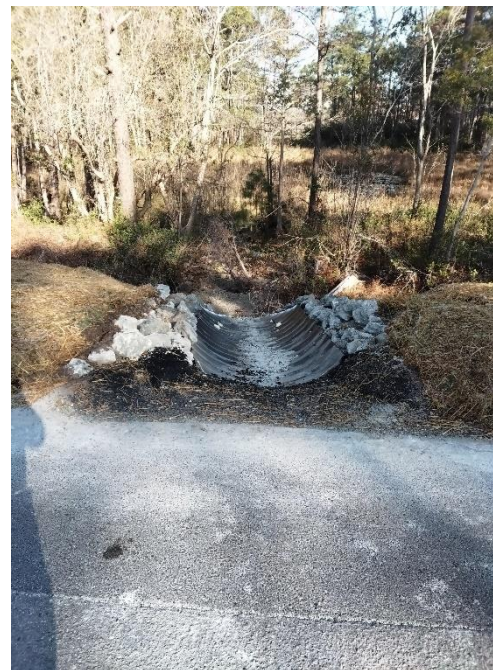
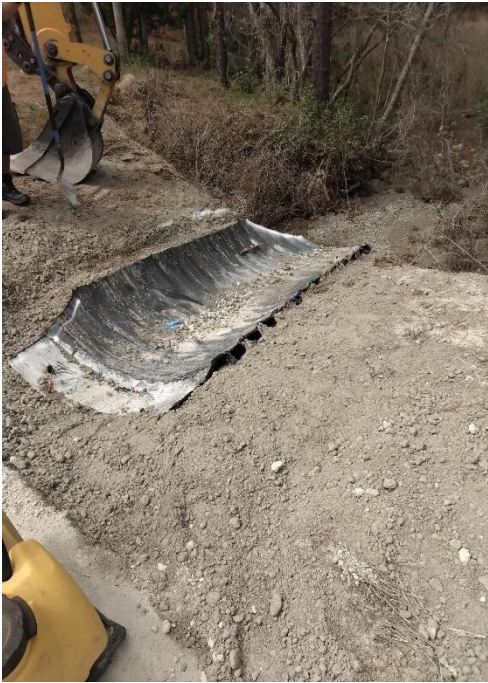
South Shore Drive
Temporary Stormwater Repair

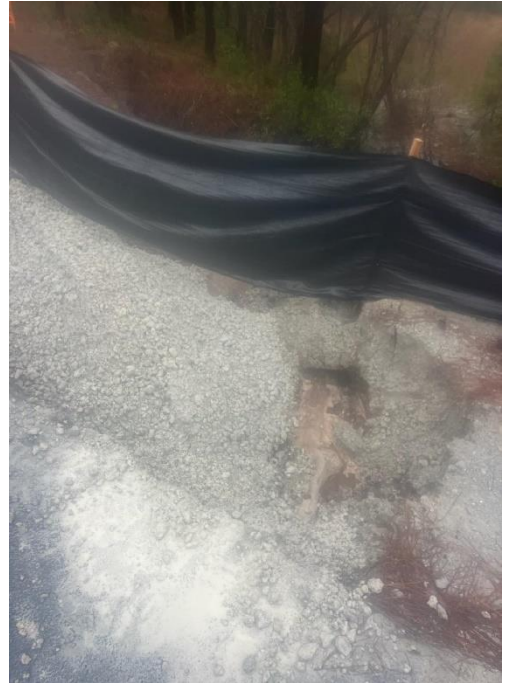
South Shore Drive
Street Washout

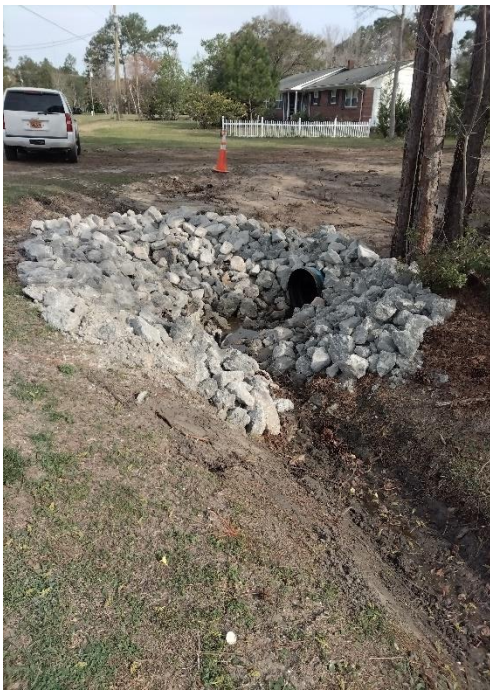
North Shore Drive
Inlet Rip-Rap Protection

The stormwater team is also working on a project located along North Shore Drive that includes the removal of an existing 24” perforated pipe that has become clogged with roots and silt and continuously underperforms and causes flooding to adjacent property owners. The project includes the removal of the existing pipe with a new 24” HDPE solid doubled wall pipe that will provide increased hydraulic performance for the conveyance of stormwater. The new pipe will terminate into a concrete headwall that will discharge into a rip-rap plunge pool to minimize scouring and soil erosion. The team will also create a graded swale just above the pipe system to handle additional stormwater from larger rain events.

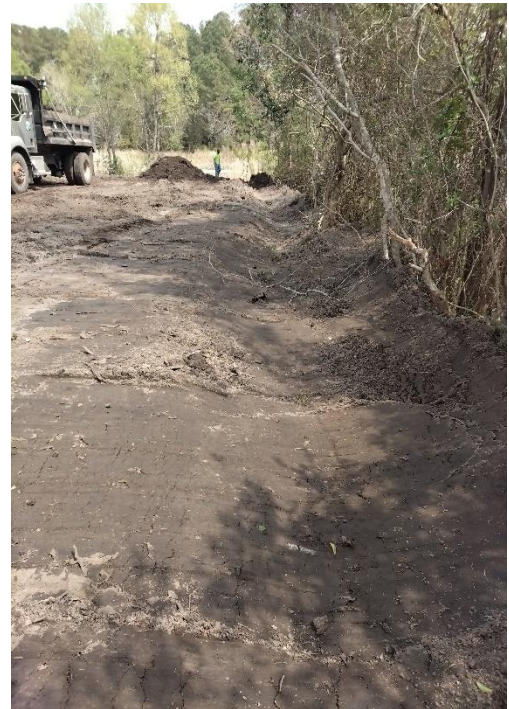
North Shore Drive
Stormwater Swale Construction

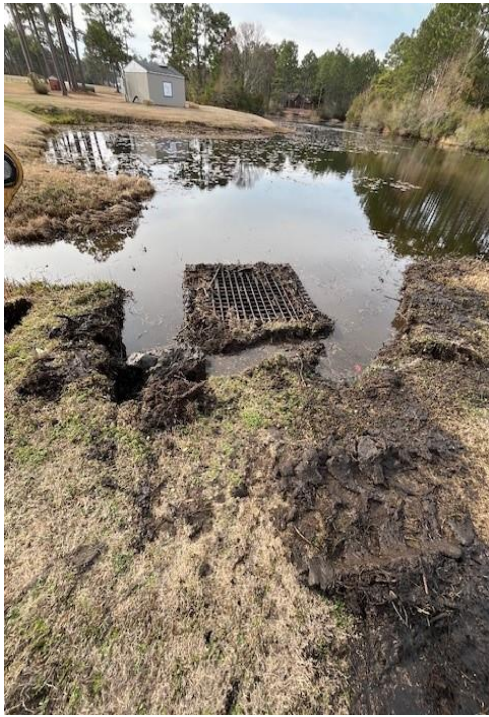
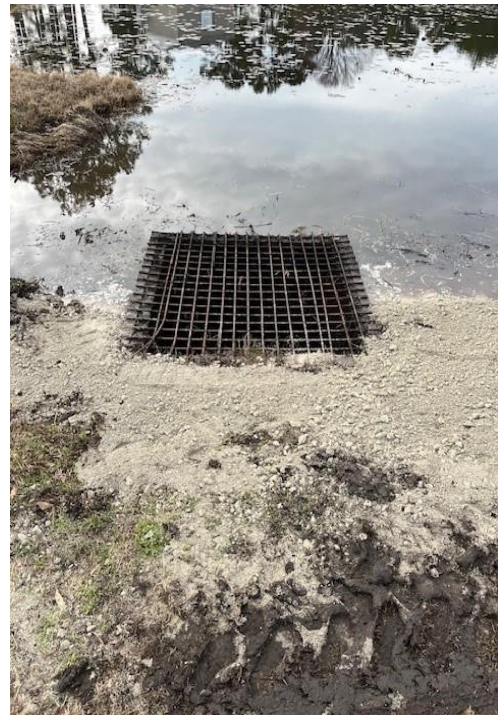
Inlet Box Maintenance & Repair

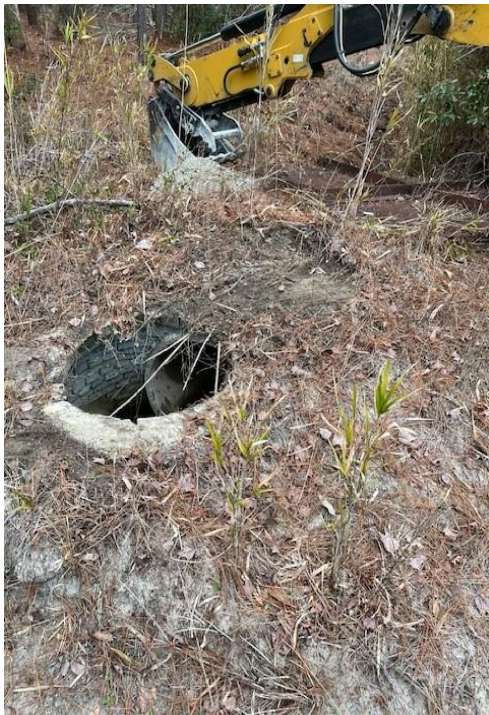
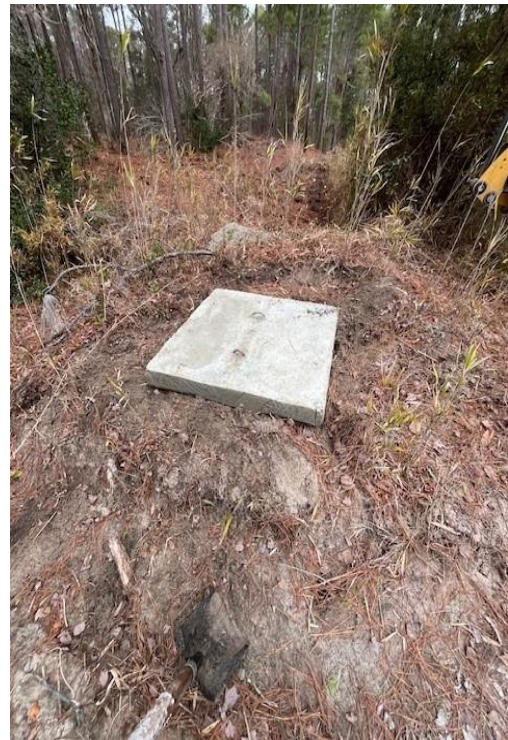
Stormwater Safety and
Maintenance Repair Work

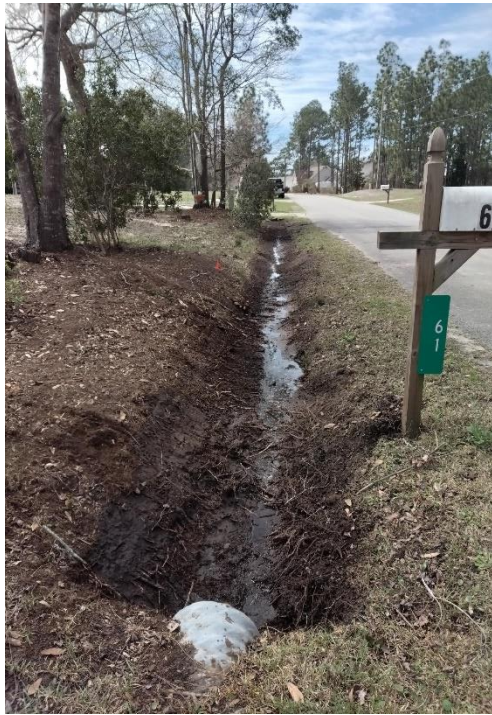
Ditch Clean and Reshaping

Note: The team has reshaped and cleaned approximately 1,891 lf. of drainage ditches to include the following area;

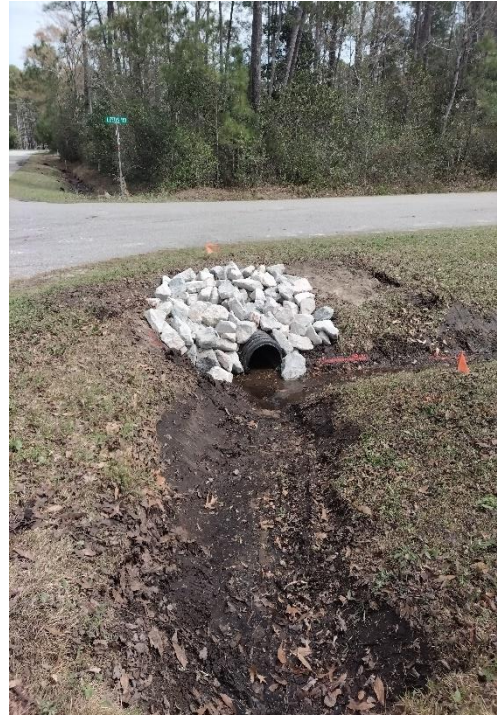
Ditch Cleaning and Reshaping
With Inlet Protection

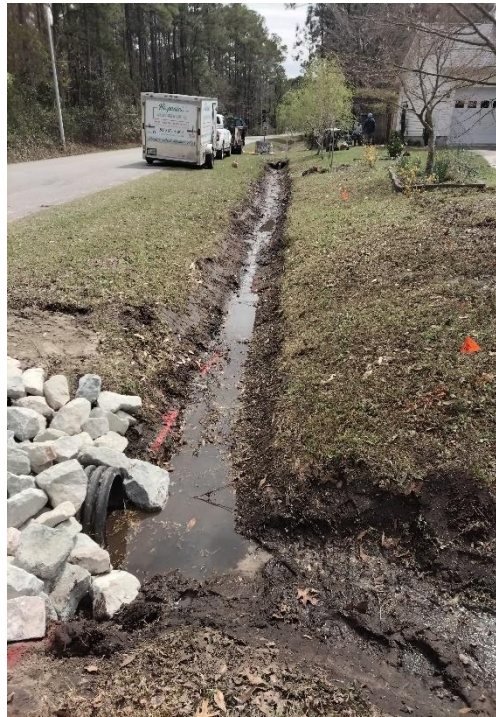
Ditch Clean and Reshaping
Swale Construction

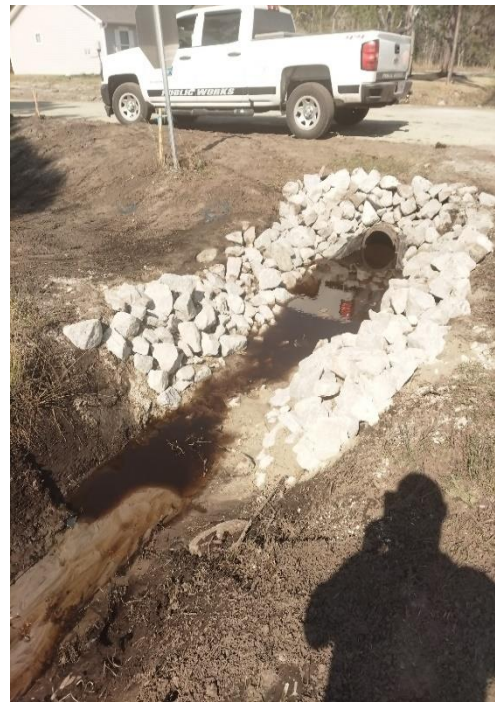
Typical Road Inlet Protection
with Flared End Section

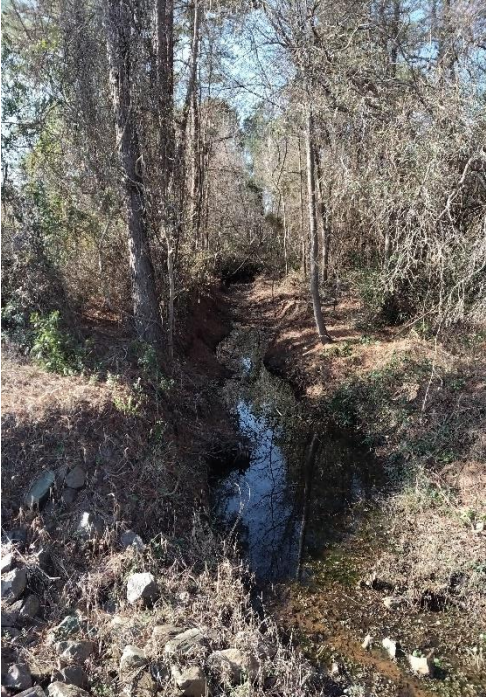
Primary Ditch Clearing
And Restoration

In addition to replacing culverts and cleaning drainage ditches, the team is also removing overgrown vegetation from many of our primary ditches, checking existing storm pumps and preparing areas that are flood prone prior to major storm events. The team is also grooming the lake bed at Pine Lake and work will be on-going for the next several weeks.
