ADDENDUM #2

**REPORT
OF
ACCESS RAILROAD SINKHOLE INVESTIGATION
BOILING SPRING LAKES, NC**

Remedial Dam Repair Investigation
and Design Report
Boiling Springs Lake Dam
Boiling Springs Lake, North Carolina
S&ME Job No. 1051-87-291

**REPORT OF SUBSURFACE EXPLORATION AND GEOTECHNICAL
ENGINEERING ANALYSIS**

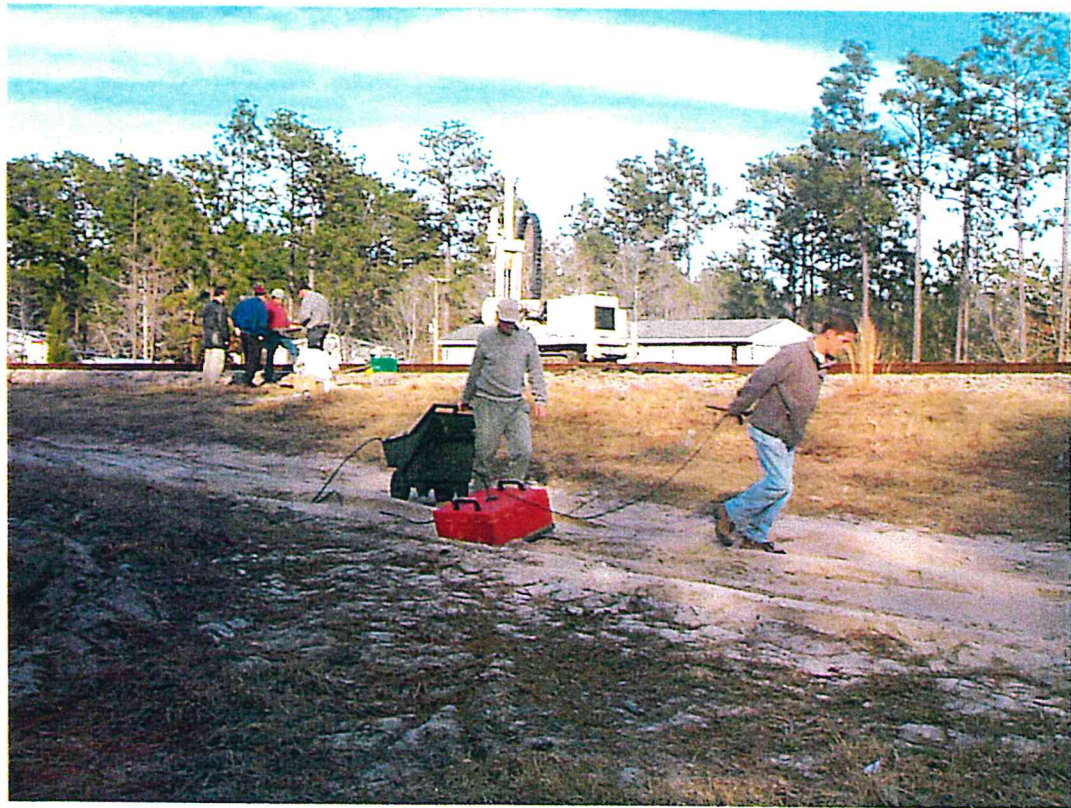
During investigations conducted for the nearby land bridge construction, ground-penetrating radar (GPR) had been shown to give good results in locating potential sink areas before they manifested at the ground surface. Geophex Services performed a detailed GPR survey along a 350 x 60-foot area of the railroad near the new sinkhole (Photo 2).

Photo 2. GPR Survey with Geoprobe in Background.

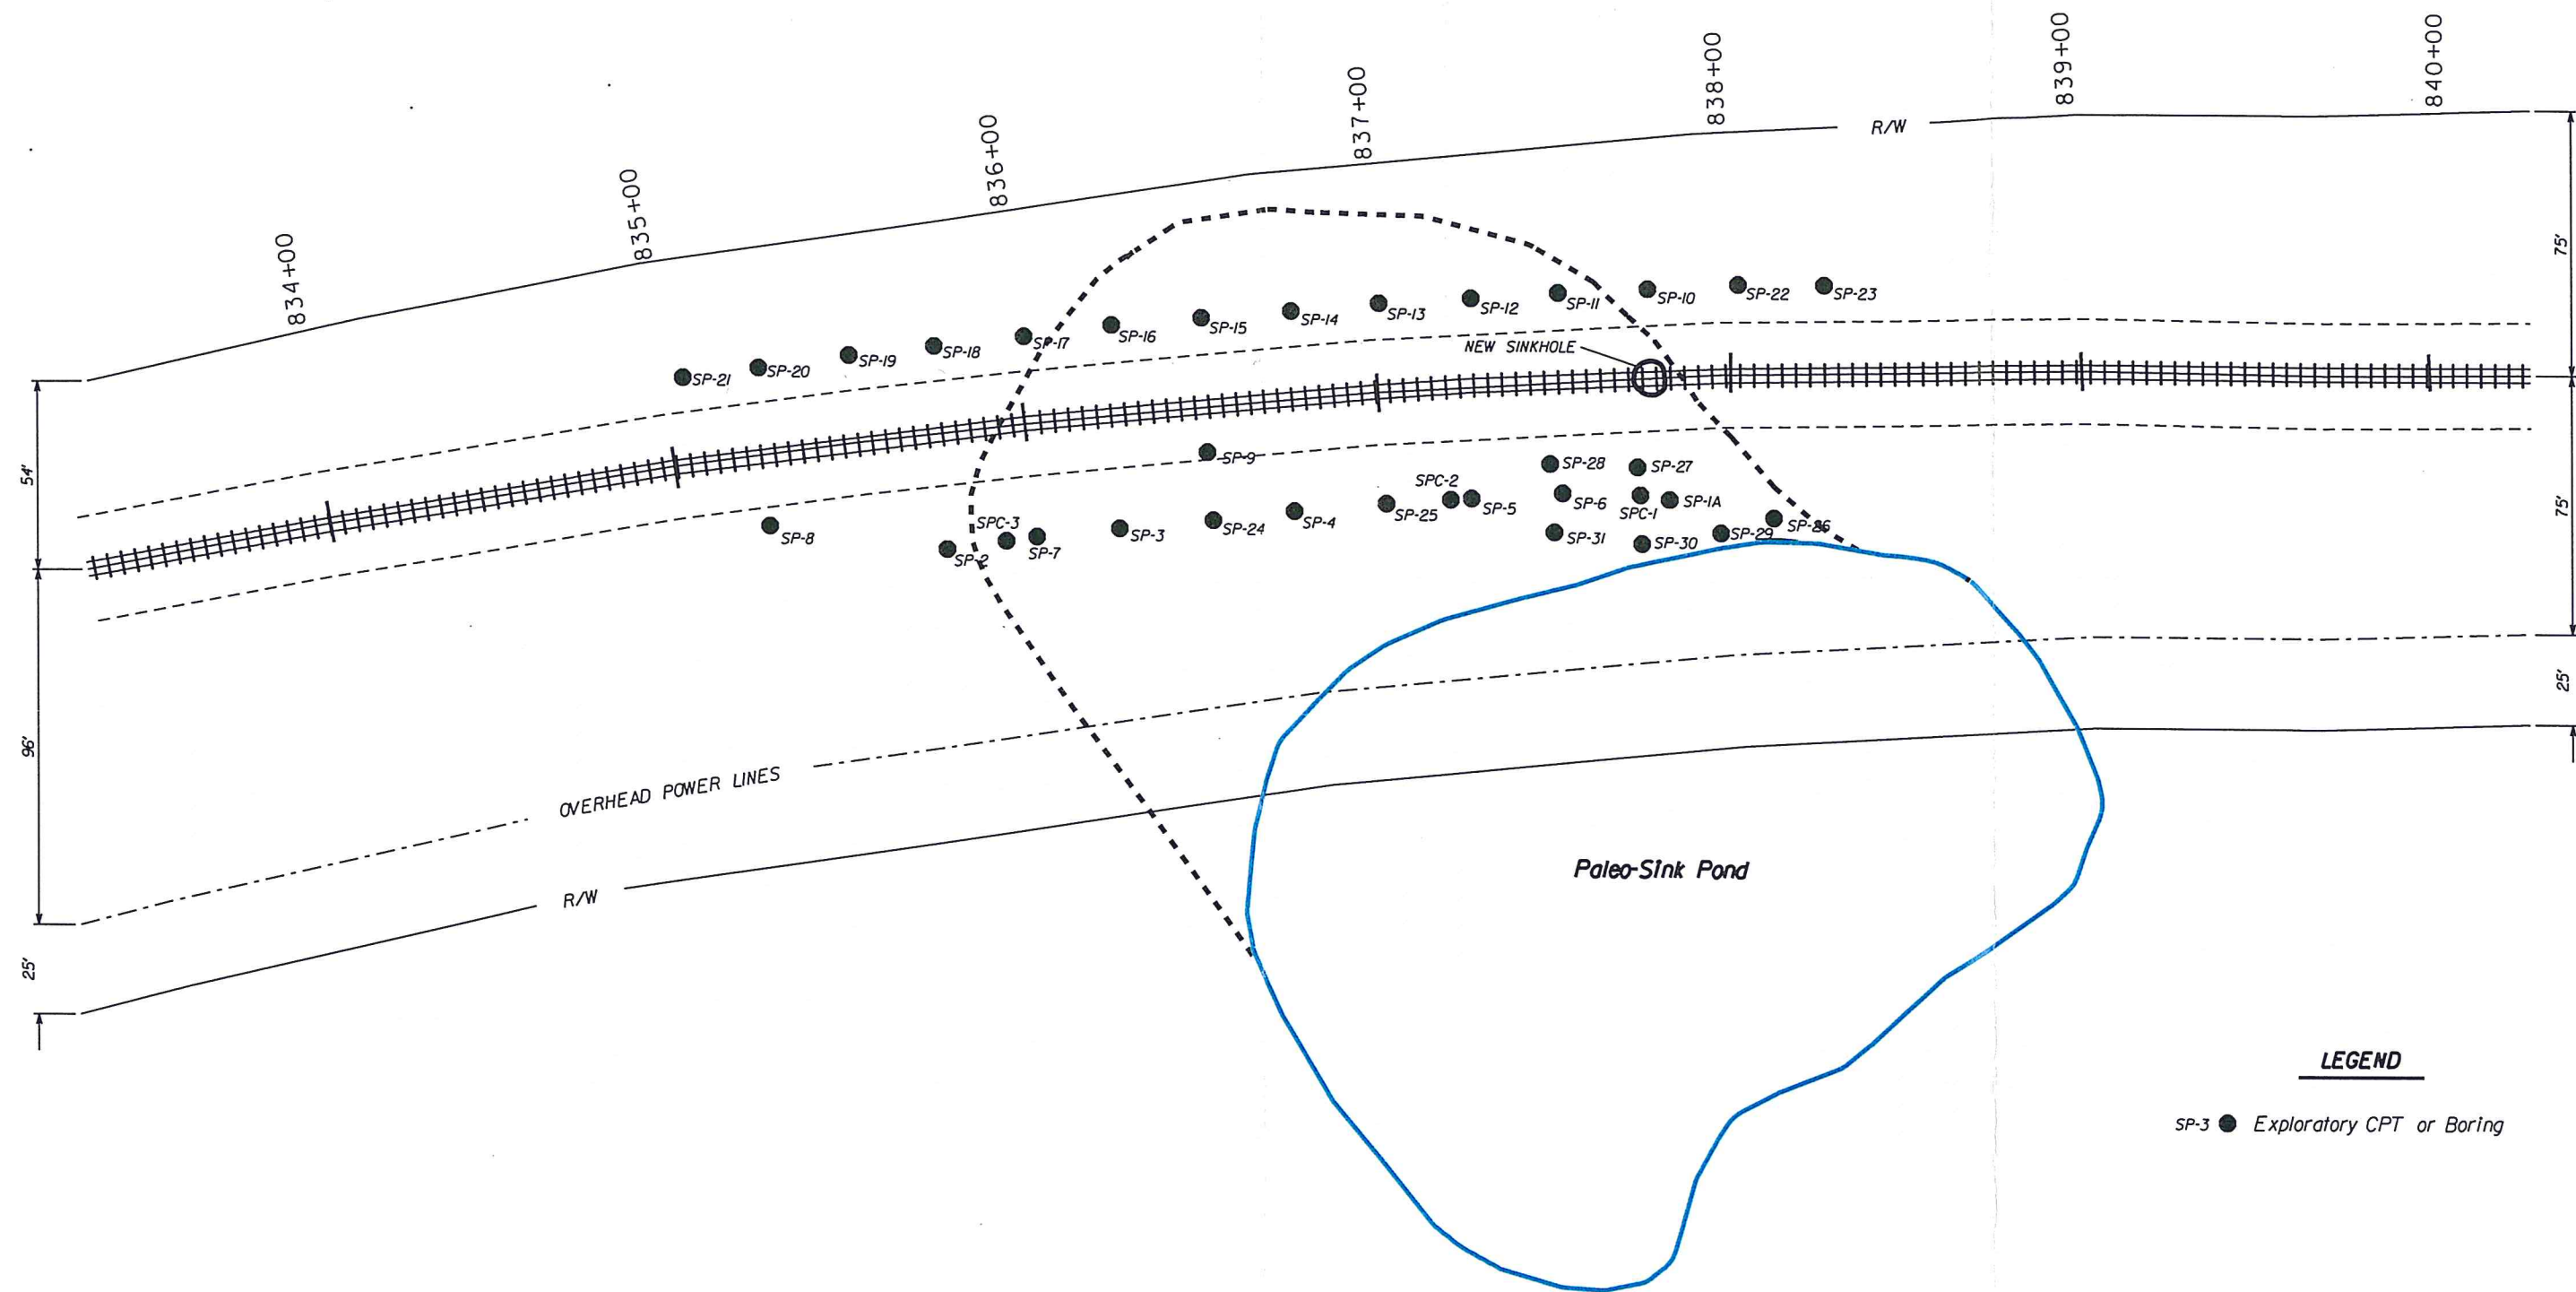
FIGURE 5
AREA 'A' SITE DETAIL

Six probes were performed in the immediate area of the sinkhole (Figure 5), to an average depth of about fifty feet below ground surface (BGS). These probes, including one in the approximate center of the sinkhole below the track, indicated a zone of exceptionally weak soil from about 30 to 40 feet in depth. This zone was indicated by the requirement of only light pushing with the Geoprobe® hydraulics, without hammering. In several of the probes closest to the sinkhole, the probe could be advanced by pushing down by hand.

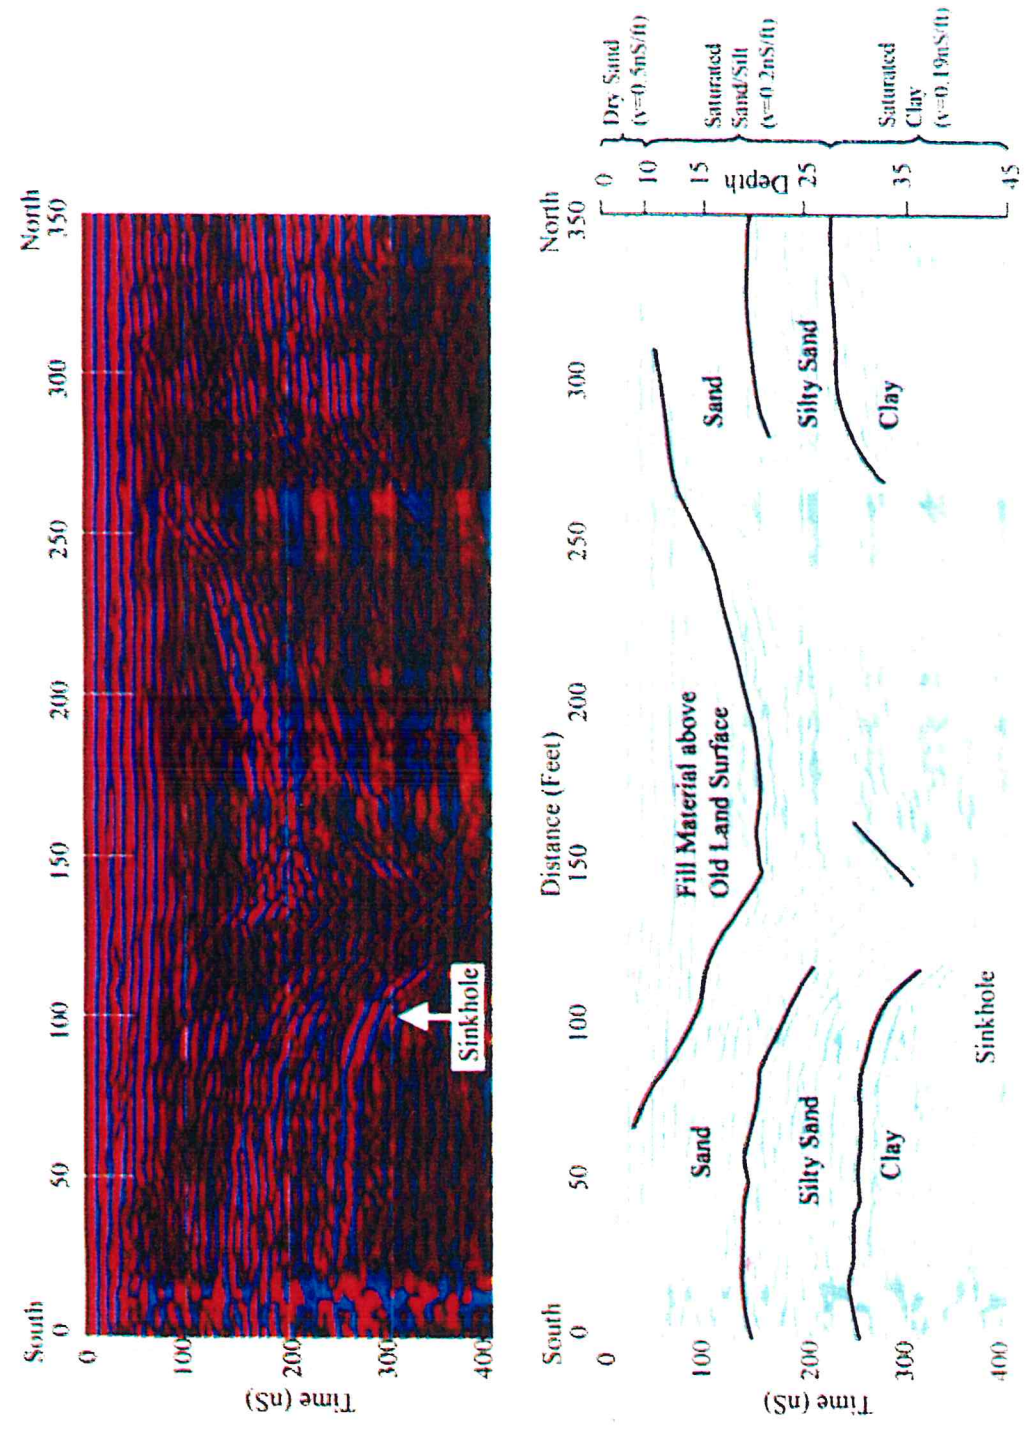
FIGURE 6
AREA "A"
GPR SURVEY DATA

Based on the Geoprobe® work and the GPR survey, the general soil profile along the track (Figure 6) consisted of about 15 feet of silty sand (SM) fill material comprising the track embankment, underlain by about 25 feet of sand to silty sand (SM-SP). About 8 to 10 feet of soft fat clay (CH) was found below the SM-SP. Below the CH was about 10 to 15 feet of clayey, silty fine sand (SC) with numerous shells and shell fragments. One outlying probe about 150 feet north of the sinkhole encountered limestone at about 65 feet BGS.

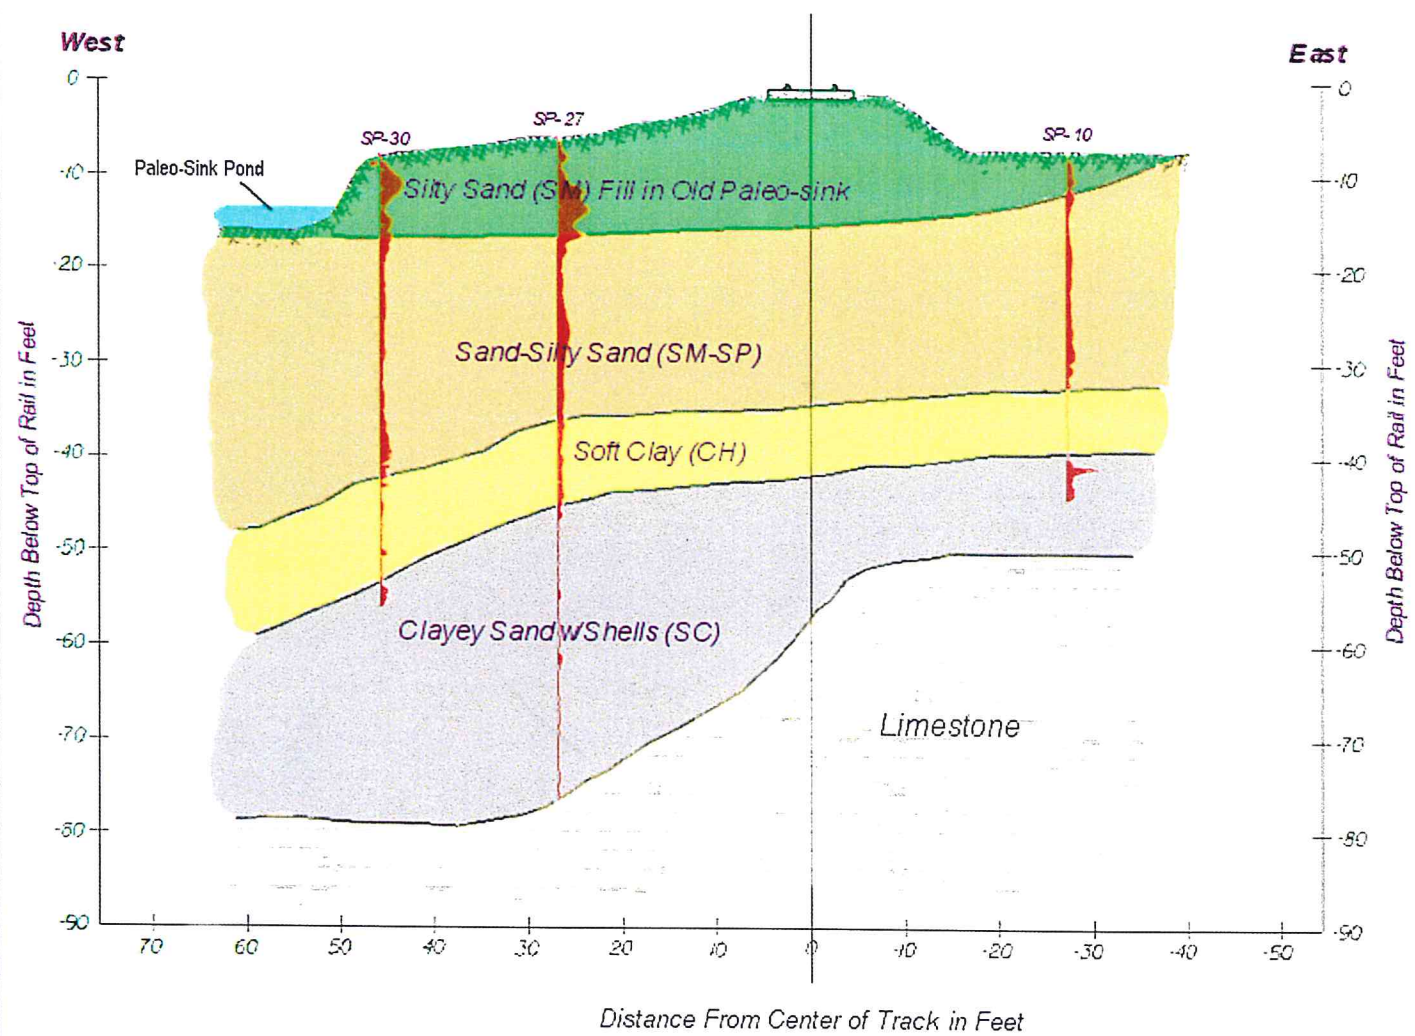
FIGURE 7
GEOLOGIC SECTION
AT TRACK STATION 837+78

SPC-1 was drilled about 35 west of the new sinkhole, and near several SCAPS CPT pushes. Continuous SPT data was collected in this boring down to a depth of 49.5 feet BGS. At 49.5

feet, all drilling fluid in the borehole was lost and soil from above this zone could be heard caving into the uncased hole. Shortly thereafter an approximately 20-foot diameter area underneath the rear end of the drill rig began to slump down about one-half foot. Since the boring was about 4.5 feet into the shelly SC zone when fluid was lost, it is apparent that a void exists within or below this zone. When this zone is breached, loose, sandy soil from above and just below a shallow dense soil zone flows down into the void, causing the bridged-over dense sand to collapse up to the ground surface due to lack of support below.

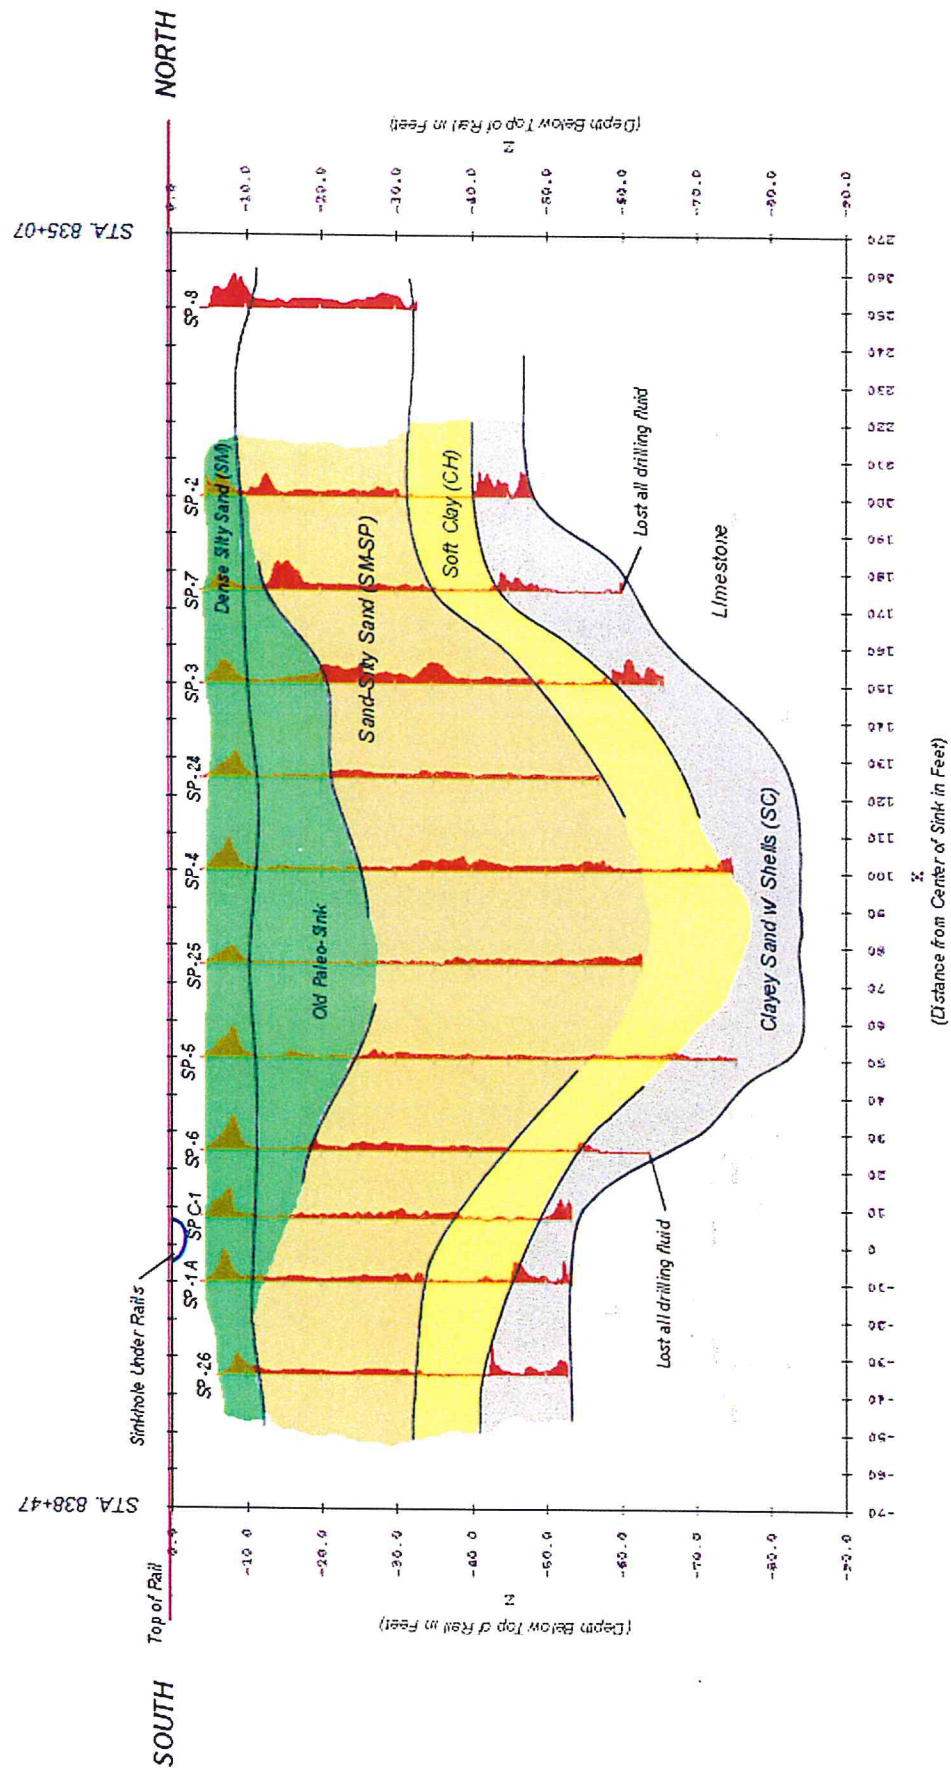
FIGURE 8
AREA "A"
SECTION ALONG WEST SIDE OF TRACK

NOTES: 1. CPT curves represent only cone (qc) data in tons per square foot (TSF), see push logs for details.
 2. SPC-1 represents blow counts from SPT boring used to correlate CPT data.
 3. Section is approximately 30 feet west of centerline of track.

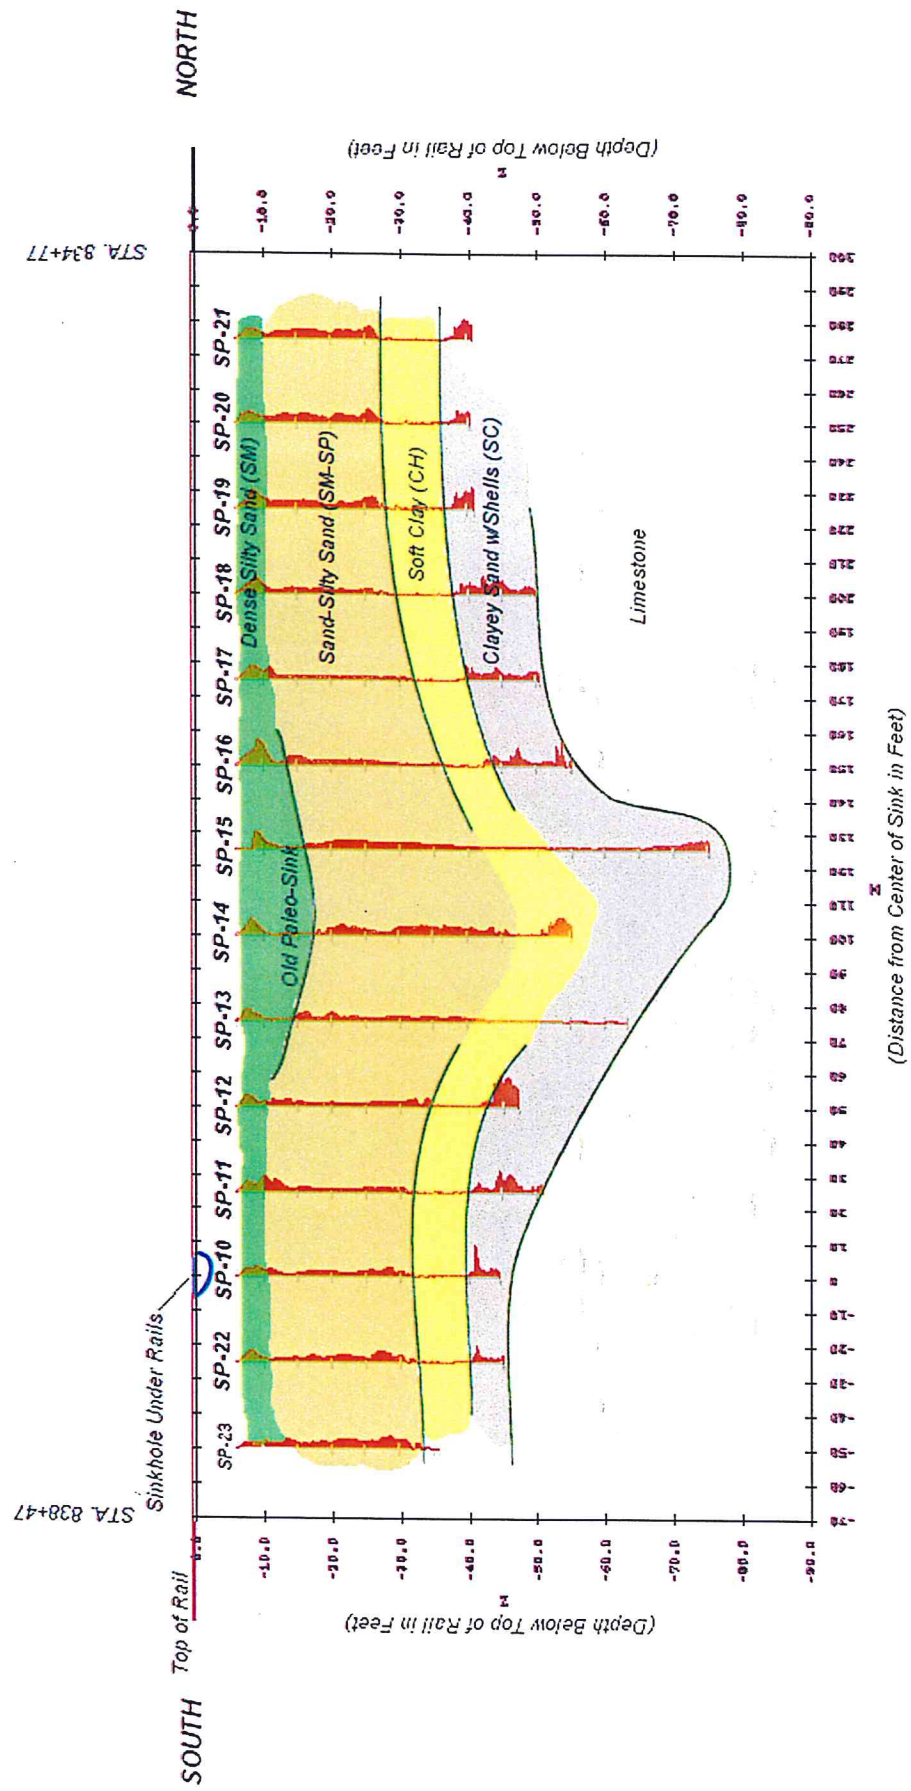
FIGURE 9
AREA "A"
SECTION ALONG EAST SIDE OF TRACK

NOTES: 1. CPT curves represent only cone (qc) data in tons per square foot (TSF), see push logs for details.
 2. Section is approximately 25 feet east of centerline of track.

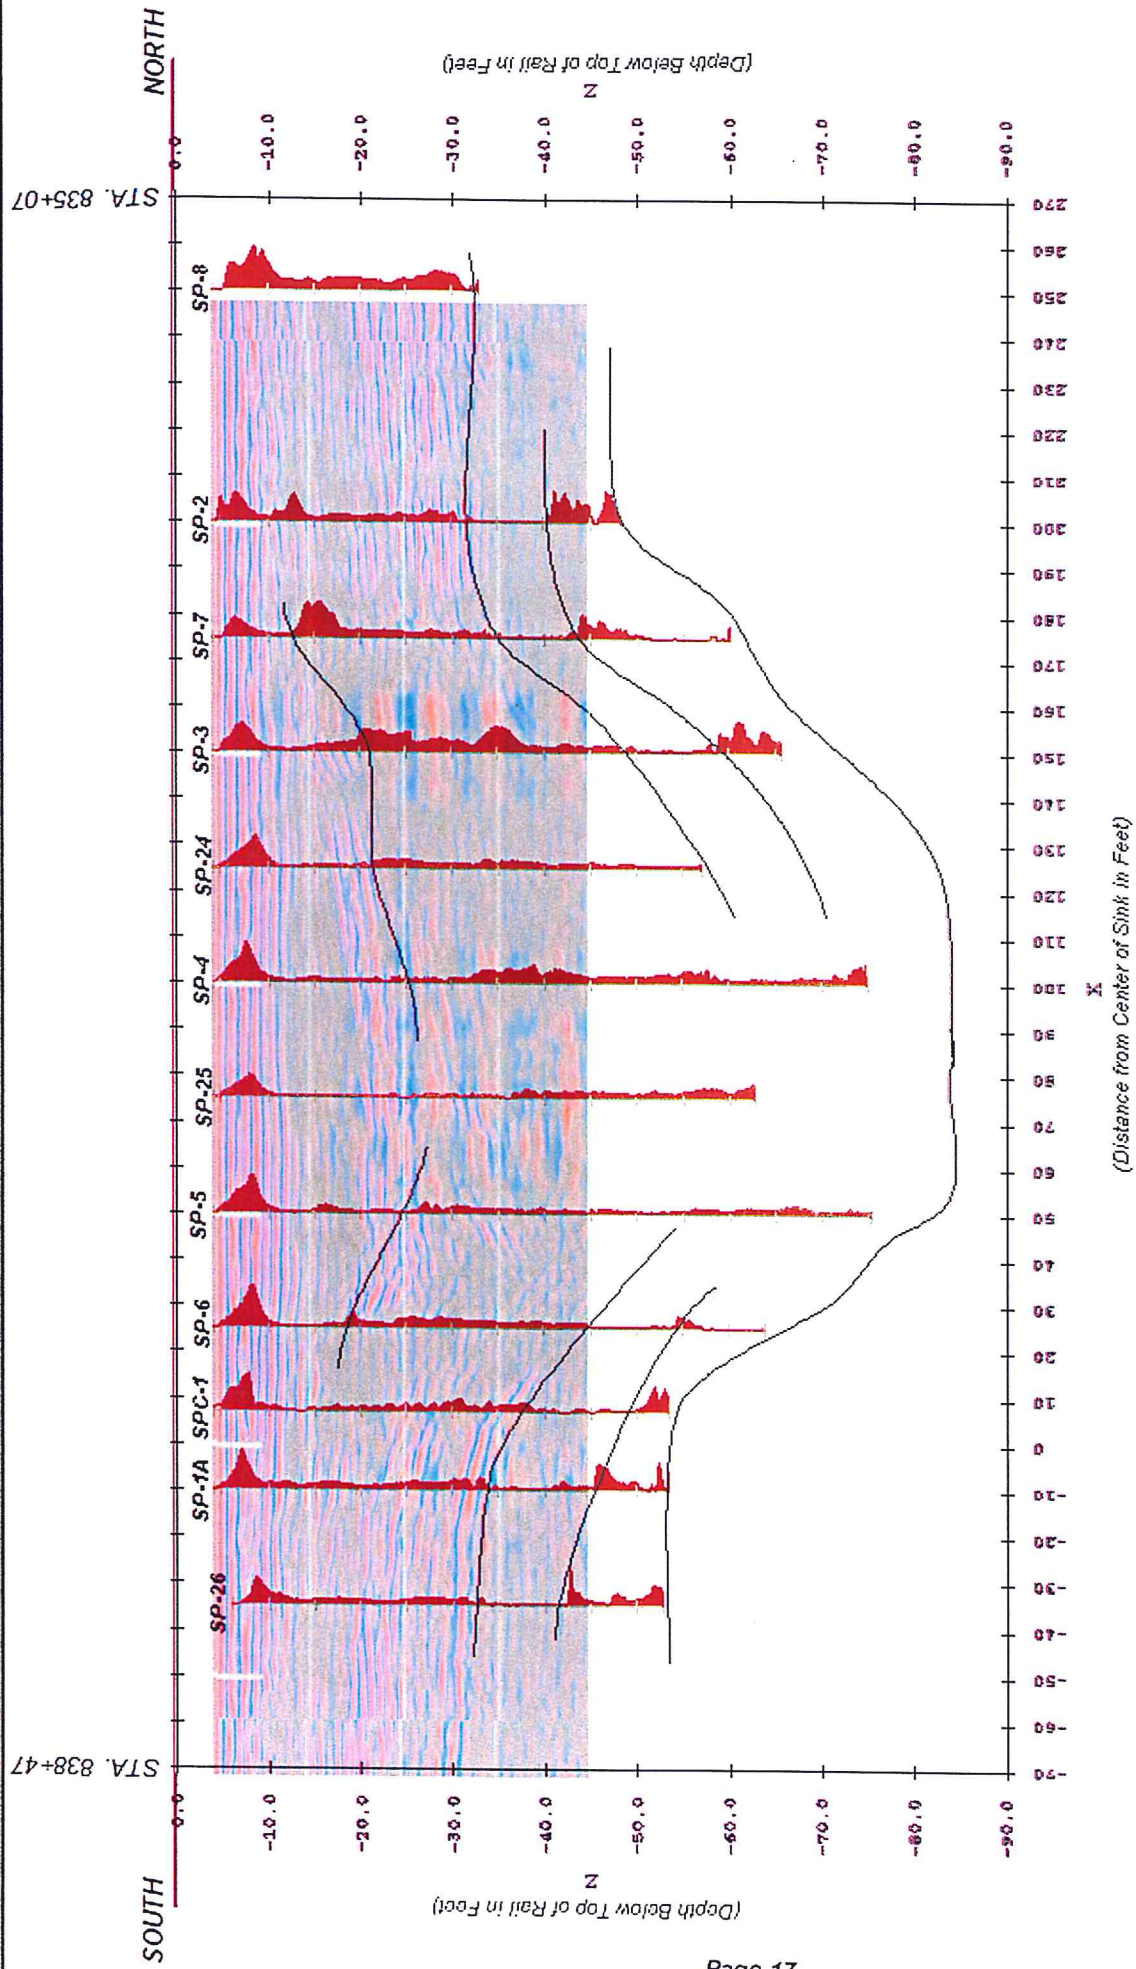
FIGURE 10
AREA "A"
CPT DATA WITH GPR DATA OVERLAY

CPT proved to be an excellent means of confirming the GPR data, obtaining soil strength data, and determining the depth to limestone. CPT cone (tip) resistance proved to be the most useful data to correlate with GPR data. Stratigraphic sections were constructed using cone resistance to group (or classify) soils of relative strength (Figures 7, 8, and 9). The excellent correlation can be seen in an overlay of the cone data (with inferred stratigraphy) by GPR data (Figure 10). Logs of the SCAPS CPT pushes can be found in Appendix B.

Note: CPT curves represent only cone (Qc) data in tons per square foot (TSF).

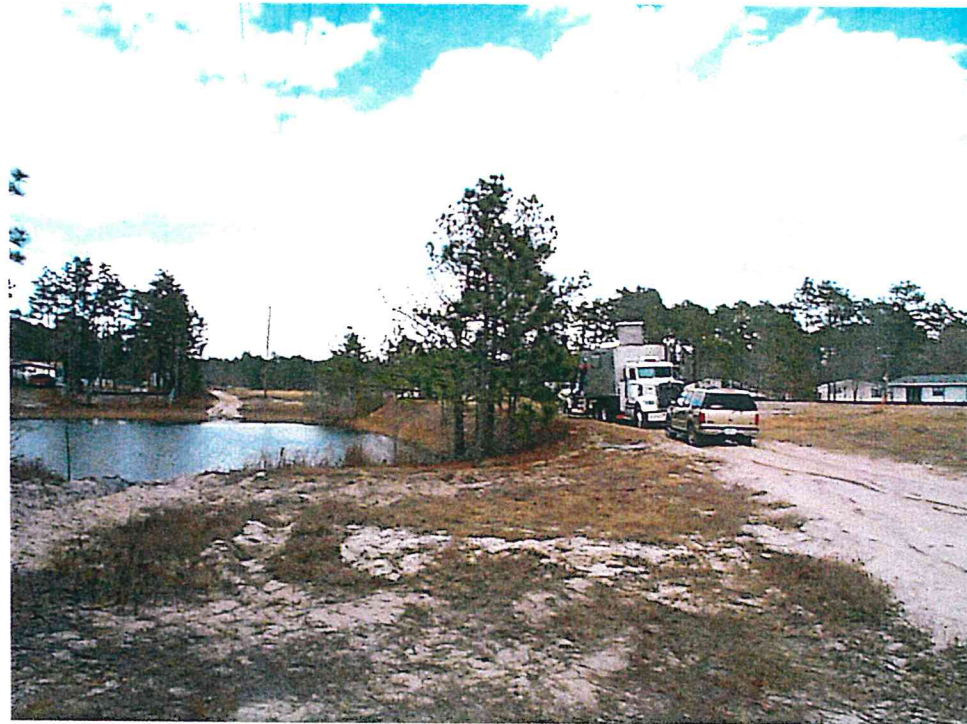
The SCAPS CPT work was started on the west side of the railroad track near the new sinkhole and progressed northward on roughly 50-foot centers (Figure 5 and Photo3). As the work progressed to the east side of the track, the distance between pushes was reduced to roughly 25 feet. Additional pushes on the west side were done to generally fill in between 50-foot pushes. The intent of the CPT work was to try to correlate the GPR data with CPT, determine the strength of the underlying soils, and determine the depth to the top of the limestone. A total of 40 CPT pushes were completed in about 4 days.

Photo 3. SCAPS Rig Between Paleo-Sink Pond and Railroad Track.

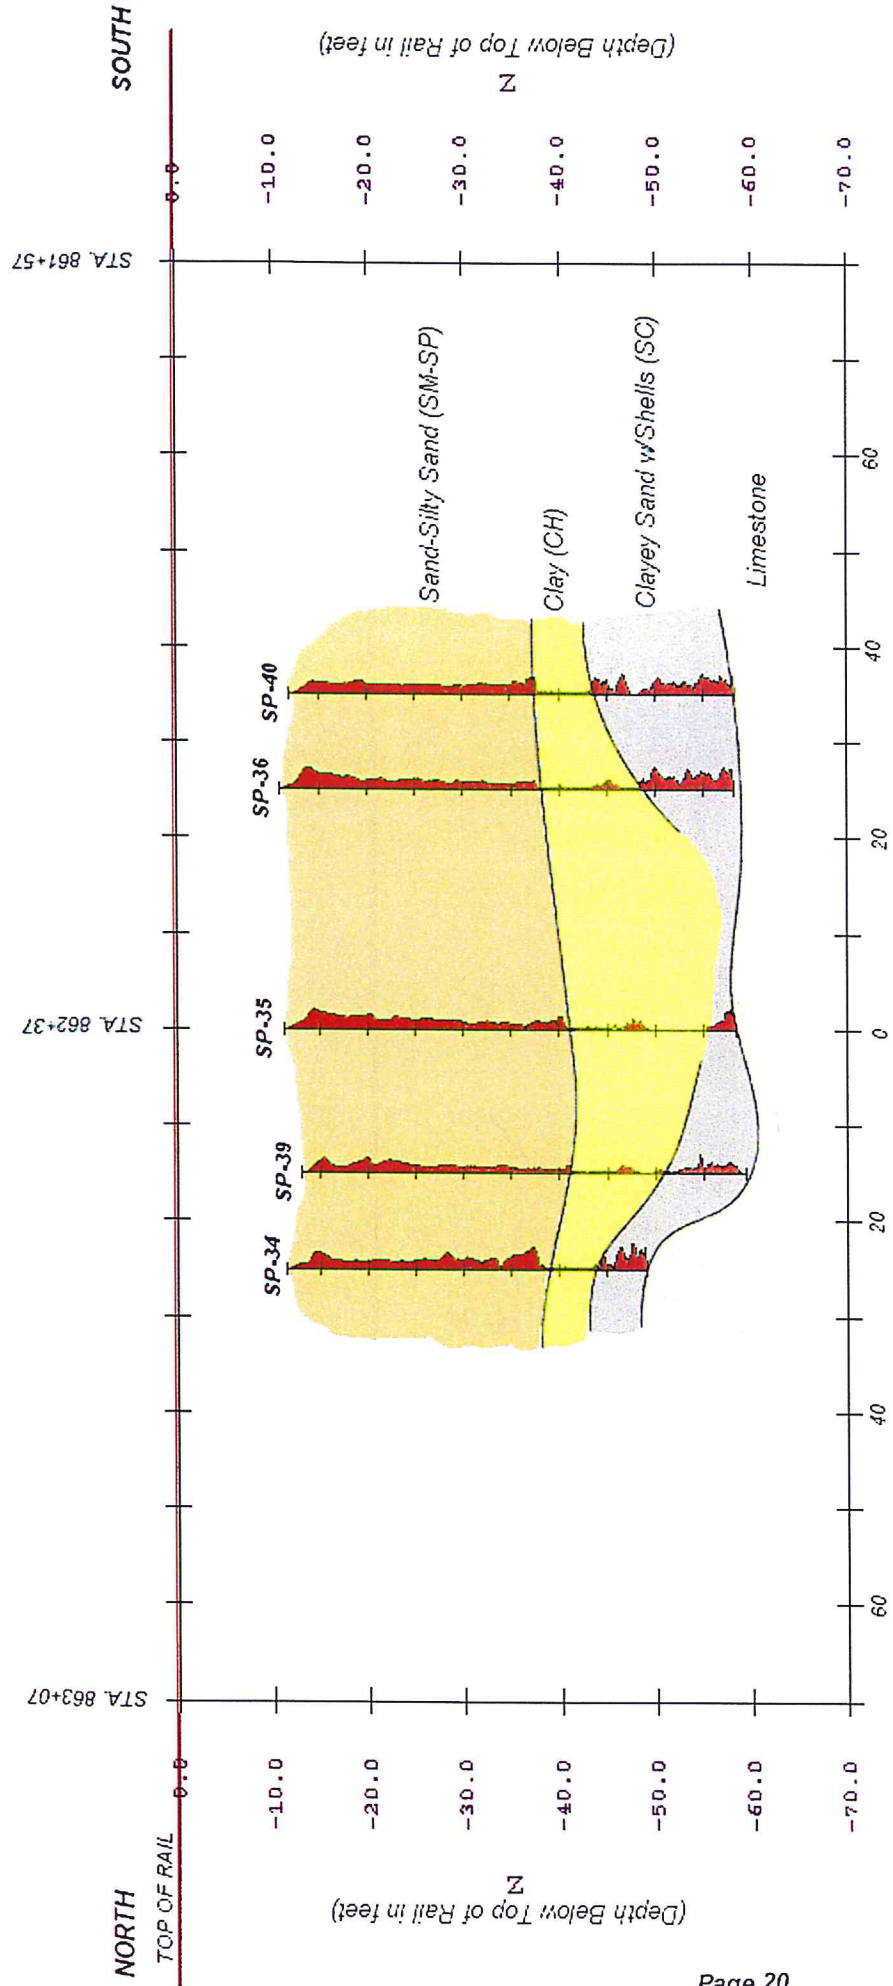
FIGURE 11
AREA "B"
SECTION AT TRACK STATION 862+50

The additional GPR survey along the railroad track south of the new sinkhole, conducted by Geophex Services, revealed a small anomaly underneath the track in an area about 2,400 feet south (towards MOTSU) of the new sinkhole (Geophex Services, Ltd. report in Appendix C). Five SCAPS CPT pushes were made in the area of this anomaly; SP-34, SP-35 and SP-36 on the west side of the track and SP-39 and SP-40 on the east side (Area "B" on Figure 4). Interpreted sections constructed along these pushes (Figures 11 and 12) reveal a zone of disturbed (down-warped) soil from about 40 to 55 feet below the top of the track. The top of limestone in this area appears to be about 60 feet below the top of the track. This zone of disturbed soil is apparently related to a feature in the limestone, which is allowing the soil structure to be gradually weakened and slumped.

- Notes:
1. CPT curves represent only cone (qc) data in tons per square foot (TSF), see push logs for details.
 2. Section represents borings on both east and west sides of track.
 3. This section is located in the area of a GPR anomaly.

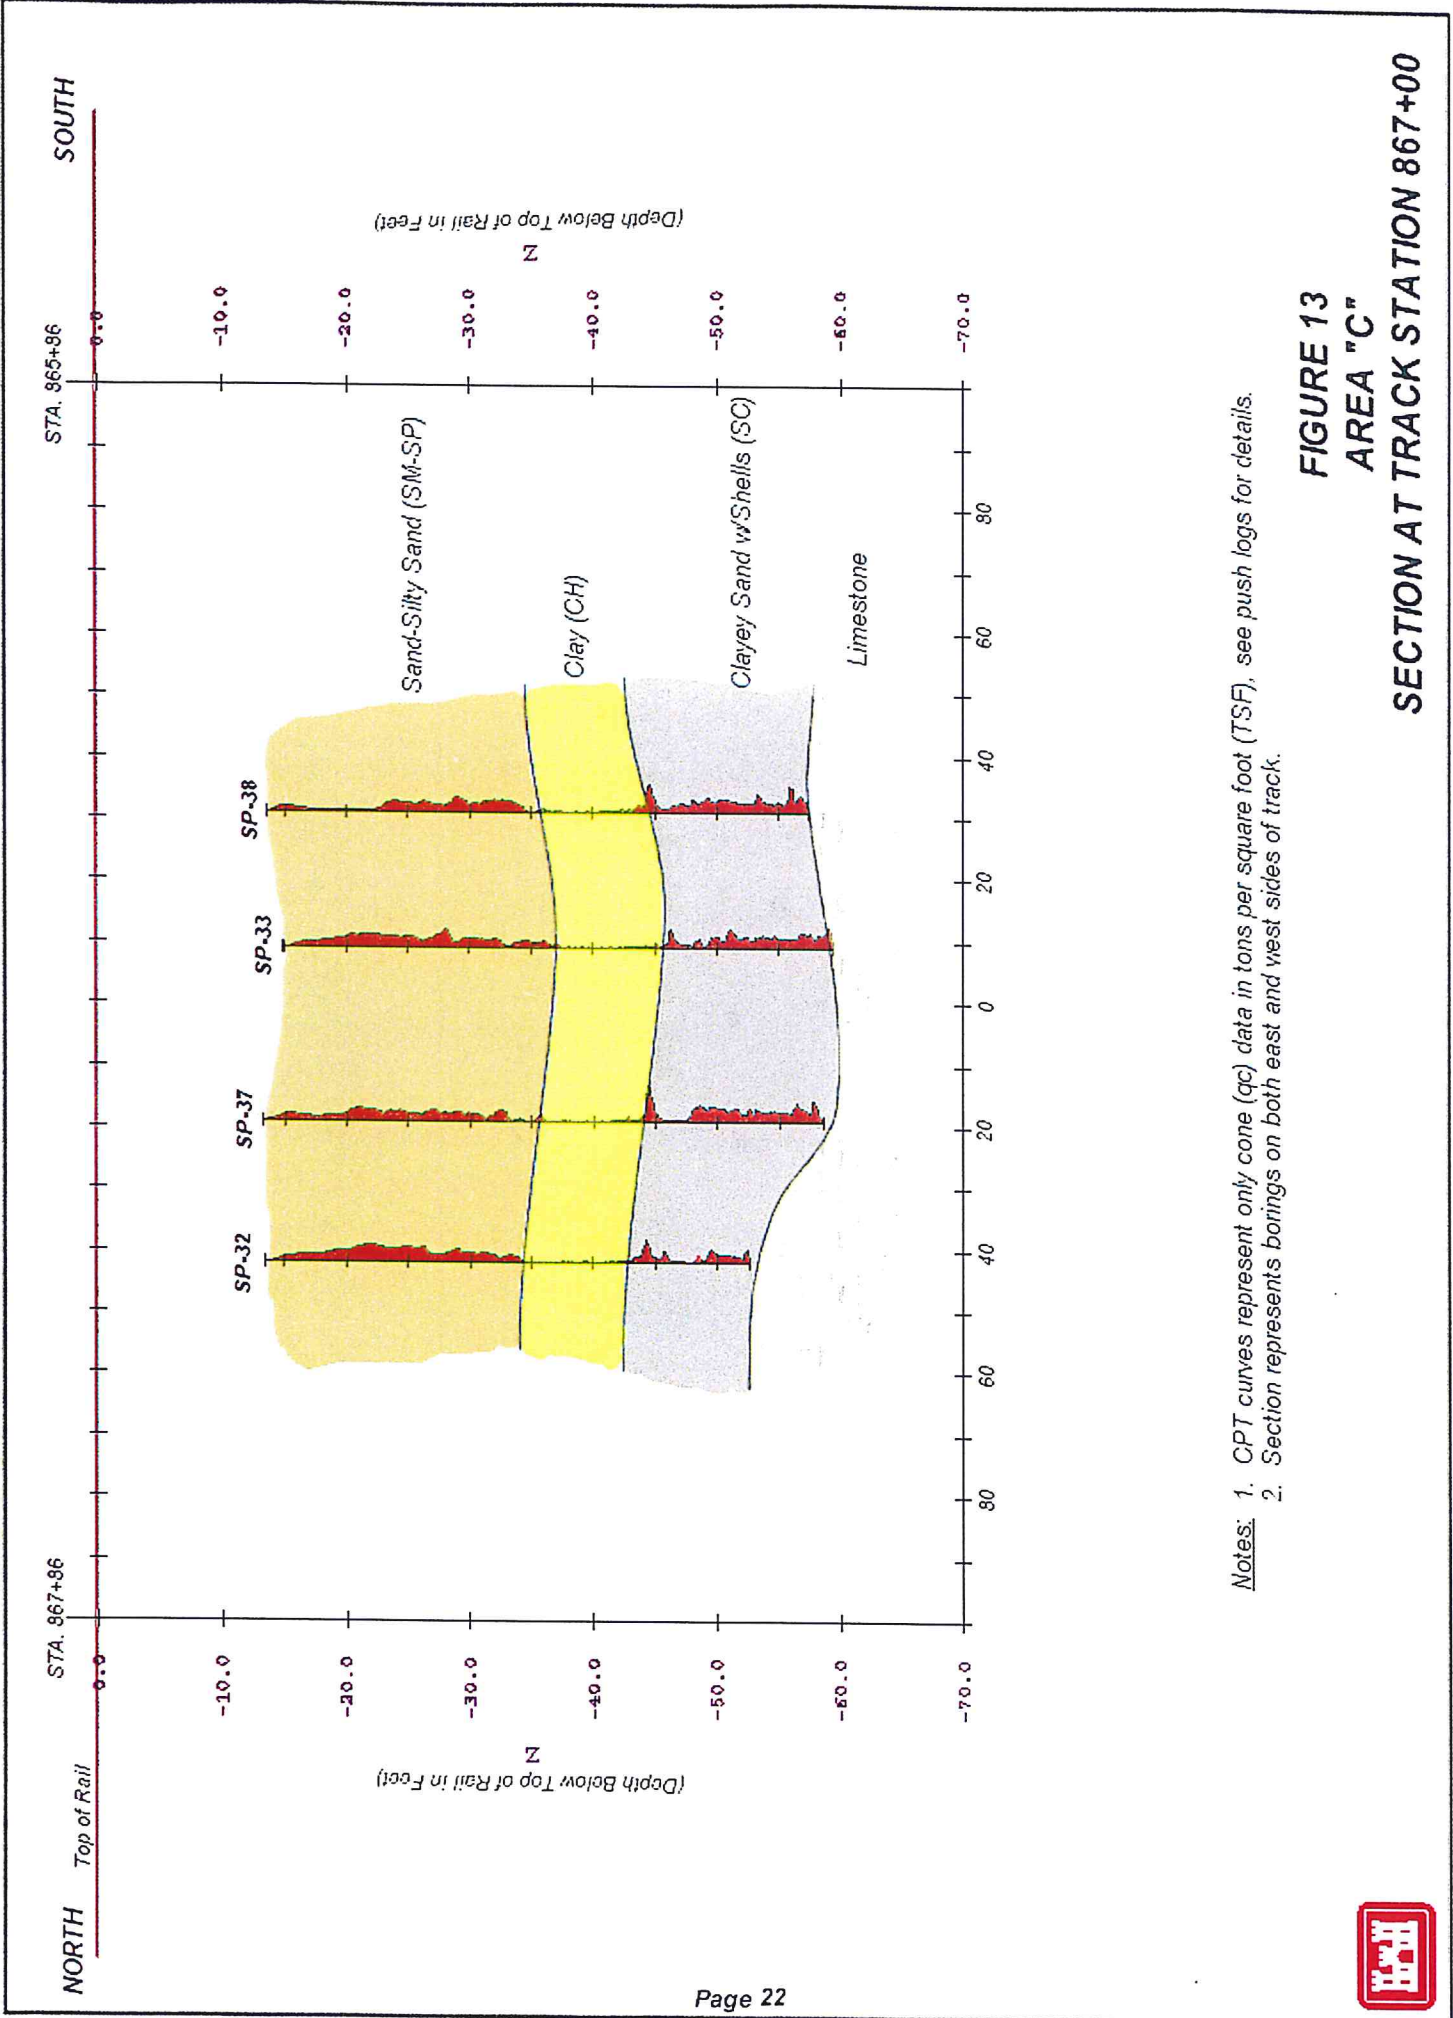
pushes SP-32 and SP-33 were made on the west side of the track, and SP-37 and SP-38 on the east side. An interpreted section along these pushes is shown in Figure 13. These pushes revealed no disturbed or weakened soil zones. GPR results in this area also revealed no anomalies.
