CITY OF BOILING SPRING LAKES

EWP—HURRICANE FLORENCE RECOVERY
ISSUE FOR REVIEW & PERMITTING

October 2020

PREPARED BY:
LDSI, Inc.

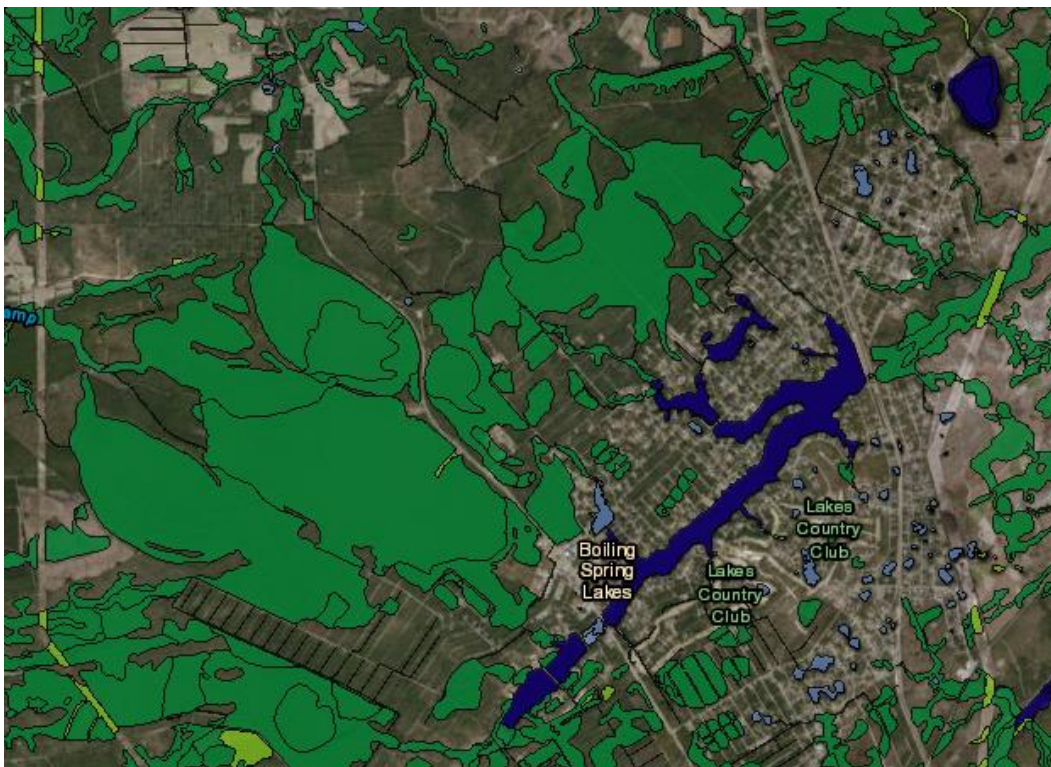
Figure 1: National Wetlands Inventory Wetlands map of Boiling Spring Lakes

The City of Boiling Spring Lakes lies within the coastal plain of North Carolina and is surrounded by predominantly Pineland, Drained Wetlands, and residential areas. The soils present within the project sites are primarily sandy, well-drained soils that are typical of North Carolina's Coastal Region. The damage done to the nine sites within the project was caused by approximately 29.5 inches of rainfall that occurred during Hurricane Florence. This resulted in severe debris build up, stream bank erosion, scour, shoreline erosion, and damage to dams. The existing conditions of the nine specific project sites is listed below.

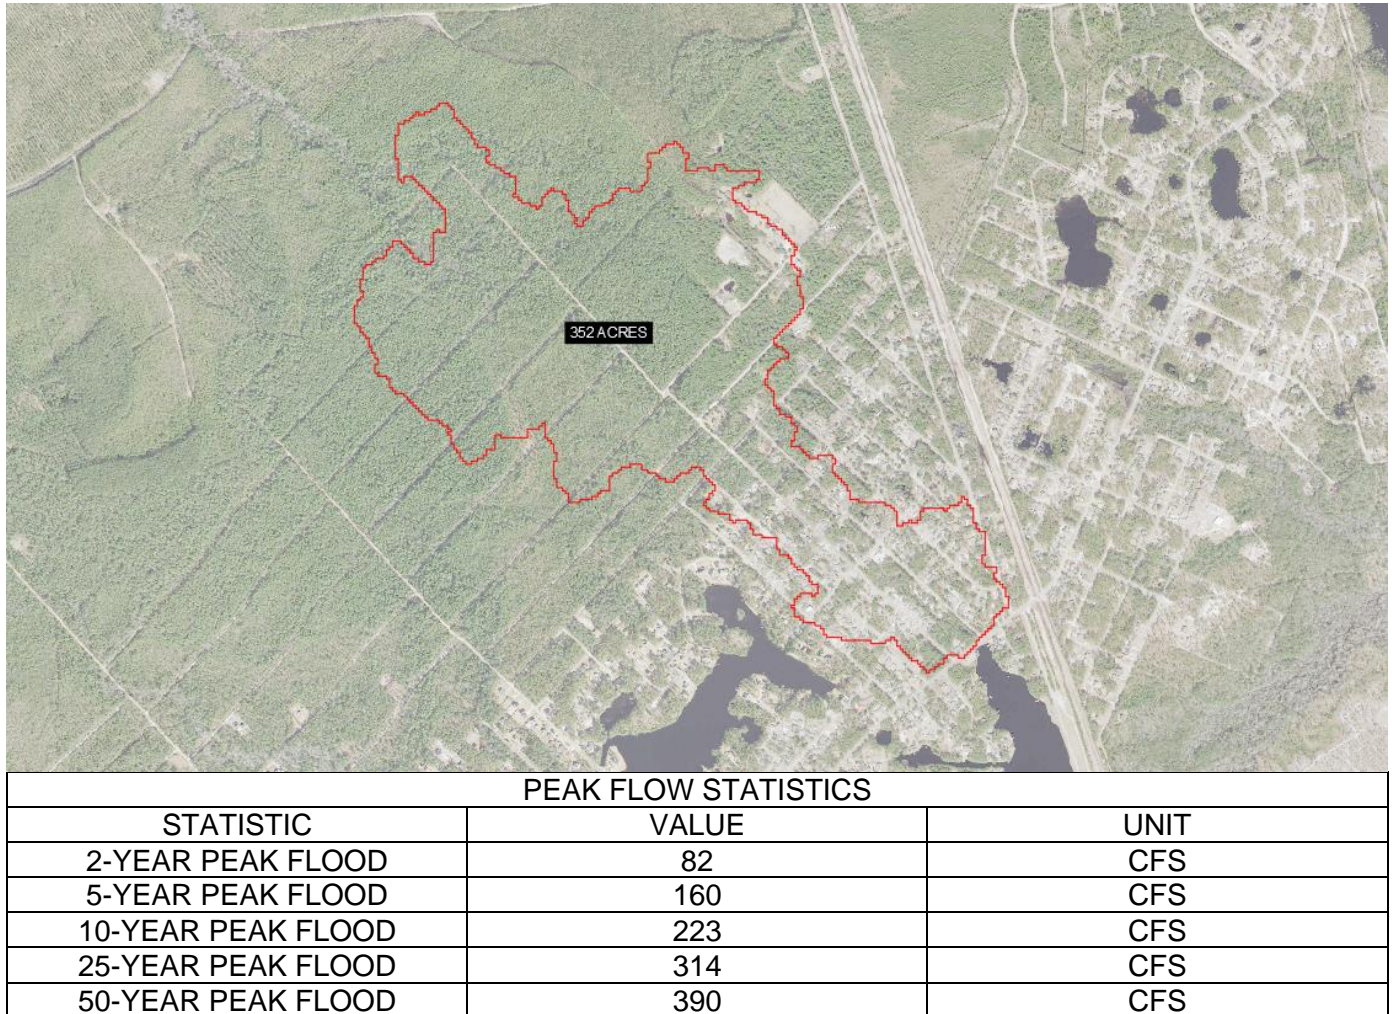
Figure 2: StreamStats Watershed and Peak Flow Statistics for the Cherry Road Stream

Watershed characteristics for the Cherry Road stream were determined primarily through the USGS StreamStats tool along with field reconnaissance. It was found that the watershed draining into the Cherry Road stream is approximately 350 Acres in size and has a 50-year peak flow of approximately 390 CFS (Figure 2). A detailed Drainage Area and Soils Map for the watershed leading to the stream at Cherry Road can be seen in Appendix A.

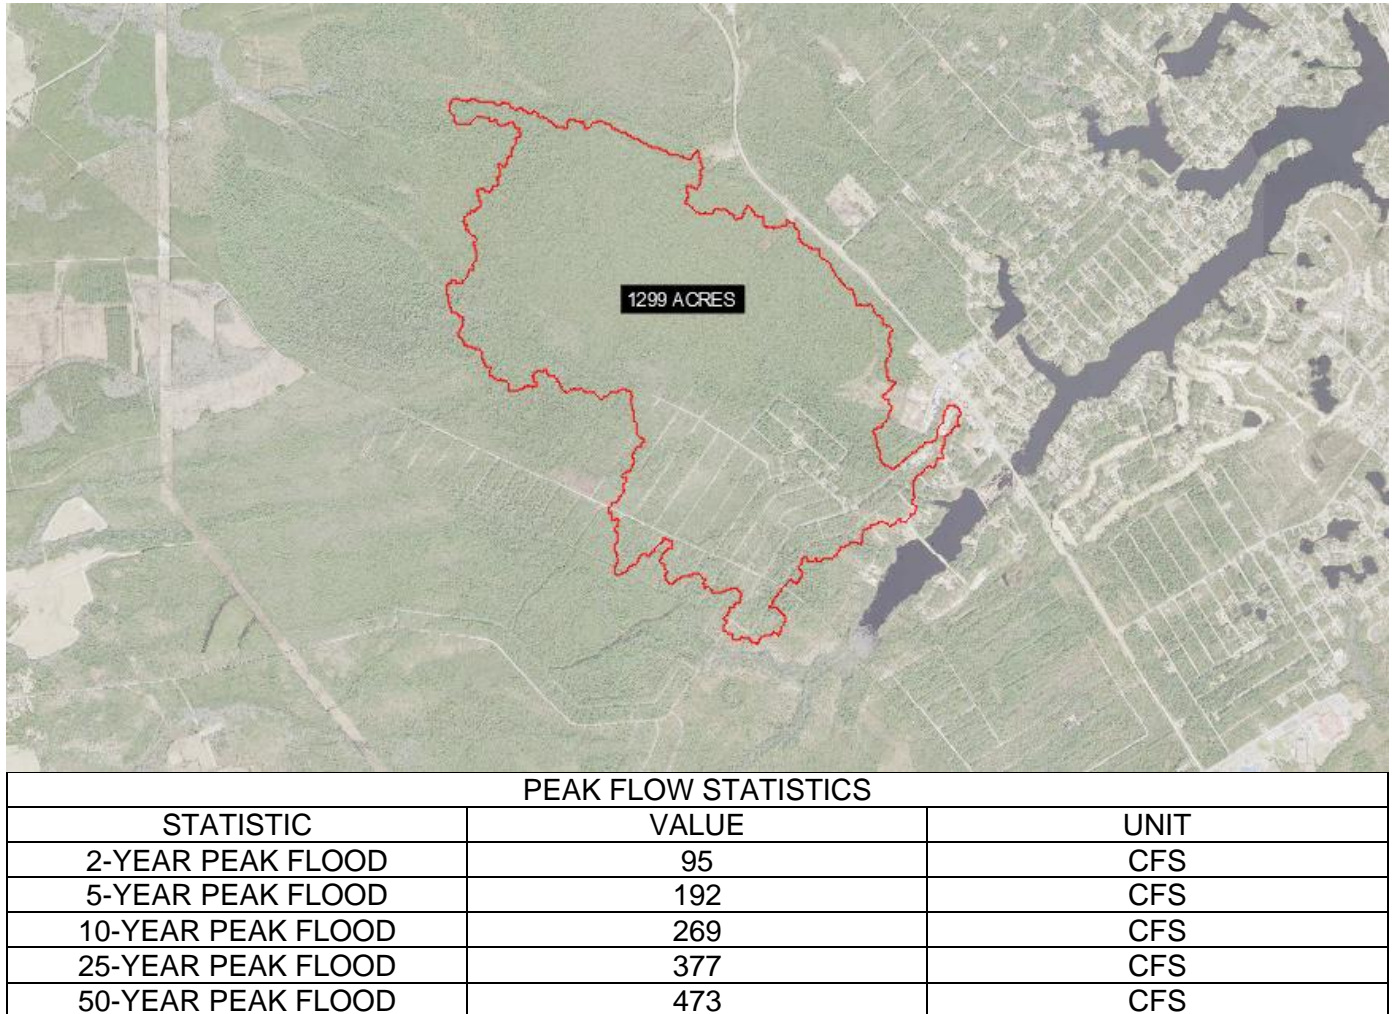
Figure 4: StreamStats Watershed and Peak Flow Statistics for the Hunters Road Stream

Watershed characteristics for the Hunters Road stream were determined primarily through the USGS StreamStats tool along with field reconnaissance. It was found that the watershed draining into the Hunters Road stream is approximately 1300 Acres in size and has a 50-year peak flow of approximately 473 CFS (Figure 4). A detailed Drainage Area and Soils Map for the watershed leading to the stream at Hunters Road can be seen in Appendix A.

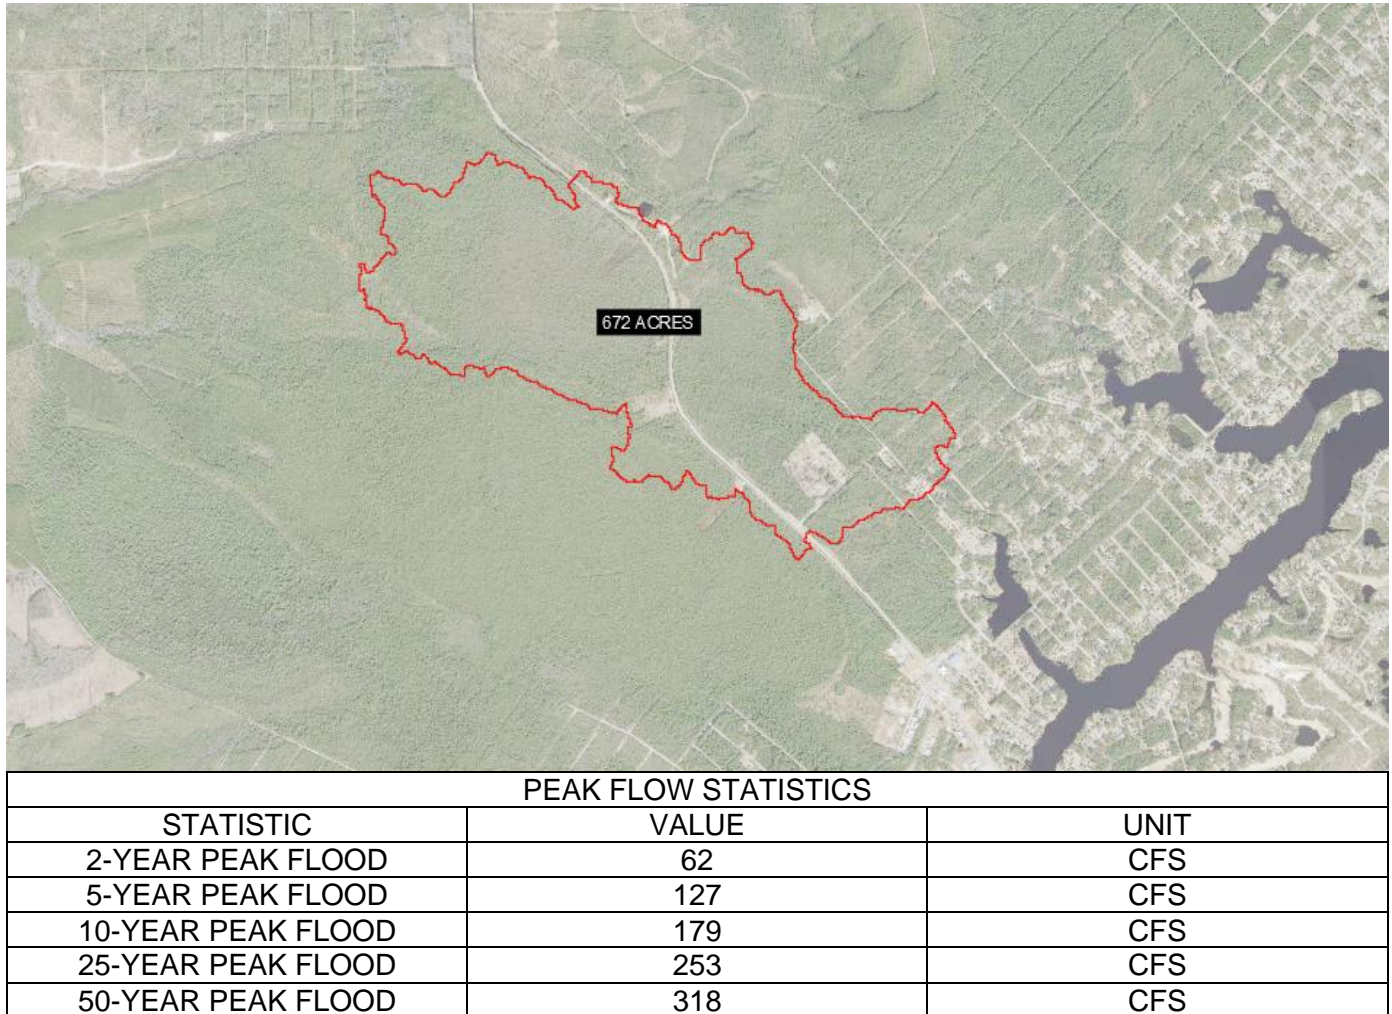
Figure 6: StreamStats Watershed and Peak Flow Statistics for the Pine Lake Road Stream

Watershed characteristics for the Pine Lake Road stream were determined primarily through the USGS StreamStats tool along with field reconnaissance. It was found that the watershed draining into the Pine Lake Road stream is approximately 670 Acres in size and has a 50-year peak flow of approximately 318 CFS (Figure 6). A detailed Drainage Area and Soils Map for the watershed leading to the stream at Pine Lake Road can be seen in Appendix A.

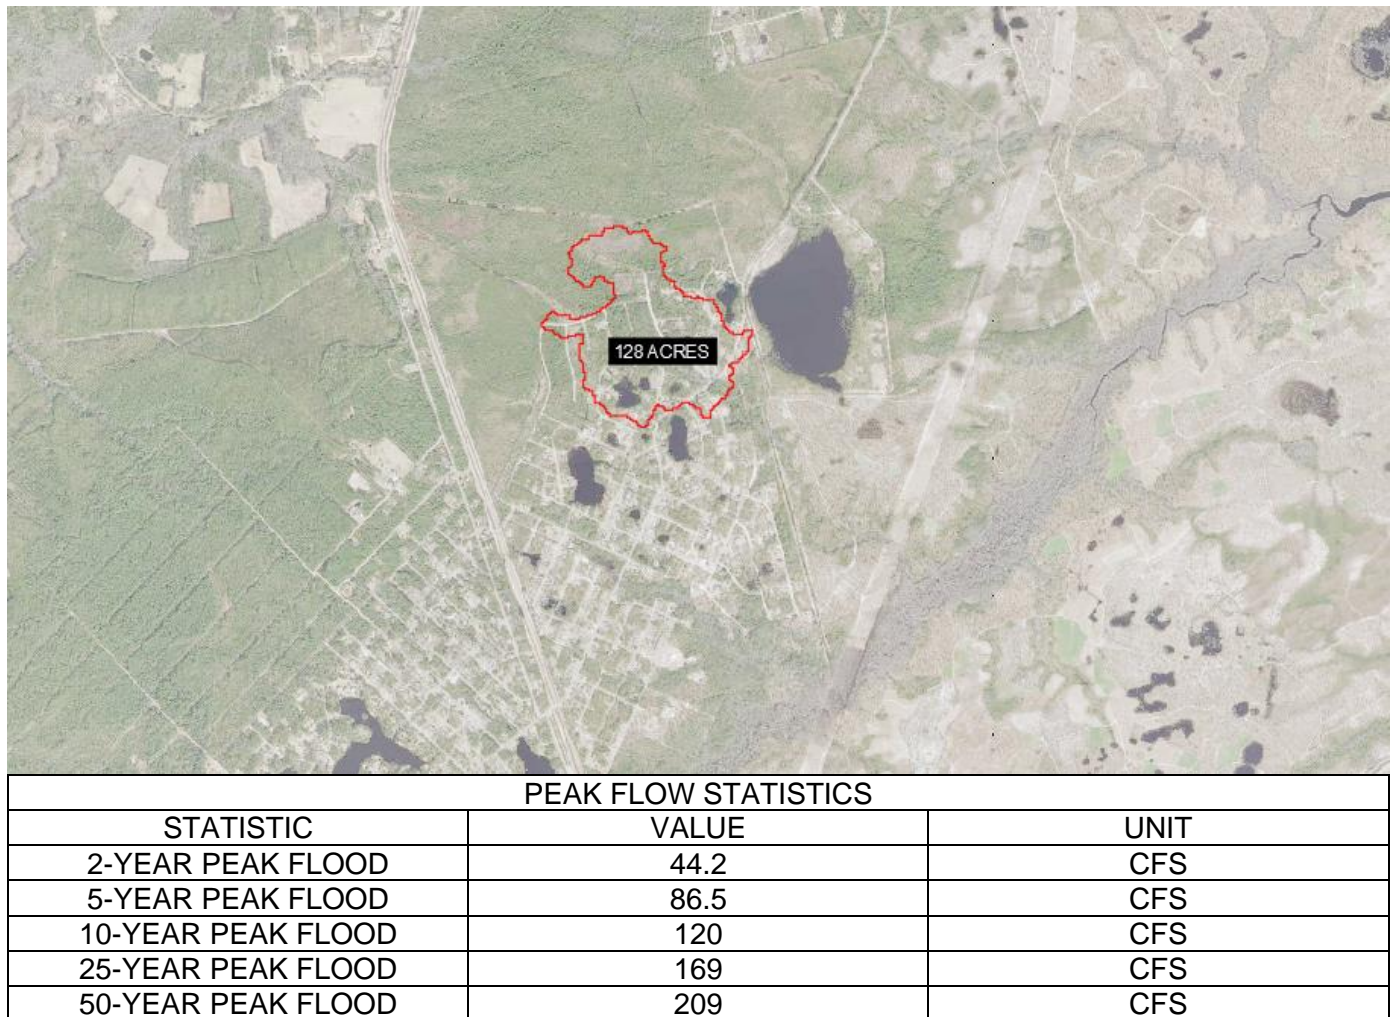
Figure 8: StreamStats Watershed and Peak Flow Statistics for Allen Creek

Watershed characteristics for Allen Creek were determined primarily through the USGS StreamStats tool along with field reconnaissance. It was found that the watershed draining into Allen Creek is approximately 130 Acres in size and has a 50-year peak flow of approximately 209 CFS (Figure 8). A detailed Drainage Area and Soils Map for the watershed leading to Allen Creek can be seen in Appendix A.
