City of Boiling Spring Lakes
9 East Boiling Spring Road
Southport, NC 28461

STAFF REPORT

Stormwater Department Status of Work Completed

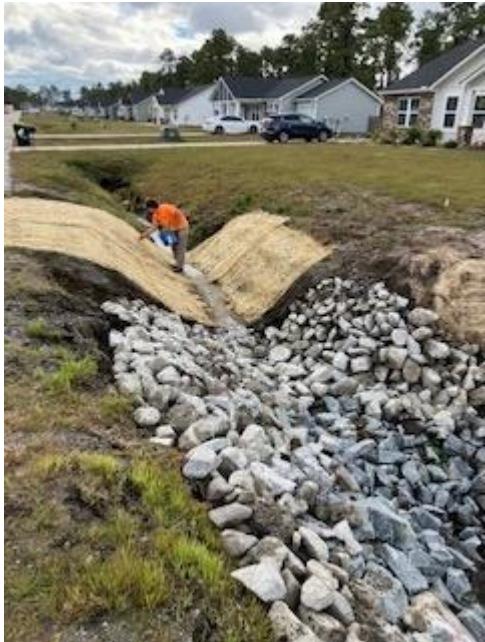
Golf View Ditch Restoration

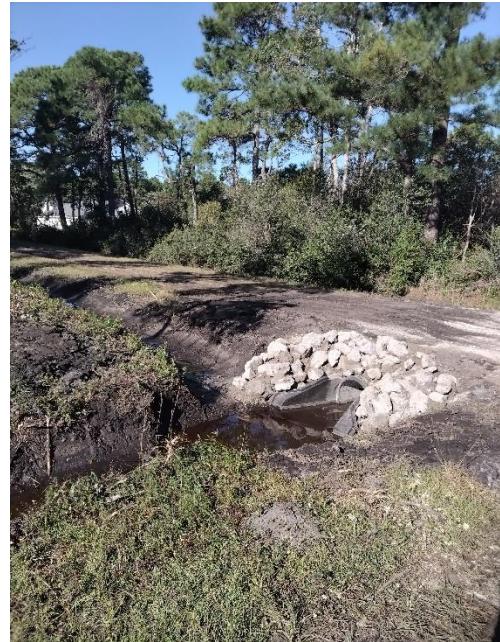
Pipe Culvert Replacement with flared end section and rip rap protection

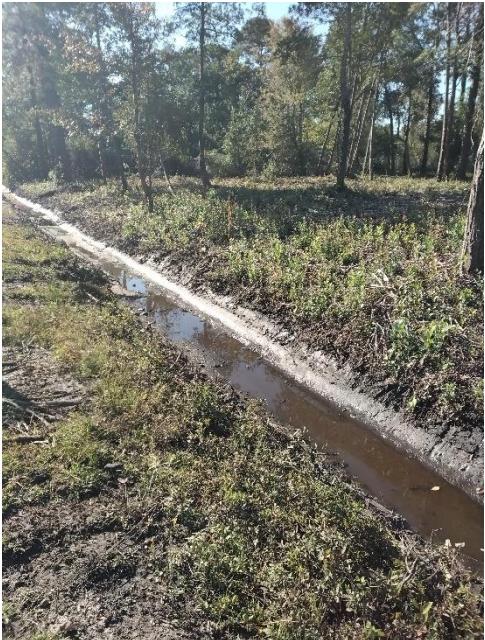
Newly reshaped and cleaned Roadside ditch

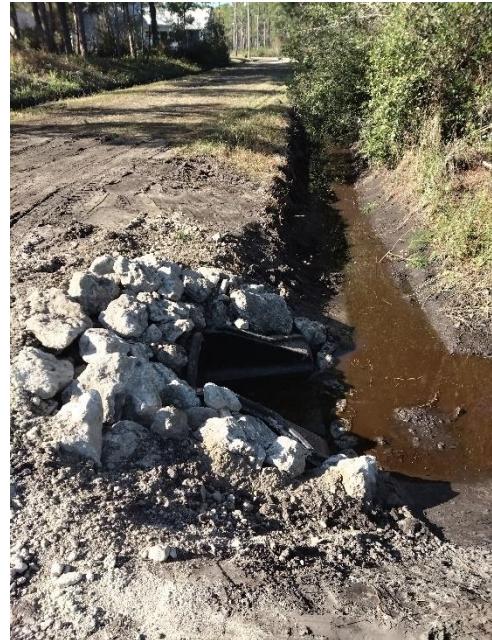
Pipe Culvert Replacement with flared end section and rip rap protection

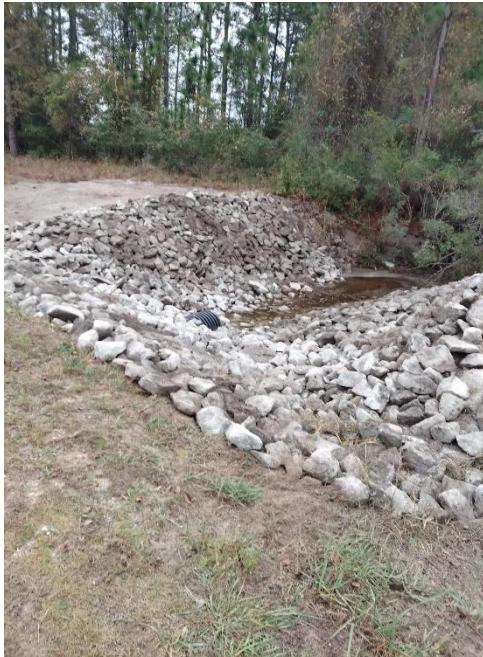
Primary Discharge with Rip Rap Protection-North Hills Drive

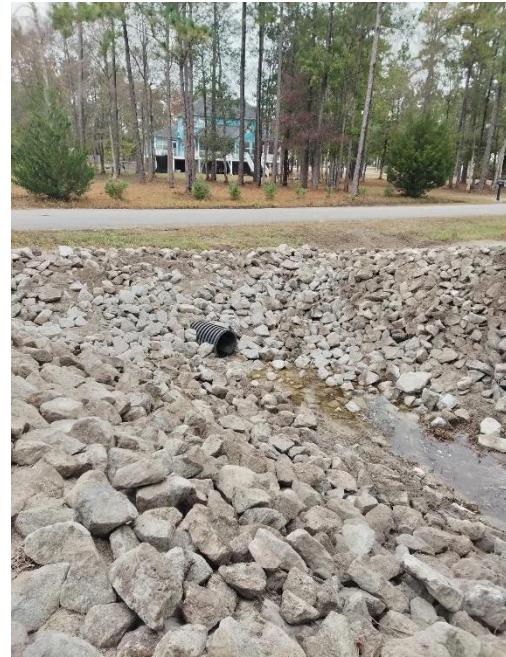
Primary Discharge with Rip Rap Protection-North Hills Drive

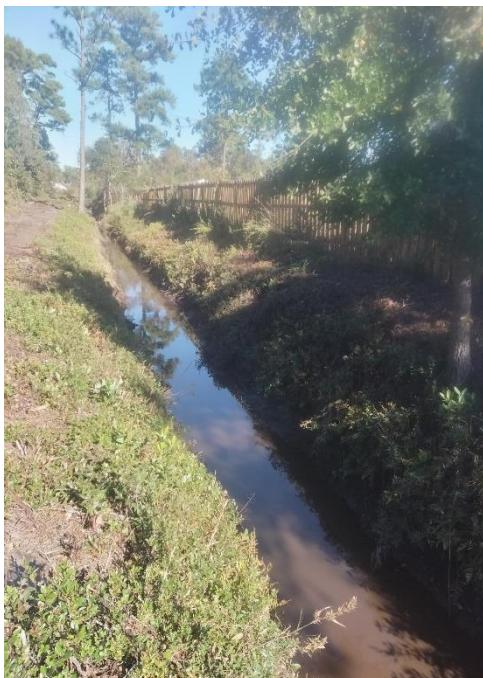
Primary ditch cleaned and groomed with maintenance path @ Gold View

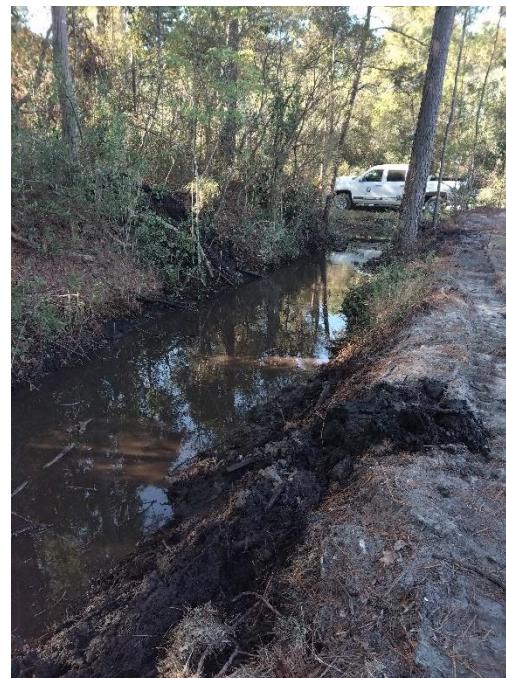
Primary ditch restoration
Goldsboro Road

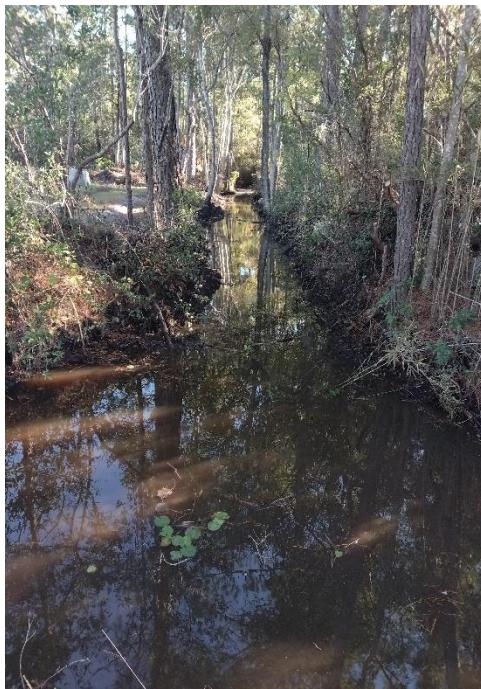
Primary ditch restoration
Goldsboro Road

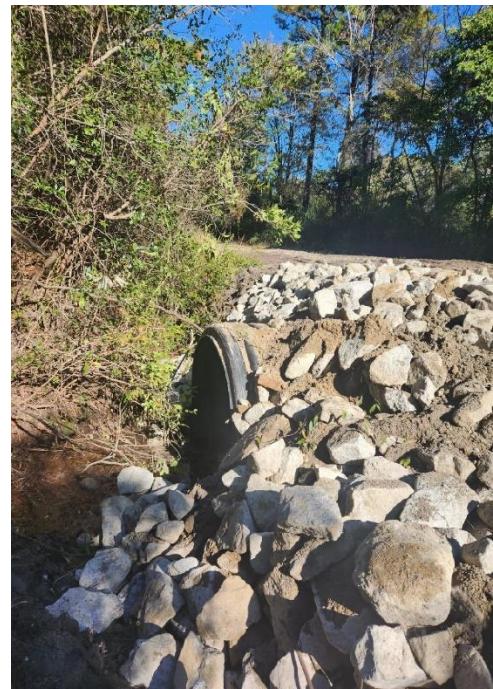
Beech Road Culvert Replacement

In addition to the ditching, several new culverts have been installed throughout the city, including a large 60 inch HDPE pipe at the intersection of Beech Road and Cherry Road. This road has been closed for awhile due to the large washout from previous storms. Other areas with culvert replacements are Liberty and Kannapolis and W. Boiling Spring Road. As we inspect areas of concern it has become apparent the older culverts that are galvanized metal pipe are deteriorating and causing issues. As we investigate further, pipes that seem problematic will be replaced with new High Density Polyethylene Pipe (HDPE). This material is standard for stormwater systems and has a high corrosion-resistance, durable with long service life.

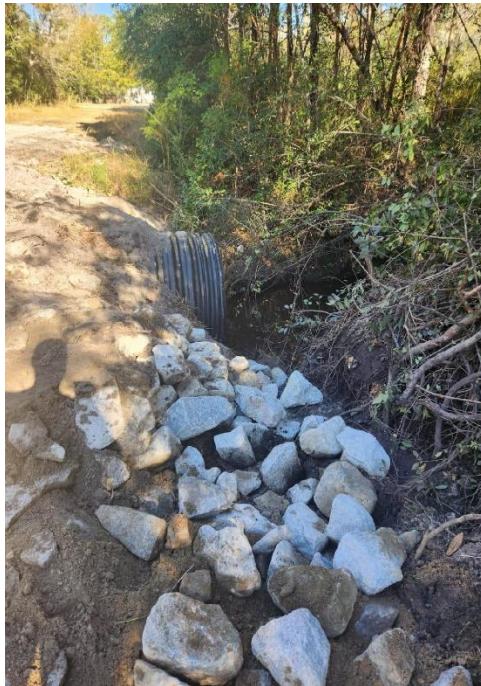
Beech Road Culvert Replacement
