City of Boiling Spring Lakes

STAFF REPORT

Stormwater Department Status of Work Completed

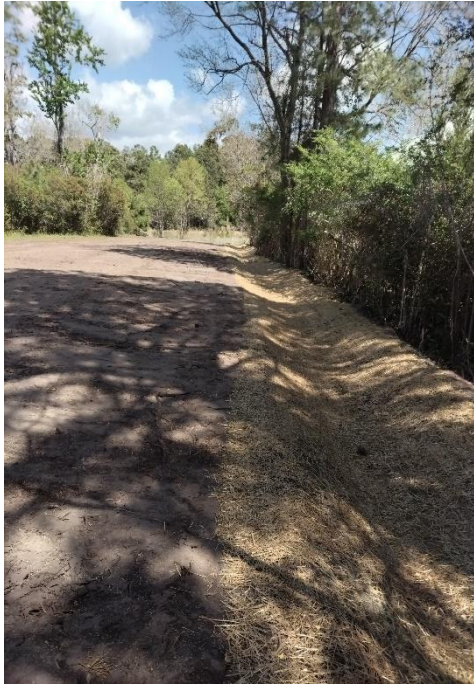
North Shore Drive
Stormwater Management
Swale Construction

In addition to ditching and stormwater maintenance, the team has finished the North Shore Drive stormwater project. This project included the removal of an existing 24" perforated pipe that has become clogged with roots and silt and continuously underperformed and caused flooding to adjacent property owners. The existing 24" perforated pipe was removed and replaced with a new 24" HDPE solid doubled wall pipe that will provide increased hydraulic performance for the conveyance of stormwater. The new pipe terminates into a concrete headwall and discharges into a rip-rap plunge pool to minimize scouring and soil erosion. In addition to the new pipe installation, a natural grass swale was constructed at grade to catch additional stormwater during larger rain events that exceed the pipe hydraulic capacity. The swale has been shaped in a parabolic configuration for increased performance and stabilized with matted hay fabric until the vegetation has been established. The swale design will also help reduce run-off velocities and remove pollutants via infiltration through the vegetated section.

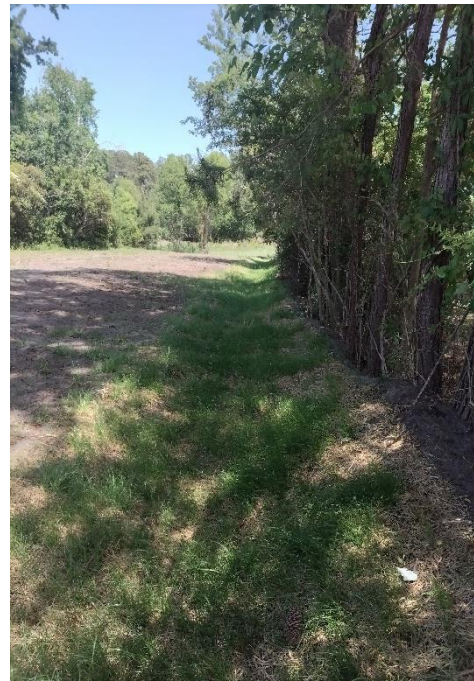
North Shore Drive
Stormwater Management
Stabilized Grass Swale

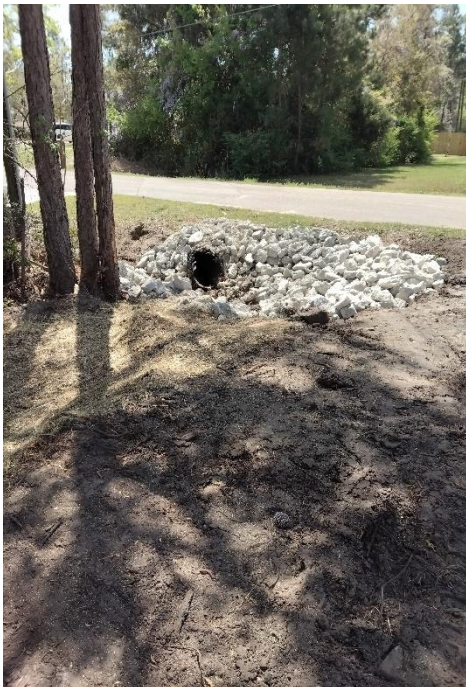
North Shore Drive
Inlet Rip-Rap Protection

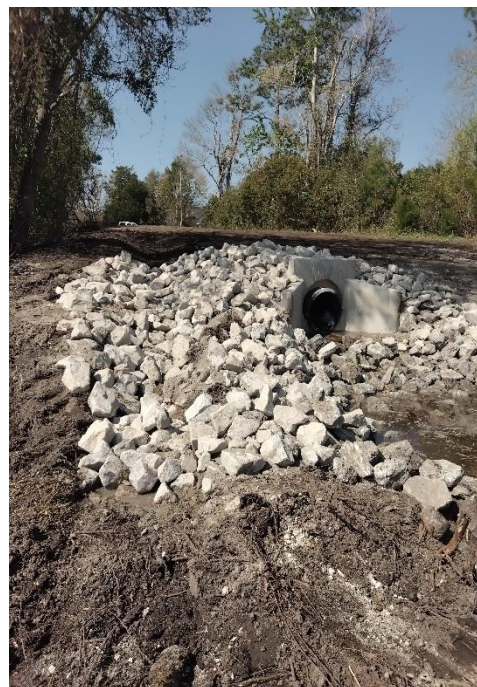
North Shore Drive
Head Wall & Rip-Rap Protection

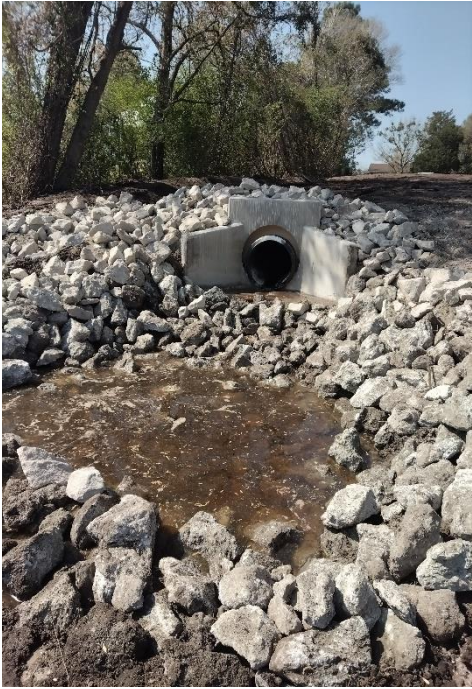
North Shore Drive
Head Wall w/Plunge Pool

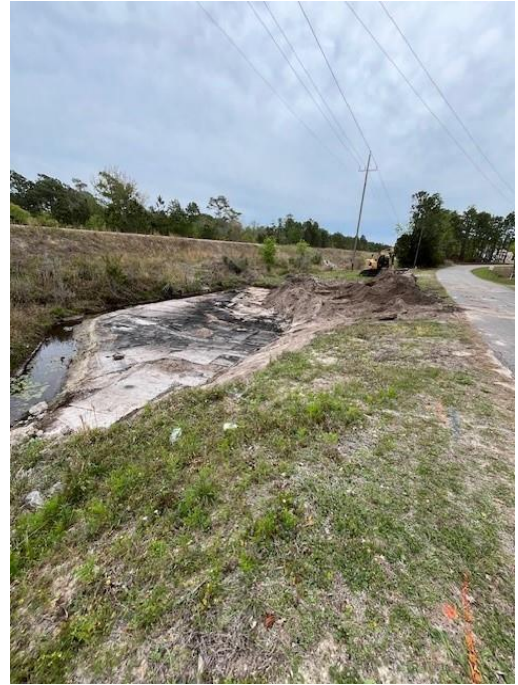
Fifty Lakes Drive
Basin Excavation

Another major stormwater project was located at the railroad tracks along Fifty Lakes Drive. This project consisted of excavating an area of mucky organic soils that was waterlogged and did not

have the ability to recharge into the sub-soil layer. The intent of this project was to remove the saturated material and provide an area for stormwater volume storage prior to entering the existing 60” concrete pipe culvert under the tracks and alleviating some upstream flooding. With coordination and approval from MOTSU, a plan was developed and implemented. The stormwater team spent time excavating, shaping, stabilizing and bank protecting the area. The cut excavation on average is about 2.5 ft. deep with a storage volume capacity of approximately 95,000 gallons of water. This project has been completed and is operational.

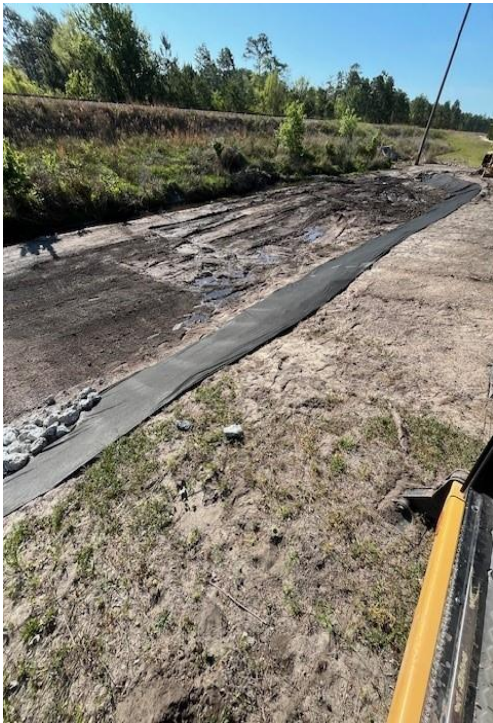
Fifty Lakes Drive
Basin Slope Fabric Underlayment

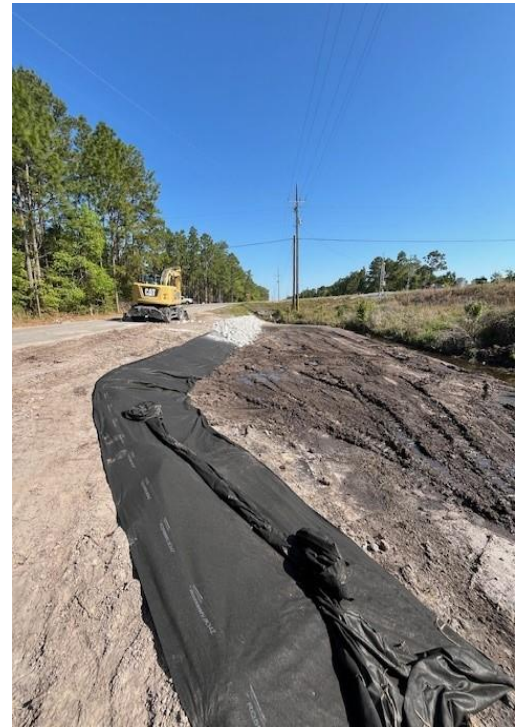
Fifty Lakes Drive
Basin Slope Fabric Underlayment

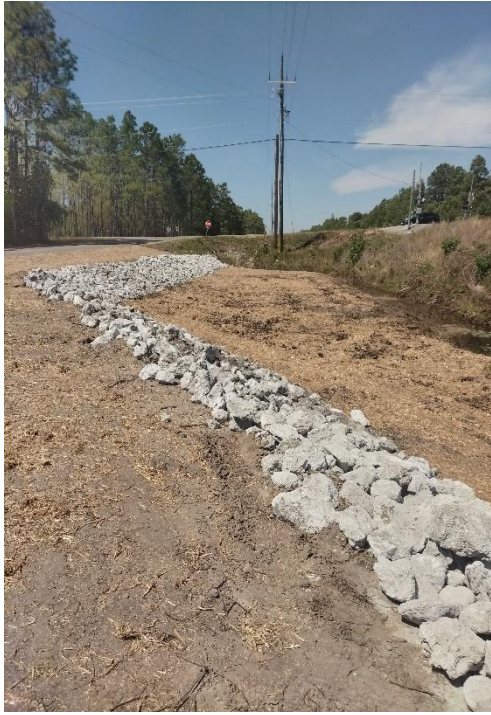
Fifty Lakes Drive
Basin Rip-Rap Slope Protection

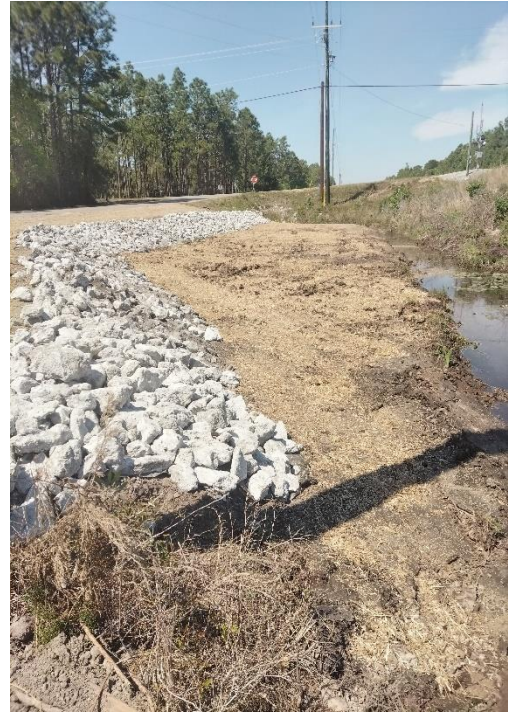
Fifty Lakes Drive
Basin Completion

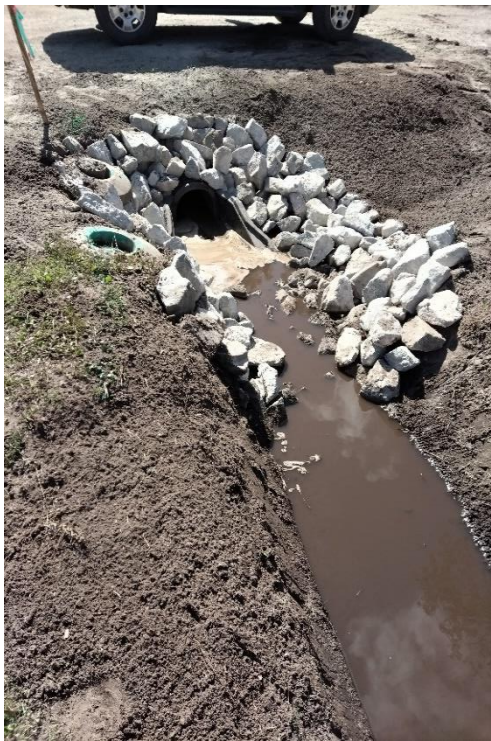
Stormwater Management
General Pipe Outlet Protection

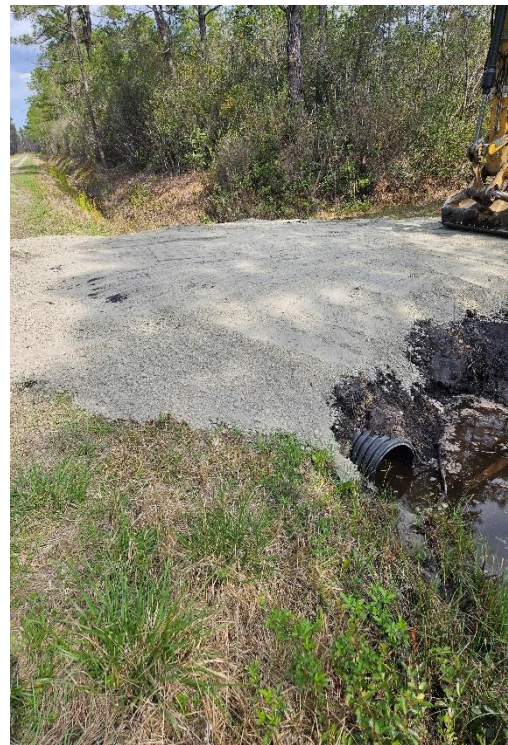
Stormwater Management
Typical Pipe Replacement

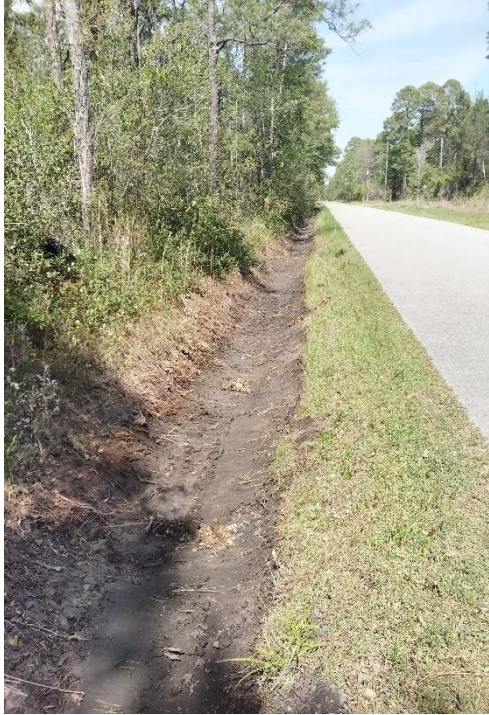
General Roadside Ditching

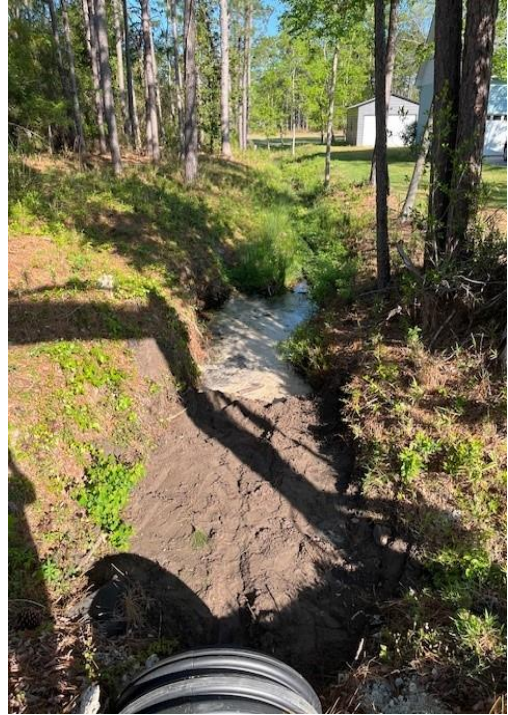
Culvert Scour Hole Repair

In addition to the major projects that are described above, other smaller drainage issues are being corrected that include reshaping a scour hole and adding a flared end section to an existing 48” pipe culvert along Windemere Drive. Another primary ditch along Fifty Lakes Drive is also being cleared of vegetation, reshaped and bank slope protected. This will provide flooding relief upstream that has been problematic in the past. The city stormwater department has been working with local builders as well with regards to individual lot drainage plans. The collaboration between the city and the local builders to mitigate run-off for new development will surely have a welcomed impact to the area. The public works team has also played a part in stormwater management by providing manpower to lake bed maintenance.

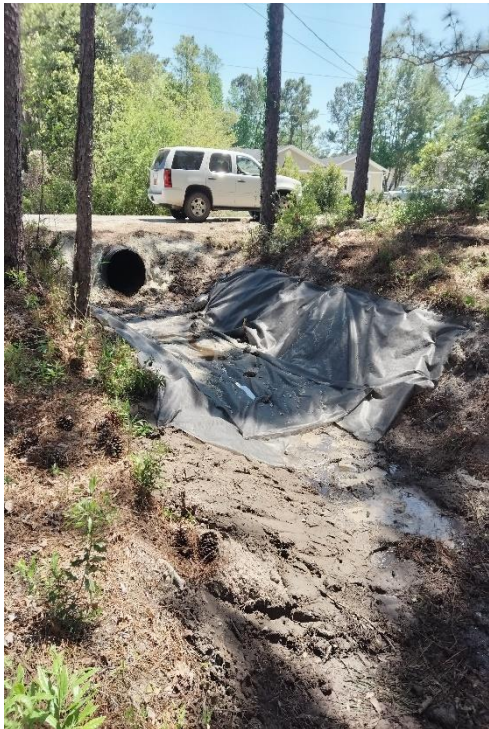
Culvert Scour Hole Repair
Fabric Underlayment

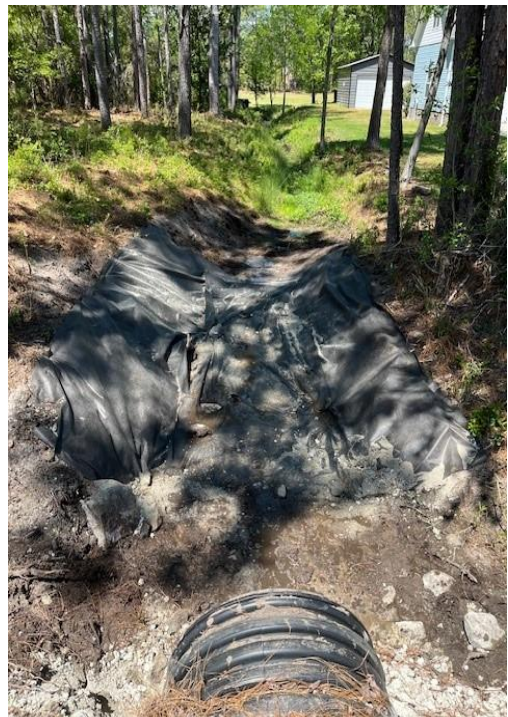
Culvert Scour Hole Repair

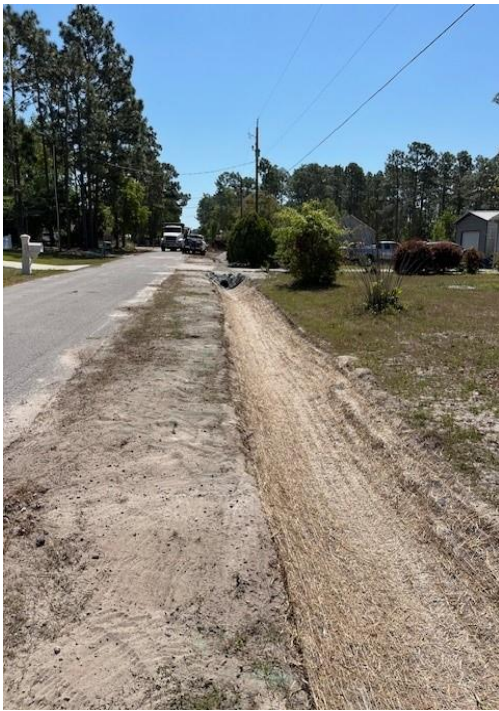
New Ditch Construction

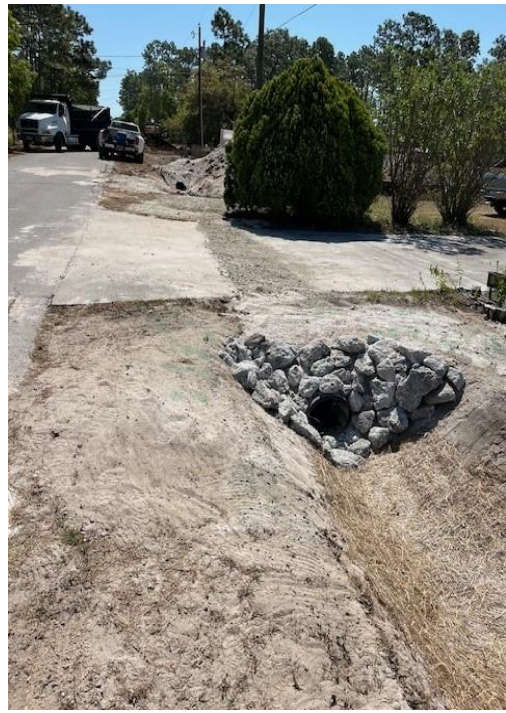
Pipe Culvert Outlet Protection

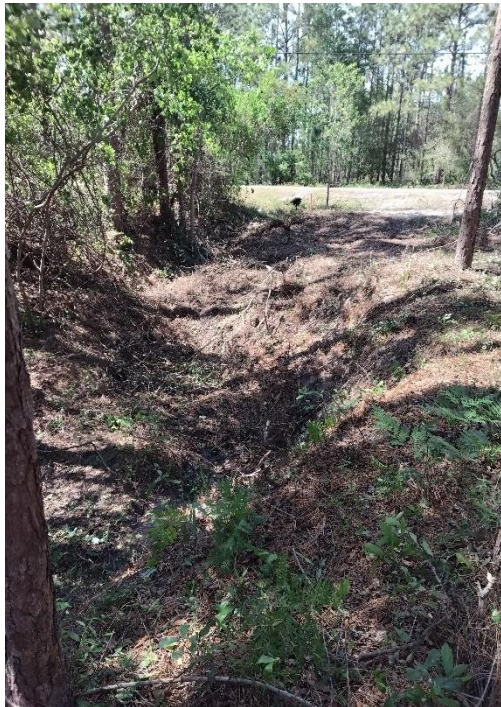
Primary Ditch Clearing
and Re-Shaping

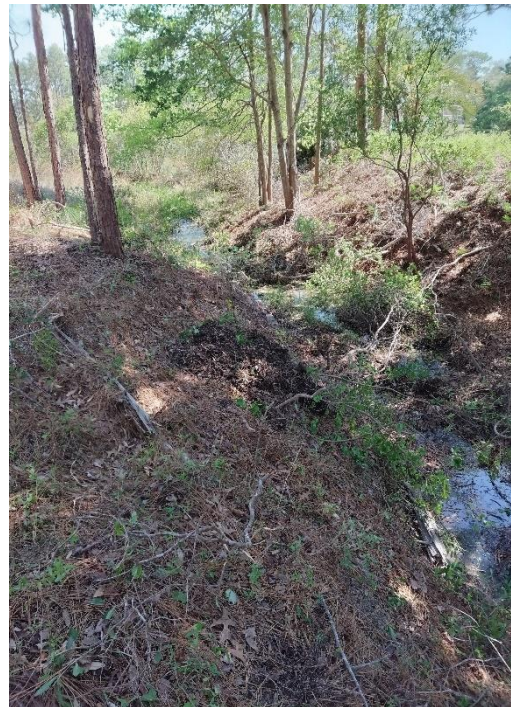
Primary Ditch Clearing
and Re-Shaping

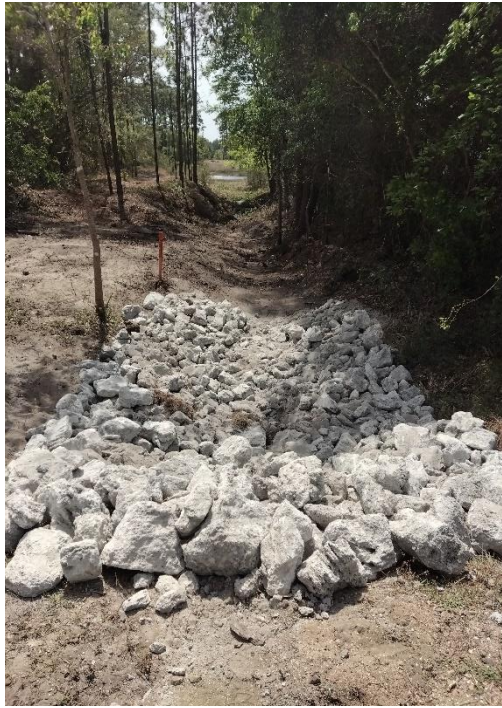
Primary Ditch Clearing
(view downstream)
Re-Shaping and Rip Rap Protection

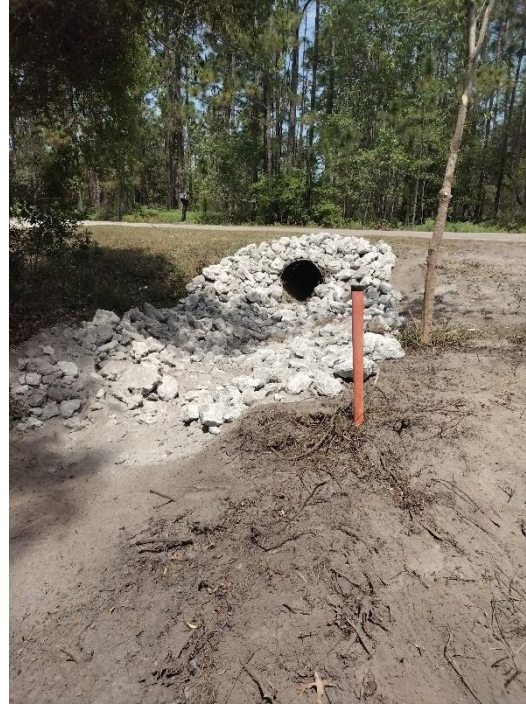
Primary Ditch Clearing
(view upstream)
Re-Shaping and Rip-Rap Protection

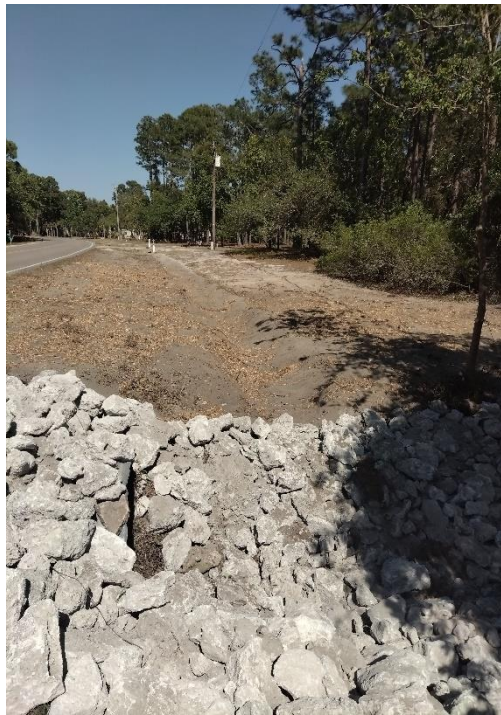
Primary Ditch Clearing
Secondary Roadside Ditch Shaping
